Arboricultural Impact Assessment

Location: 2 Templewood, NW3 7XA

Prepared by Andy Nicol, September 2022

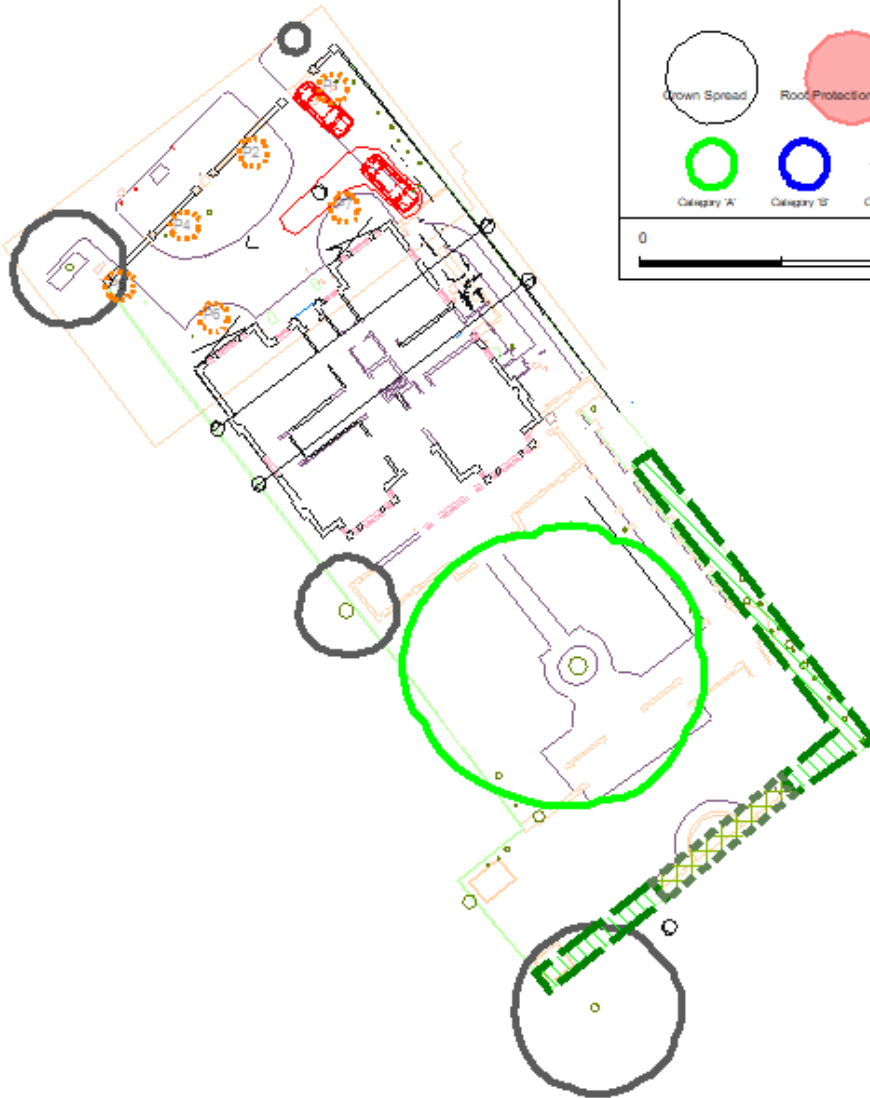
Tree Planting Plan

- Identified on planting plan as P1

- Identified on planting plan as P2 & P3

- Identified on planting plan as P4

- Identified on planting plan as P5 & P6

9.8 Mitigating replacement tree planting will impact positively on the areas sylvan character, see Appendix 7 for proposed locations and 8.2 above for recommended species.
