### A SHORT INVESTIGATION INTO AND REPORT ON THE HISTORIC METALWORK WINDOW GRILLS AT No 42 BEDFORD SQUARE, BLOOMSBURY, LONDON

OCTOBER 2022

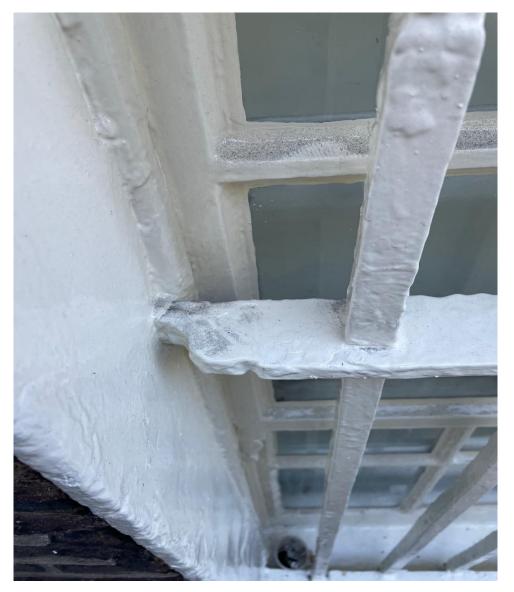
Type 1 diamond/square bar spigot into reveal

Type 1, a horizontal punched flat bar with diamond/square set spigot ends set approximately 5 ft from the base. Simple pyramidal finals, square bars with base square plate form the grill.

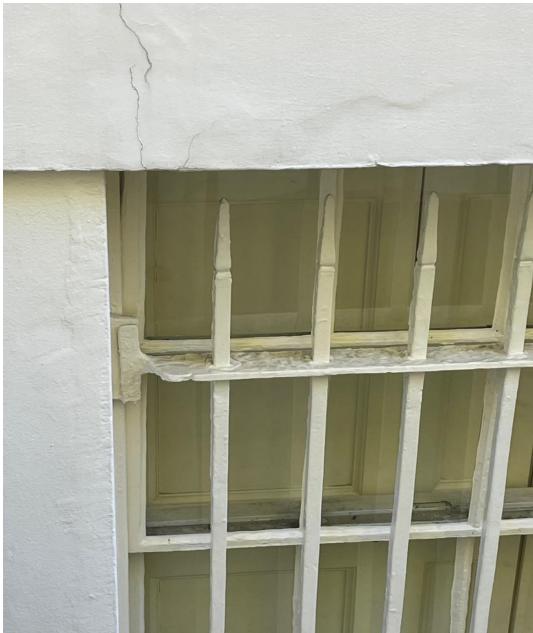
Type 2 bracket fixing to reveal

Type 3 the frame is attached to a flat bracket which is in turn nail spigot fixed to an additional piece secured to the reveal.

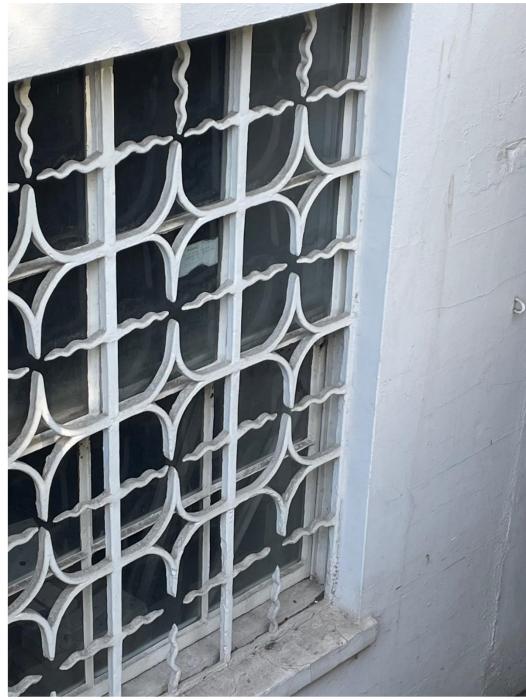
Type 3 surround square bar fixed by square bar spigot into reveal

Type 2, a surrounding square bar frame, which is set into the window reveals by diamond/square bar spigots.

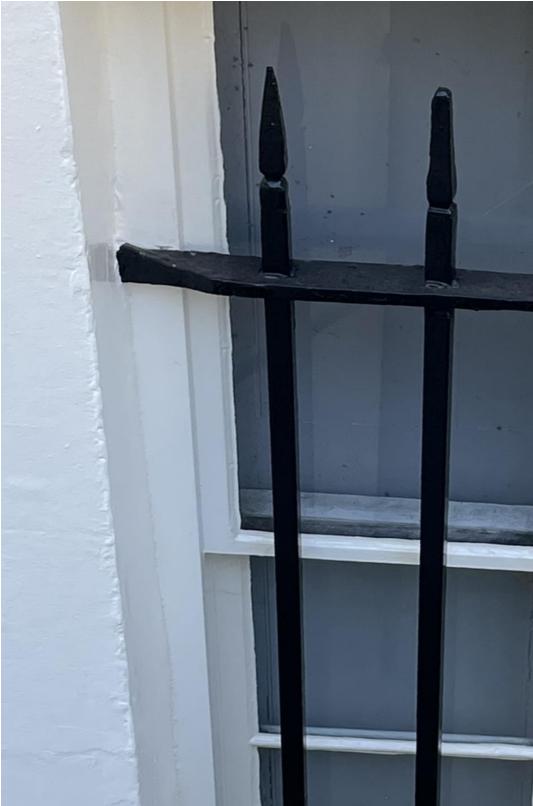
Type 4 horizontal bar forged to vertical lozenge into reveal.

Type 4 horizontal forged bar to vertical lozenge section into the reveal.

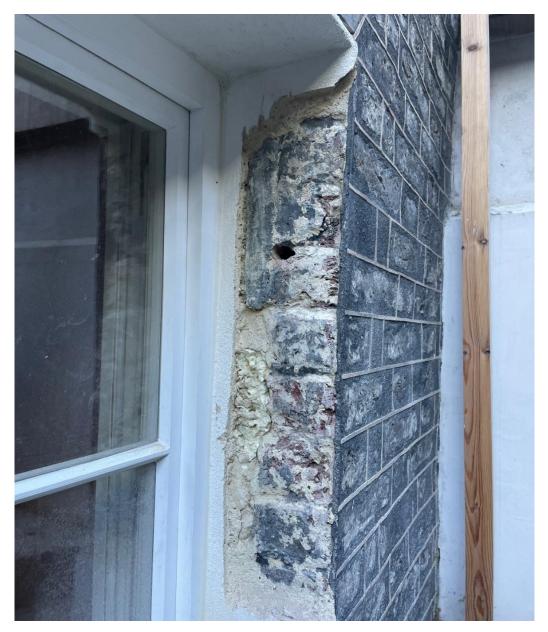
An examination of the right hand reveal to the lower right front basement window was undertaken. The reveal was cleaned of its render and the brickwork exposed.

A clear diagonal set hole was revealed with modern foam fill. The foam fill was removed, and the hole examined. Samples were taken from the wall of the hole and the hole measured for its size and position. The hole size was approximately 19/20 mm on all sides, i.e., a size appropriate to receive a  $\frac{3}{4}$ " bar. The hole is

diagonal otherwise known as diamond set. The hole had a depth of 75mm or three inches. The hole is 1600mm from the base of the windowsill, approximately 5 feet.

Right hand front basement window right reveals showing square diamond set hole 5 foot above the sill base.

The size, height, and the position of the hole to the reveal examined at 42 Bedford Square are very likely to reflect a past diamond/square set metal spigot for holding a metal horizontal bar and are consistent with other examples within the square relating to the historic security grills.

The fact that the spigot is diamond set arranges fixing for the grill suggests that a type 1 metal grille was installed at 42 Bedford Square.

The uniformity of Bedford Square would be best served by the installation of window grilles.

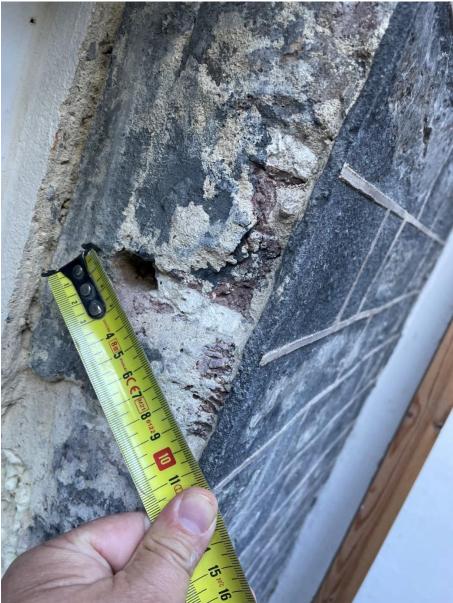
Close view of hole to reveal

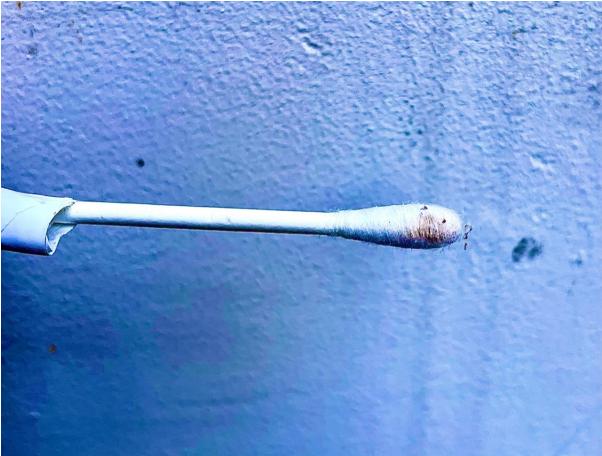
A cotton bud rub sample was taken on the back interior brick of the hole, and clear metal rust/oxidized flecks were collected on the sample. Indicating that it had previously held an iron bar.

Cotton sample showing metal oxidized flecks from interior brick surround
