01 Detailed Plan Of Affected Area
1:25@A3 / 1:12.5@A1

- 1NO EXISTING EXTERNAL MACHINES REMOVED FROM SITE
- 1NO NEW EXTERNAL MACHINE INSTALLED THROUGH EXISTING APERTURE WITH SOME REMODELLING REQUIRED
- ALL FINISHES TO BE MADE GOOD INTERNALLY AND EXTERNALLY AND TO MATCH EXISTING
- NEW EXTERNAL BUTTON SIGNAGE ABOVE NEW MACHINE
- NEW CCTV CAMERA INSTALLED

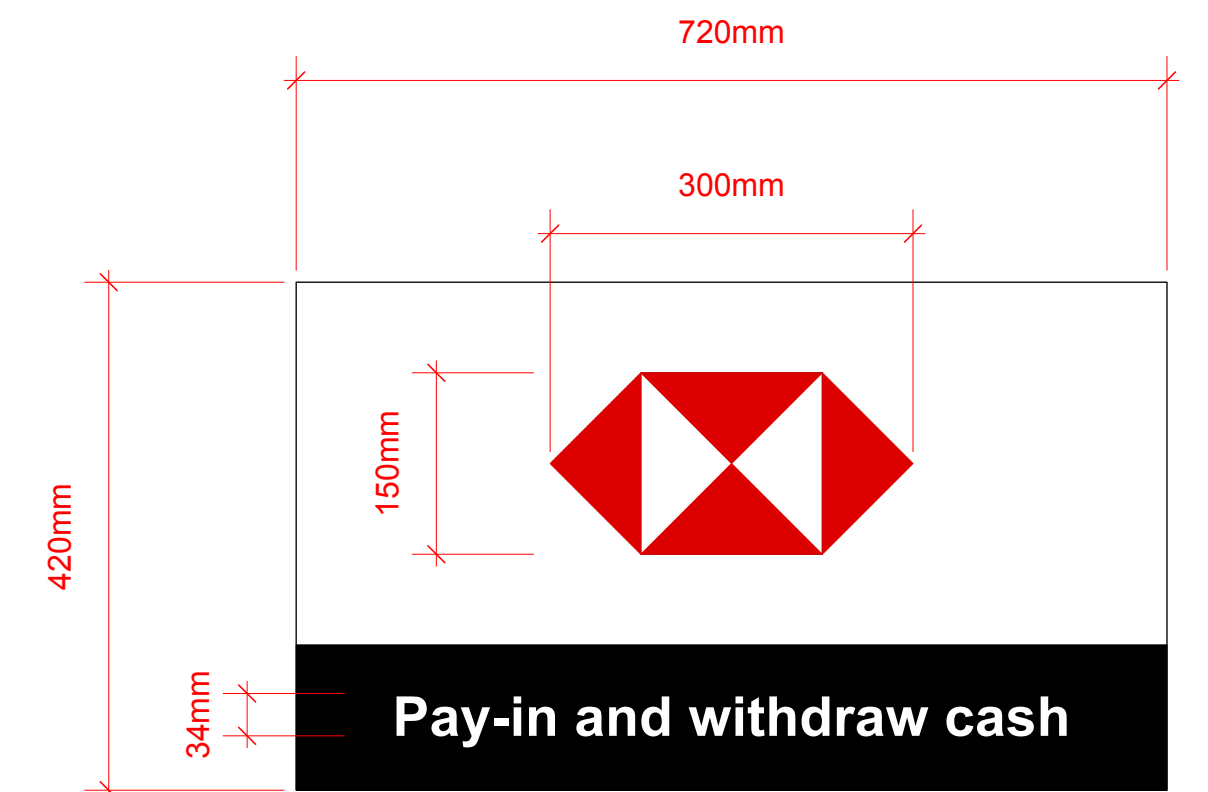
SIGNAGE DETAILS

External Standard Button Sign
