Bat Survey Report and Outline Non-Licensed Method Statement

13 Netherhall Gardens, Hampstead, London.

Report date: 23rd September 2022

Project No.: VT1005.1

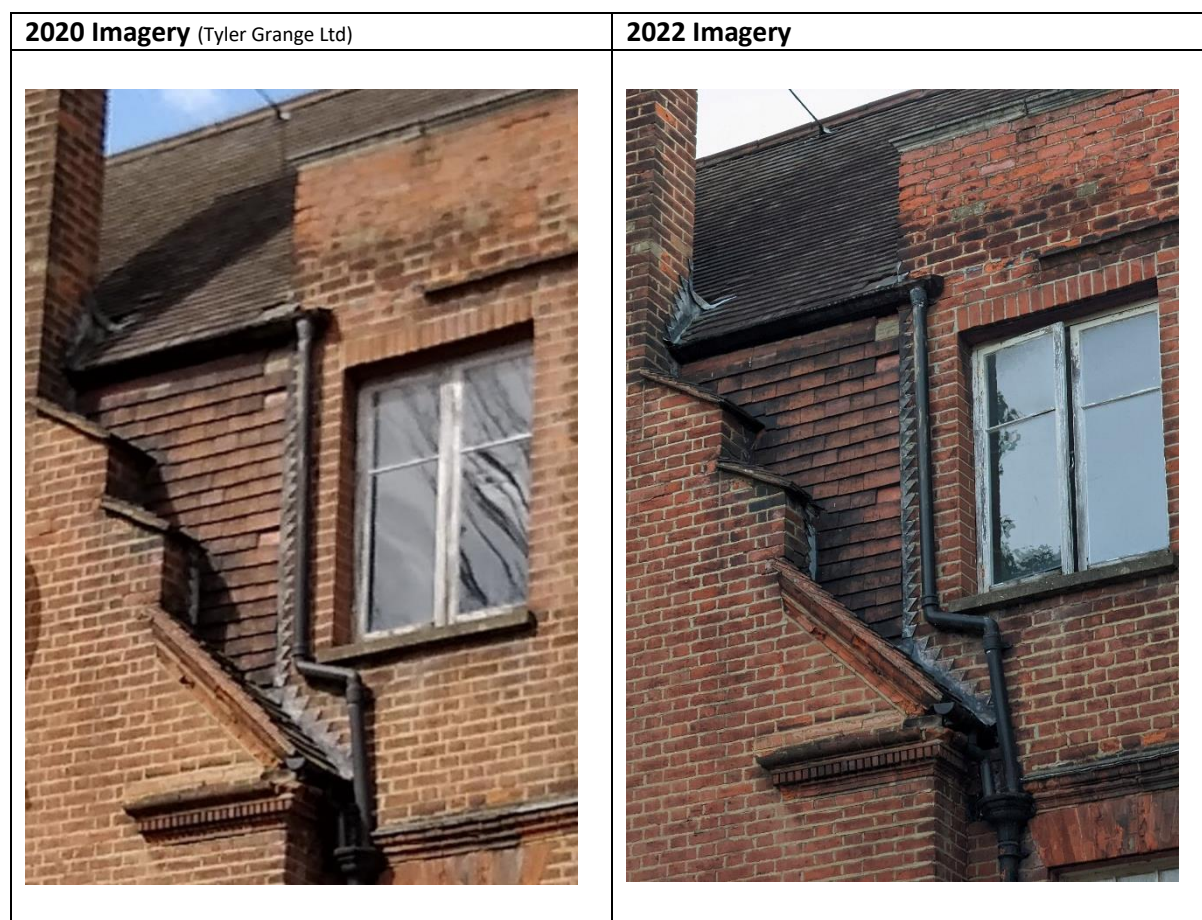
Photographs taken in 2020, when the possible roost was recorded, have been compared with photos taken in 2022. Whilst there appear to be some signs of degradation, including the loss of an additional roof tile above the possible roost location, it appears that the location remains in a similar condition to 2020.

Thermal imaging surveys of the previous roosting location were conducted on each visit. No hotspots indicating the presence of bats was found on any occasion.

Images 5.1 a and b: Location of soprano pipistrelle roost found in 2020 in comparison to 2022 images.

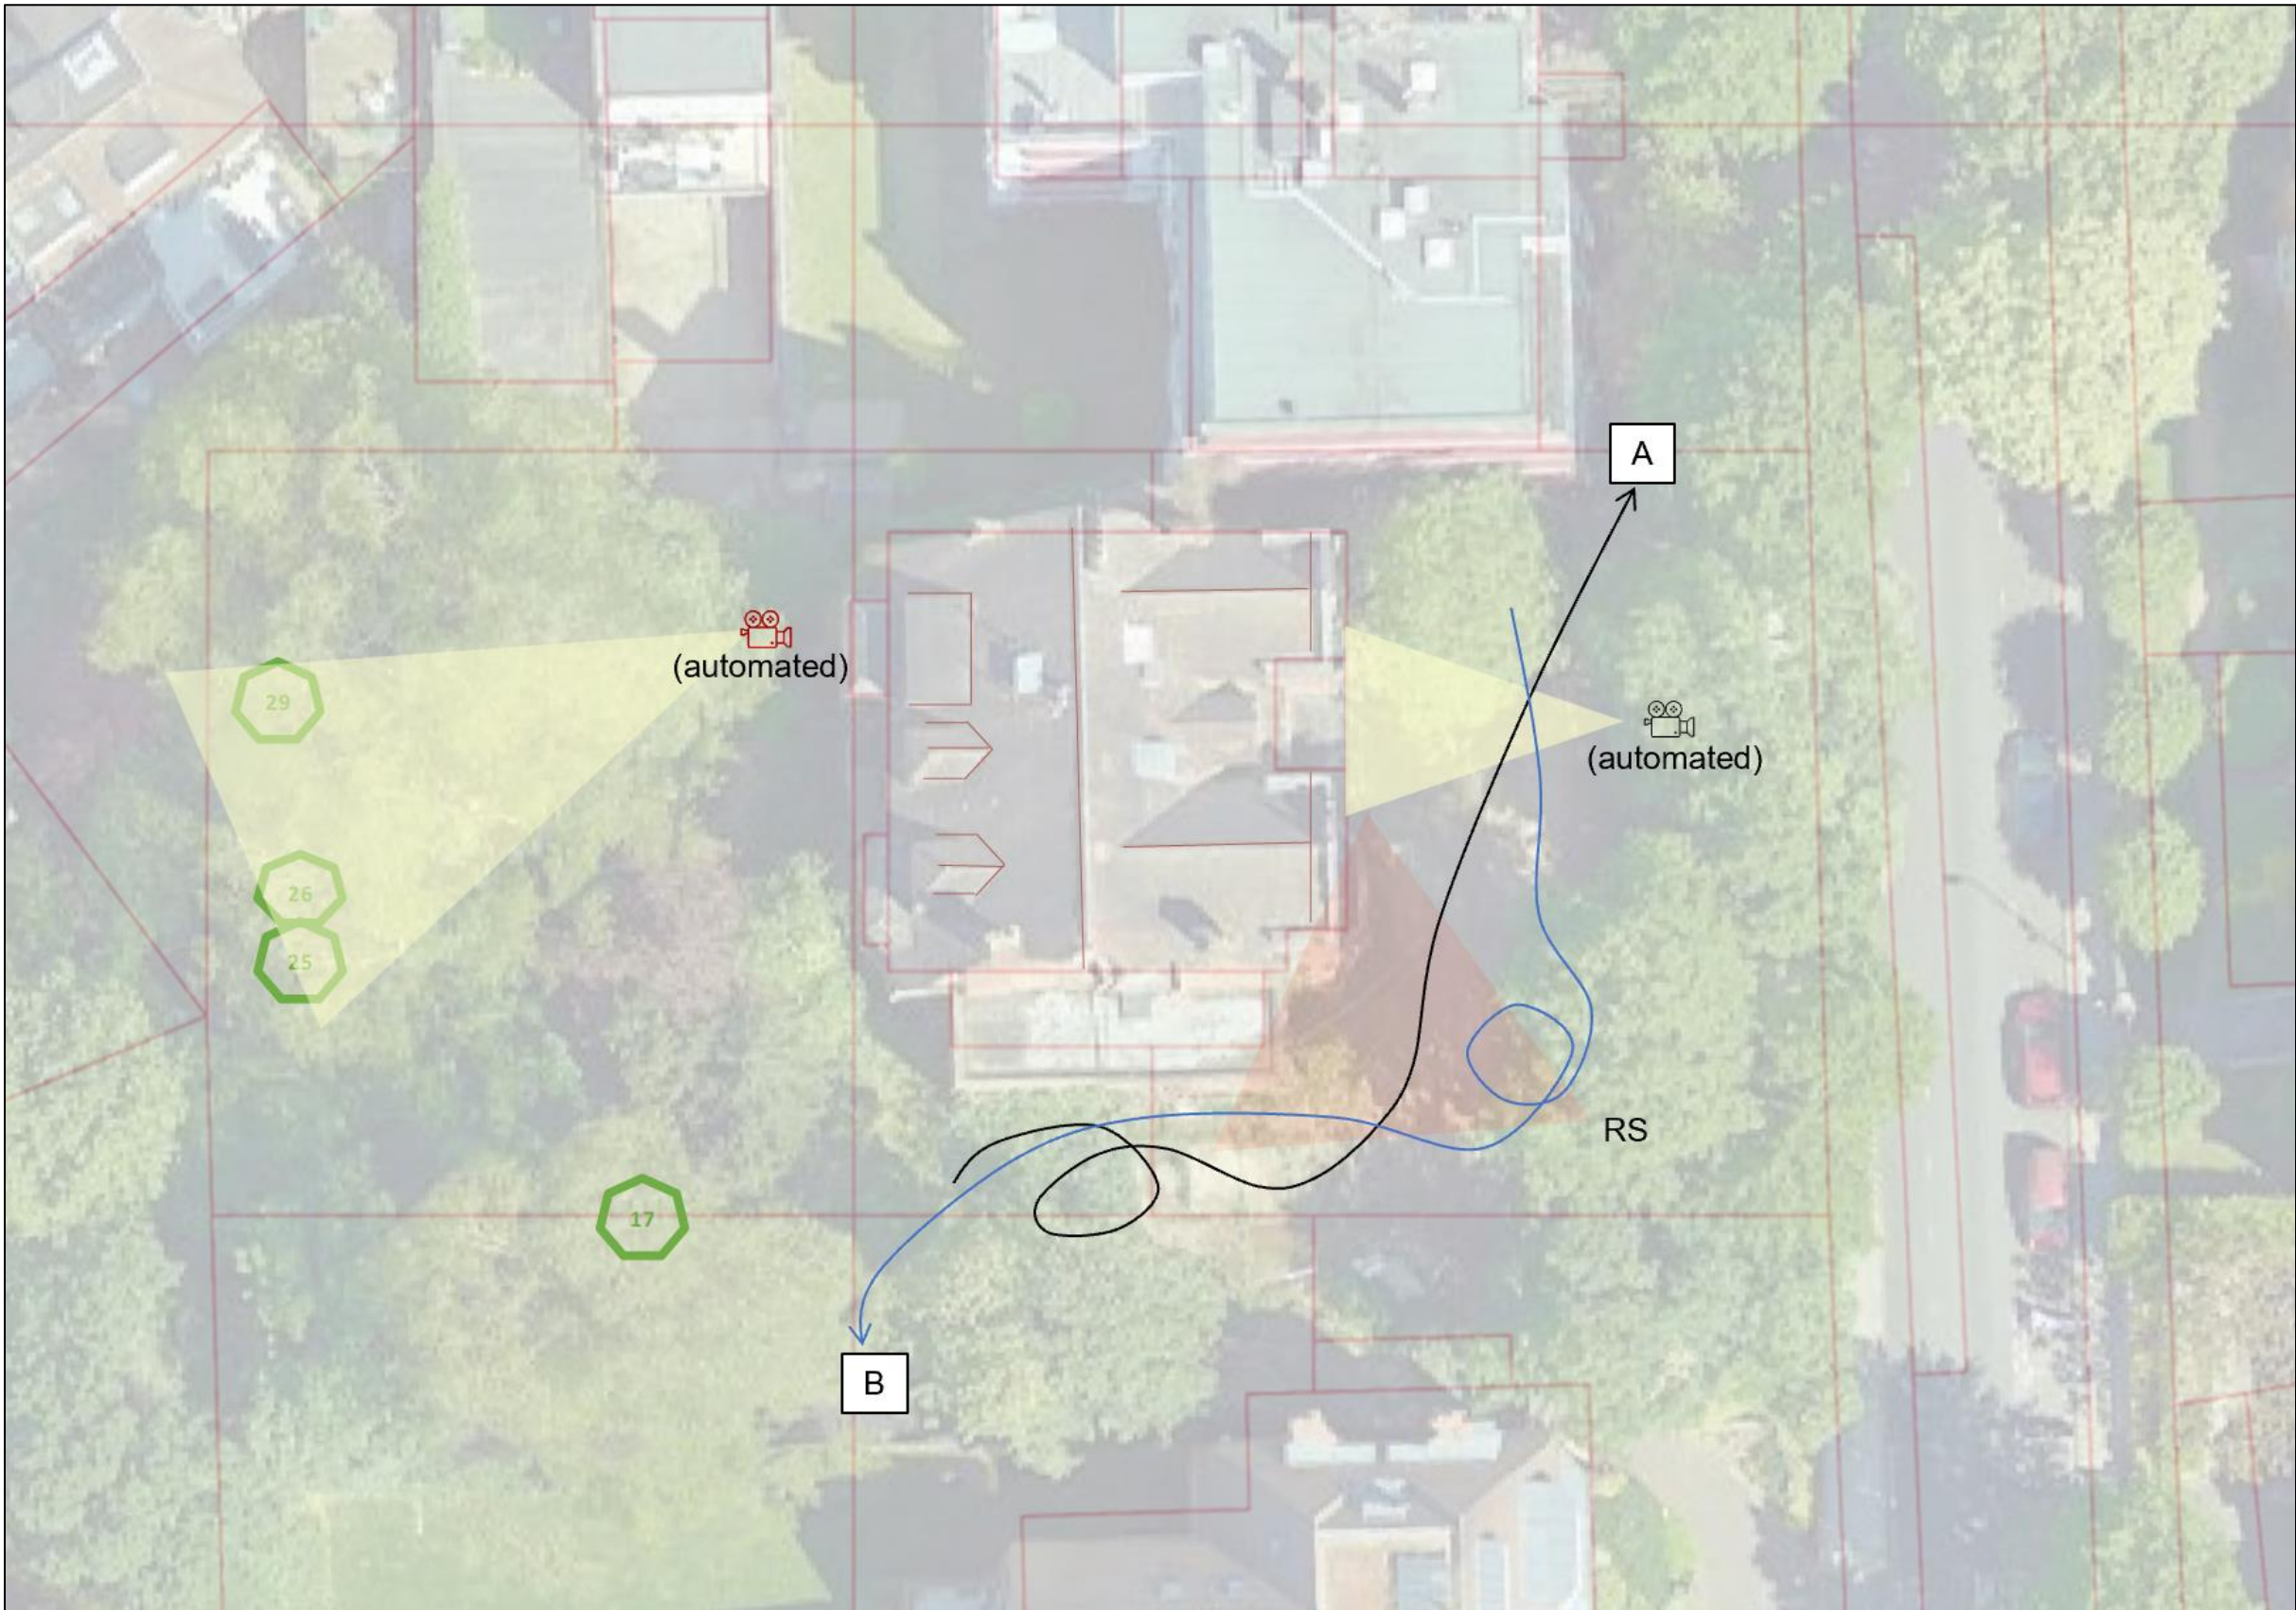
Figure A2.3 Dawn Survey – 02.07.2022 Schematic

The first bat, a foraging common pipistrelle, was observed at 04:00, 48 minutes prior to sunrise. Soprano pipistrelle was recorded foraging briefly at the west of the site, then at the south and west before commuting south. The final bat, a common pipistrelle was recorded 38 minutes prior to sunrise. **No bats were observed returning to roost in buildings or trees.** The level of bat activity was very low.

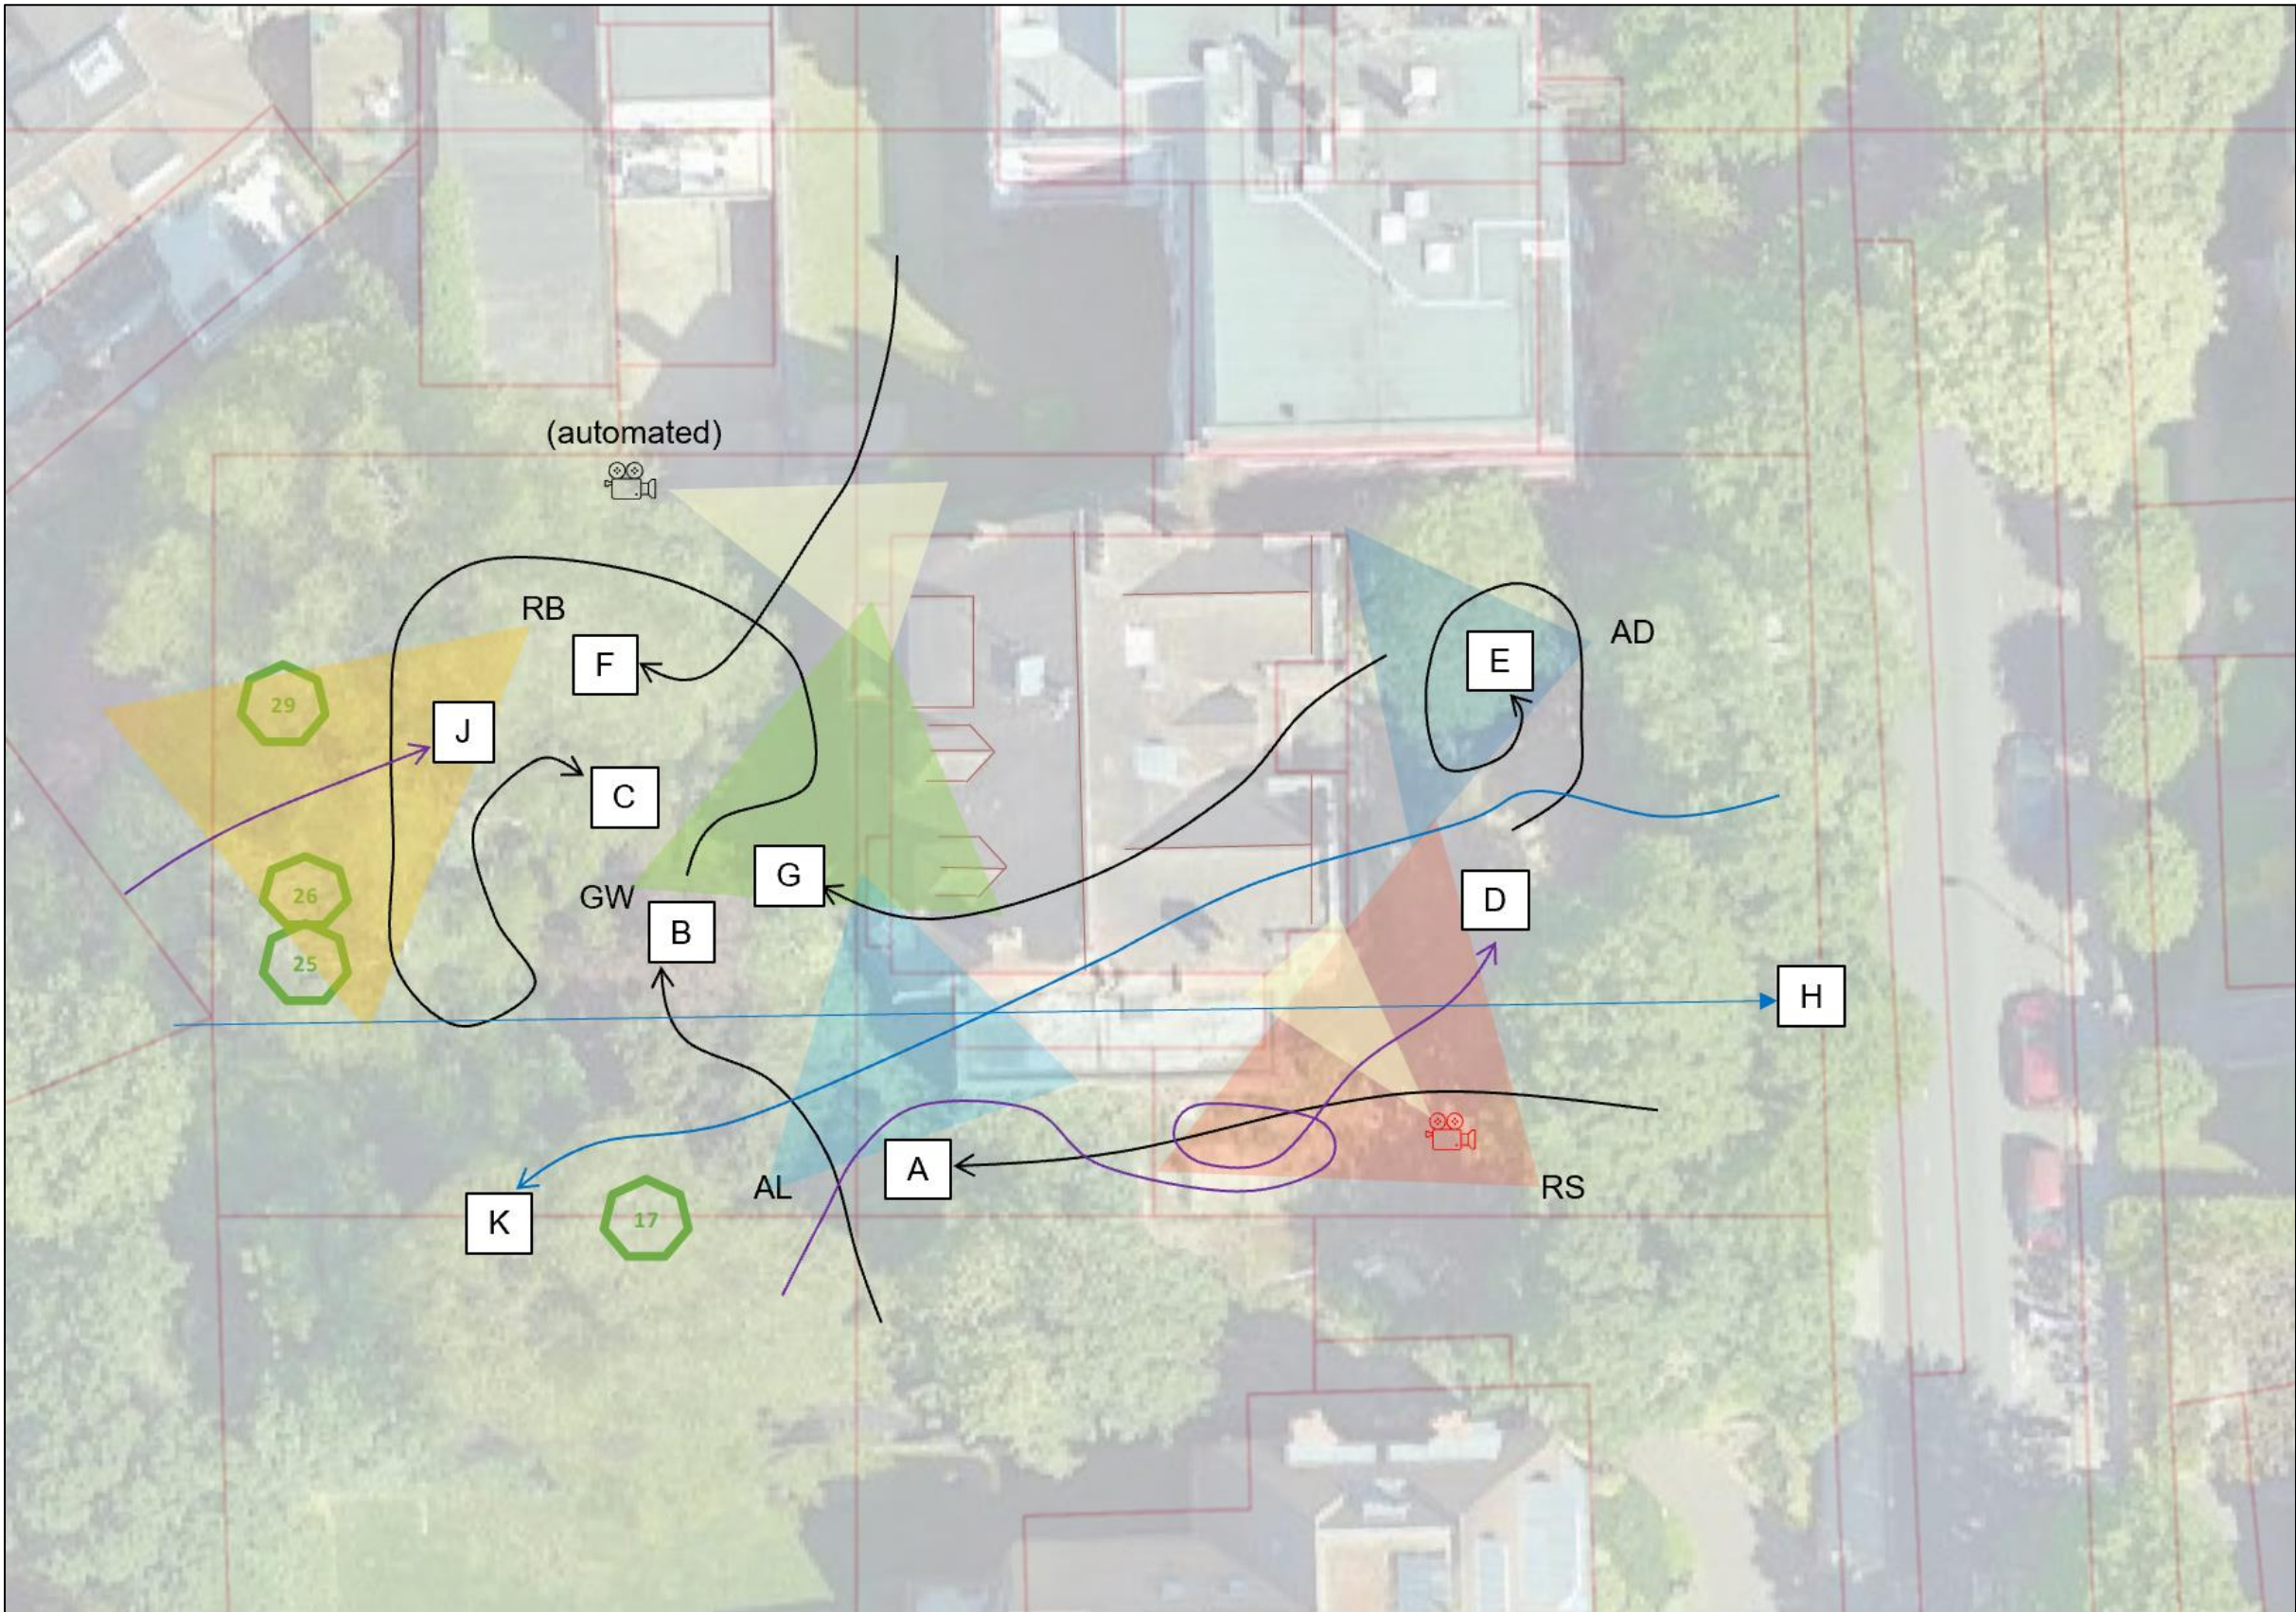
Figure A2.4 Dusk Survey – 01.08.2022 Schematic

Overcast conditions at the start of the survey gave rise to darker than normal conditions. The first bat, a commuting common pipistrelle was recorded very early in the survey, two minutes after sunset indicating an early emergence from a nearby roost to the east. A soprano pipistrelle was also observed foraging early, commuting to the site from the south. Frequent pipistrelle foraging and feeding behaviour was observed throughout the survey, with up-to three bats foraging, chasing and social calling observed at one time.

A single noctule *Nyctalus noctule* was observed flying high above the site from west to east, 20 minutes after sunset.

No bats were observed emerging from the building or trees. The level of bat activity at the site was considered moderate for an urban area.
