DISCHARGE OF CONDITIONS  
20 ETON VILLAS, LONDON

Planning Ref: 2022/0579/L  
New windows, internal staircase and roof renovation

# DISCHARGE OF CONDITIONS - 2022/0579/L

This document seeks to discharge Condition No. 4 parts A, B & C relating to application ref 2022/0579L:

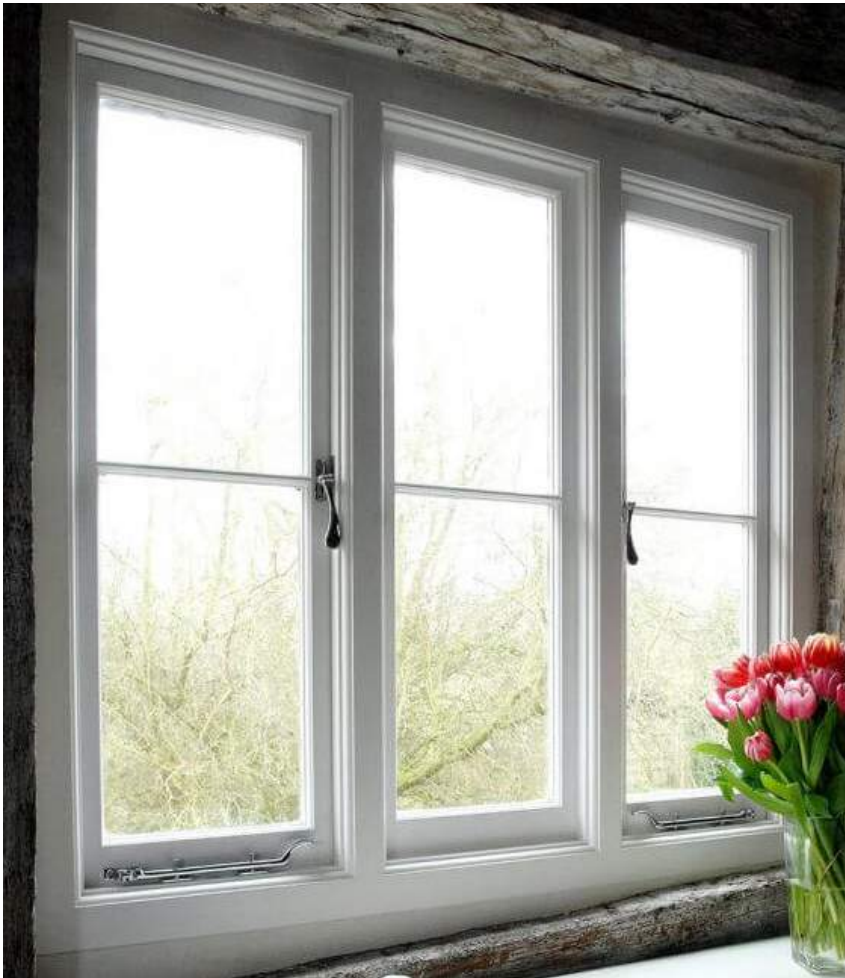
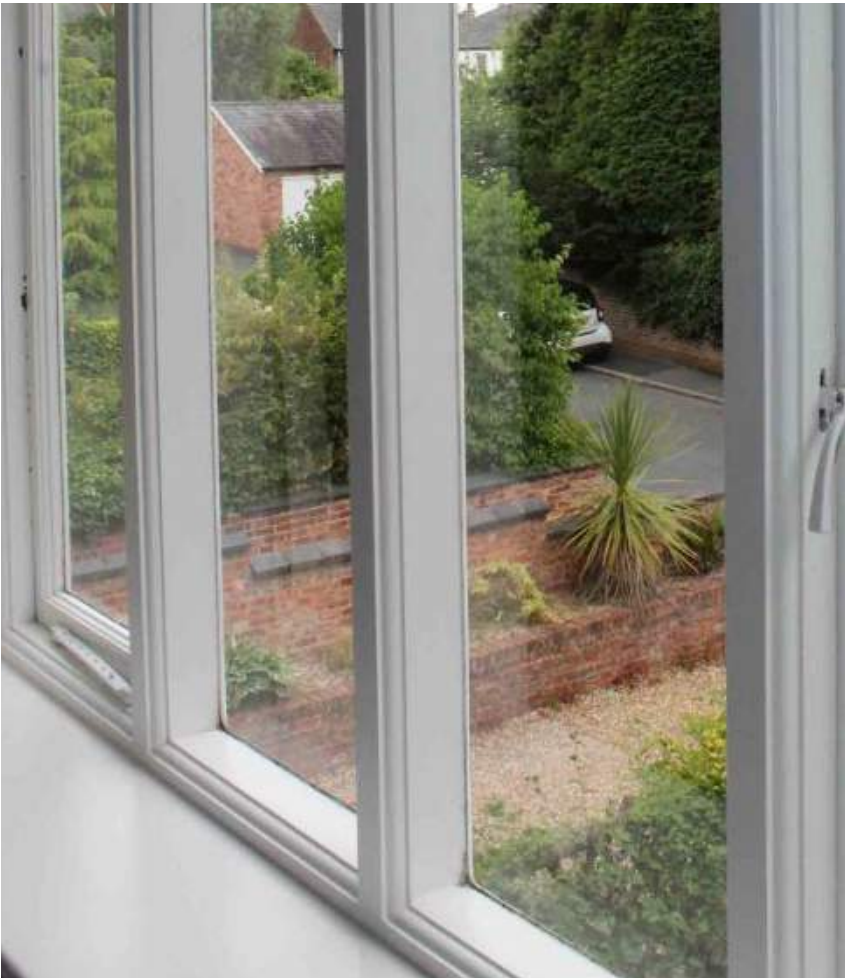
Supplier: Ventrolla  
Product: Bespoke timber casement window  
Finish/colour: Painted, solid hardwood  
Glazing: Slim 16mm (4/8/4) Double Glazed units, Krypton filled cavity

Examples of a Ventrolla bespoke timber casement windows

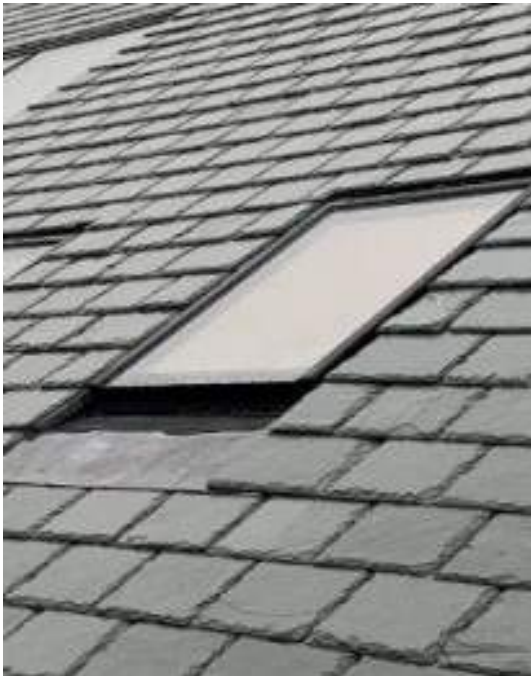
Supplier:	Stella Rooflight
Product:	Bespoke Conservation Rooflight. Between the rafter installation
Finish/colour:	Black steel frame (316L Stainless steel)
Glazing:	Outer: Toughened BioClean Natural, self-clean & solar control, Inner: Toughened Planitherm One Low E

External appearance example of a single Stella Conservation Rooflight (refer to p11 elevation for further details)

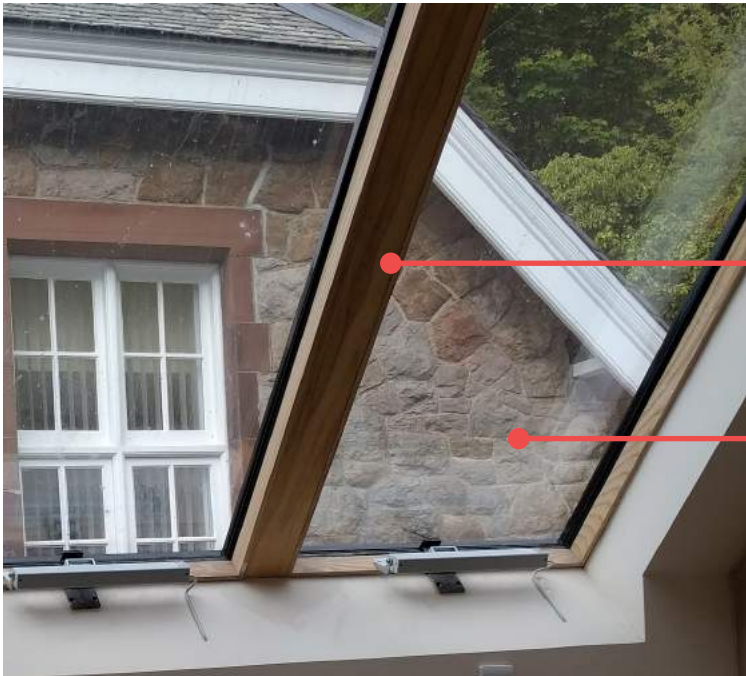
Internal appearance example.

- Existing joists to be retained in these locations between each window casement
- Additional glazing bars not shown in this example

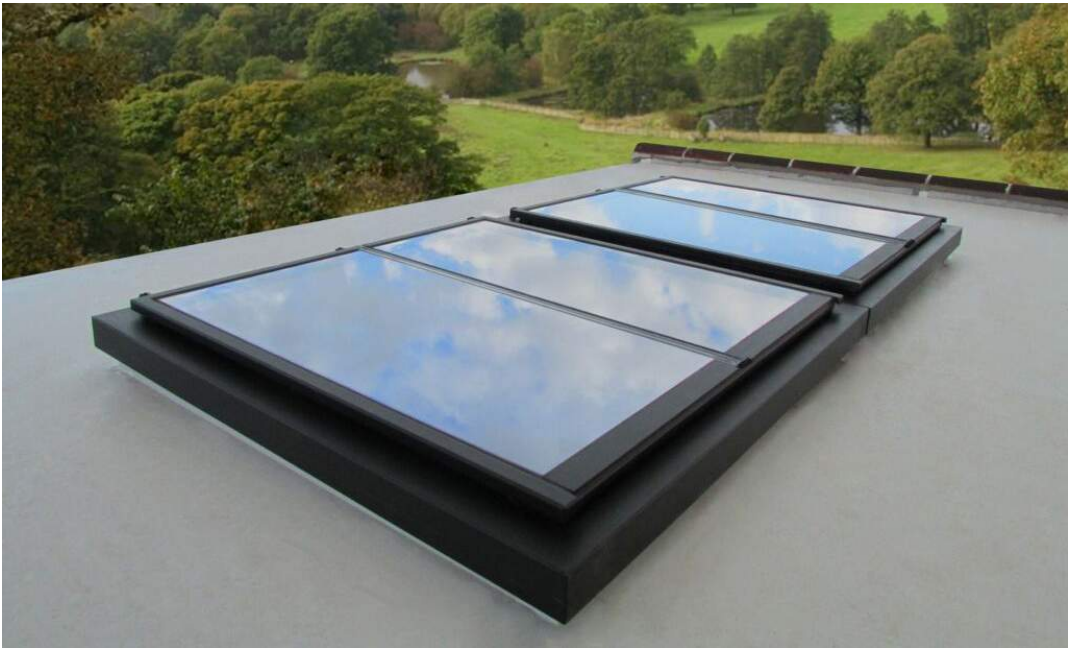
Supplier:                Stella Rooflight  
Product:                Flat Conservation Rooflight  
Finish/colour:        Black steel frame (316L Stainless steel)  
Glazing:                Outer: Toughened BioClean Natural, self-clean & solar control glass, Inner: Toughened Planitherm One Low E glass

External appearance example

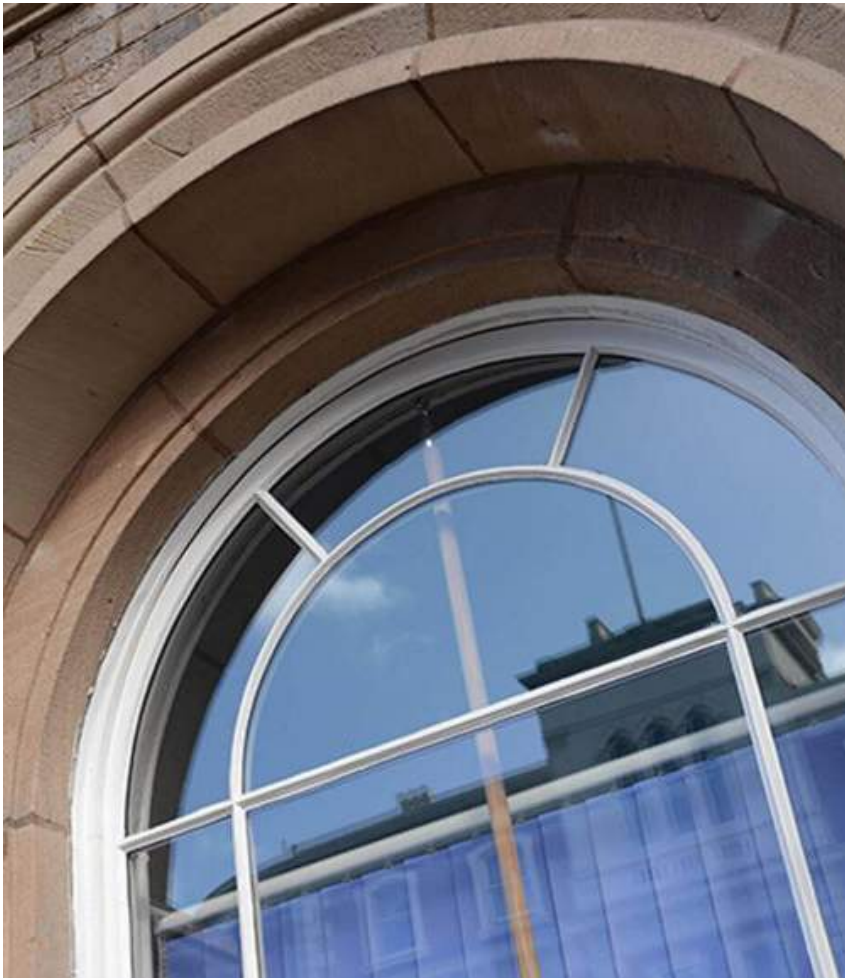
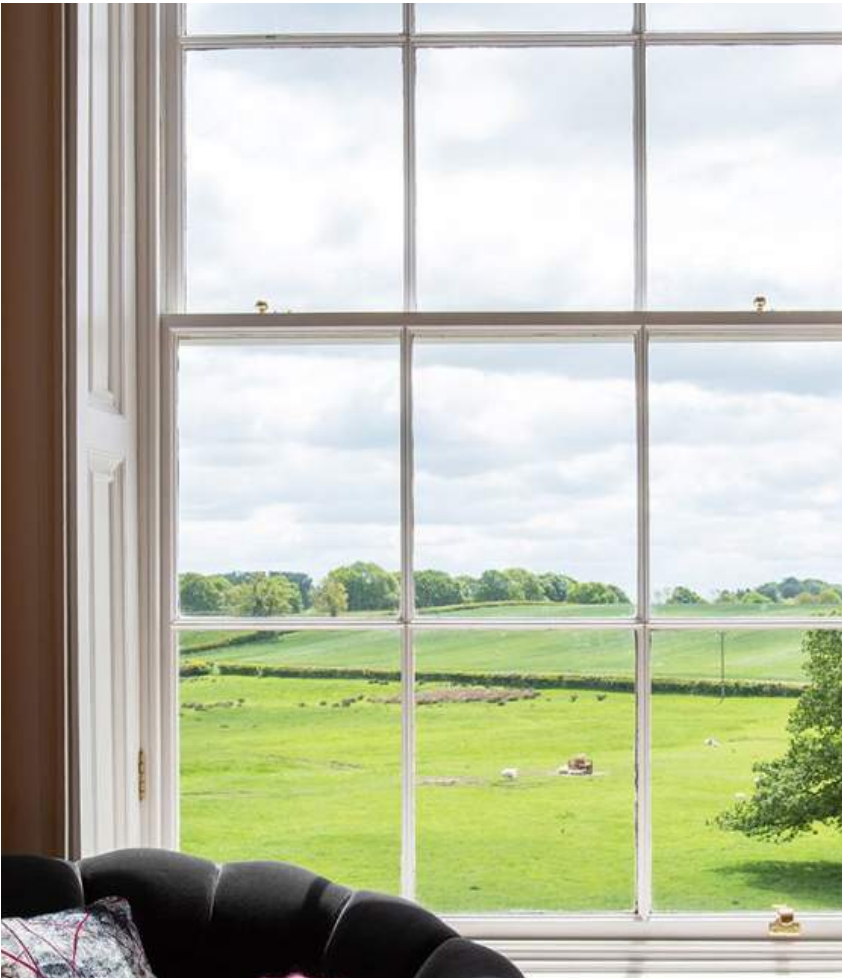
Supplier:            Ventrolla  
Product:            Bespoke timber sash window  
Finish/colour:       Painted, solid hardwood, multi-purpose linseed putty  
Glazing:             Single glazed, Saint Gobain Planitherm Total+ Glass

Examples of a Ventrolla bespoke sash windows

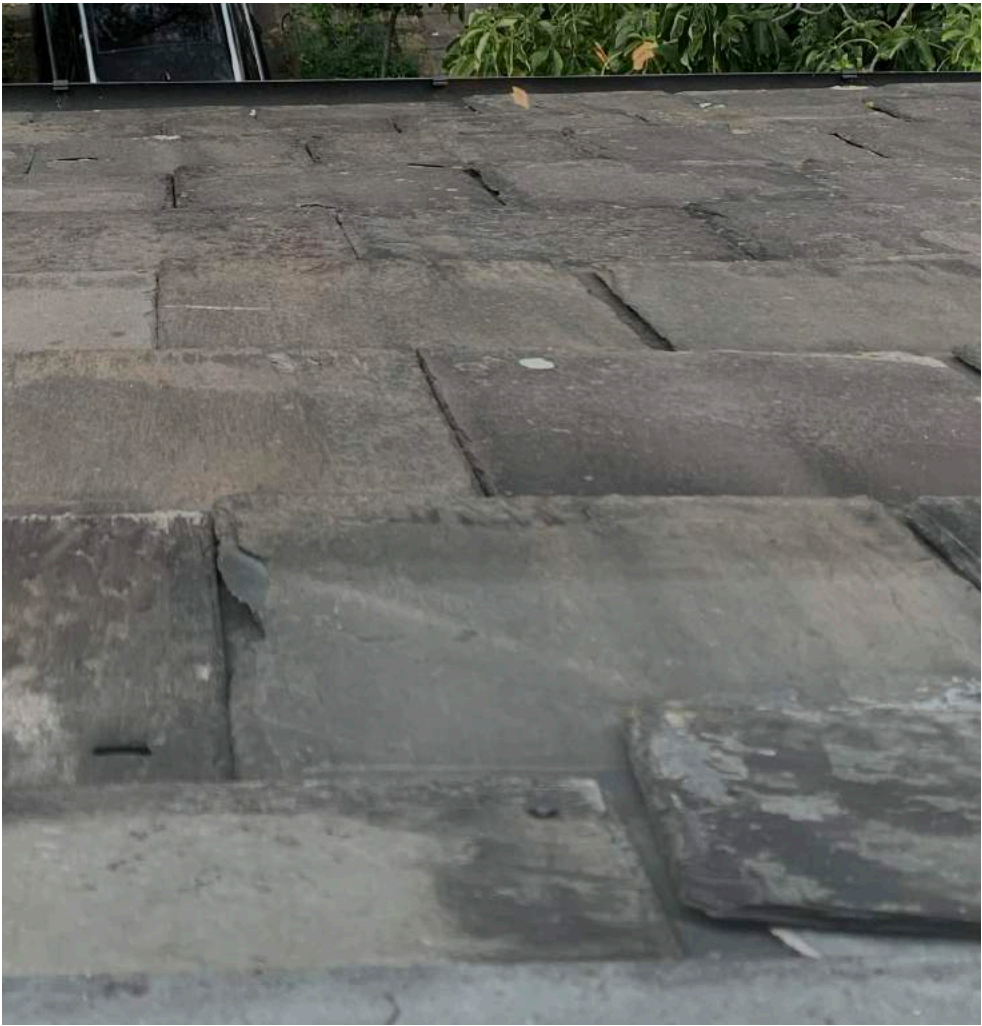
Existing roof. Existing tiles will be removed and brushed/cleaned. Existing tiles to be re-used wherever possible with only broken or defective slates to be replaced.
