20-22 SOUTHAMPTON PL. & 46-47 BLOOMSBURY SQ., HOLBORN  
DESIGN & ACCESS STATEMENT, DECEMBER 2021

**20-22 SOUTHAMPTON PL.  
& 46-47 BLOOMSBURY SQ.,  
HOLBORN**  
DESIGN & ACCESS STATEMENT

This document has been produced to support the planning application for the refurbishment works of 46-47 Bloomsbury Square. The information contained within this document should be read in conjunction with the GOA Heritage Statement, WSP Planning Statement and the submitted drawings.

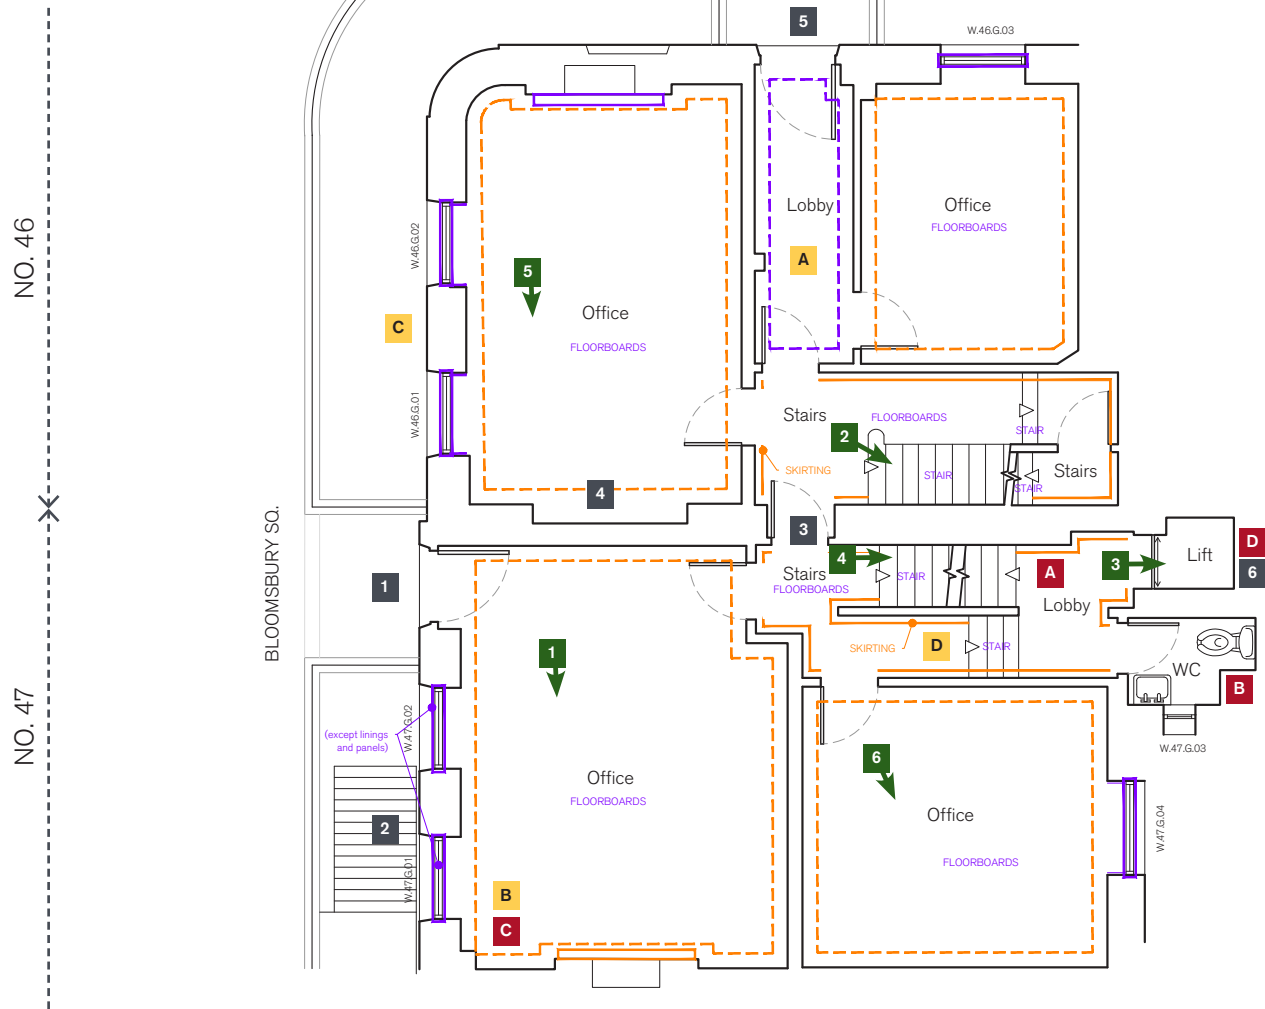
Existing Ground Floor Plan

- 1 Main entrance into 46-47 BP
- 2 Ground floor metal stairs to lower ground floor
- 3 Link between 46-47 BP
- 4 Existing brickwork arch
- 5 Fire escape exit
- 6 1970s extension with lift and WC provision.

- A Lift located on half landing.
- B Restricted space within the WC.
- C Unsightly wall mounted FCUs within rooms generally.
- D Small outdated lift.

- A Reconfigure fire escape strategy to enable opening up of lobby and office
- B Reconfigured unsightly wall mounted FCUs at high level.
- C Refurbish and redecorate façades and windows.
- D Redecorate generally keeping historic features and replacing poor modern features with 'in keeping' alternatives.

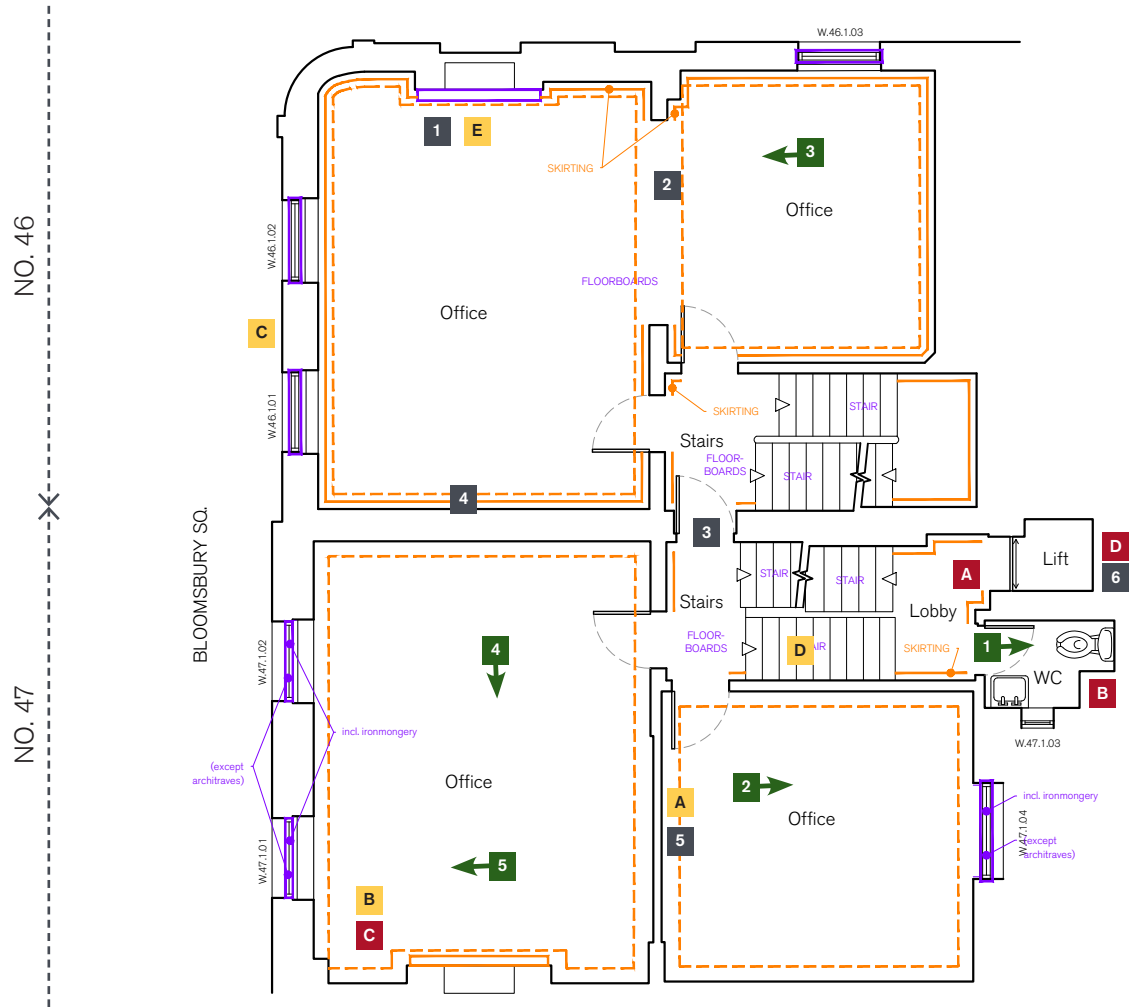
Existing First Floor Plan

- 1 Existing historic fireplaces
- 2 Existing opening between front and back rooms
- 3 Link between 46-47 BP
- 4 Existing brickwork arch
- 5 Previous opening infilled with recessed plasterboard
- 6 1970s extension with lift and WC provision.

- A Lift located on half landing.
- B Restricted space within the WC.
- C Unsightly wall mounted FCUs within rooms generally.
- D Small outdated lift.

- A Open up previously infilled openings between front and back rooms
- B Reconfigured unsightly wall mounted FCUs at high level.
- C Refurbish and redecorate façades and windows.
- D Redecorate generally keeping historic features and replacing poor modern features with 'in keeping' alternatives.
- E Repair/restore existing fireplaces with new hearths and linings

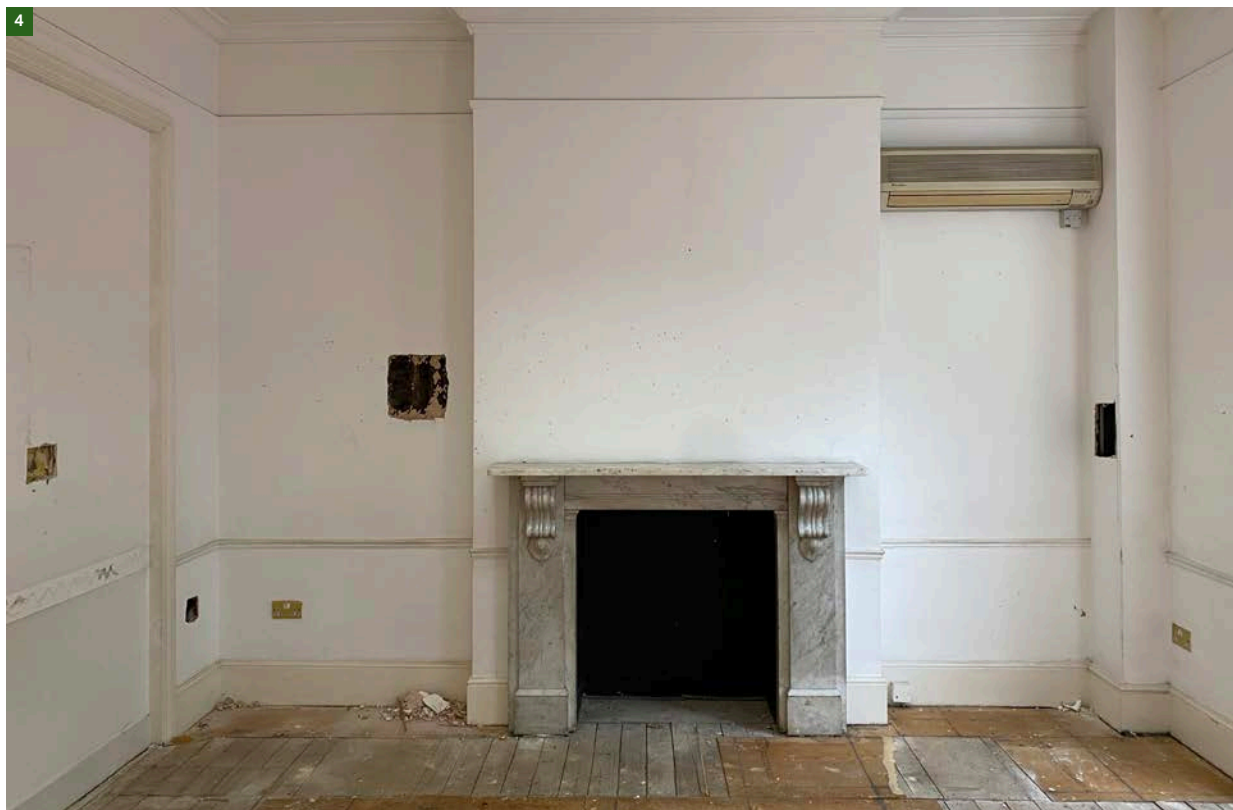
Figure 25. Existing fireplace, wall mounted FCU and in filled opening between front and back rooms in 47 BS.

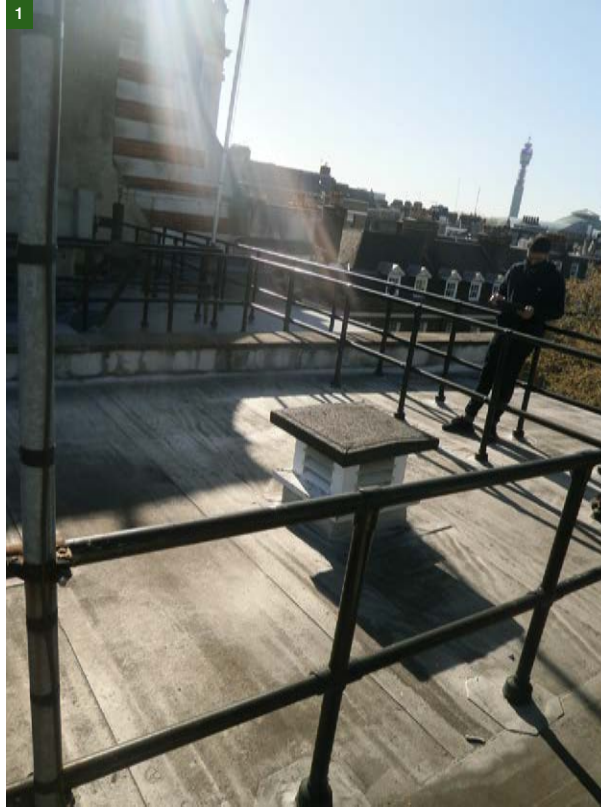
Figure 33. Existing roof over 4 BS showing ventilation cowls and showing current edge protection.

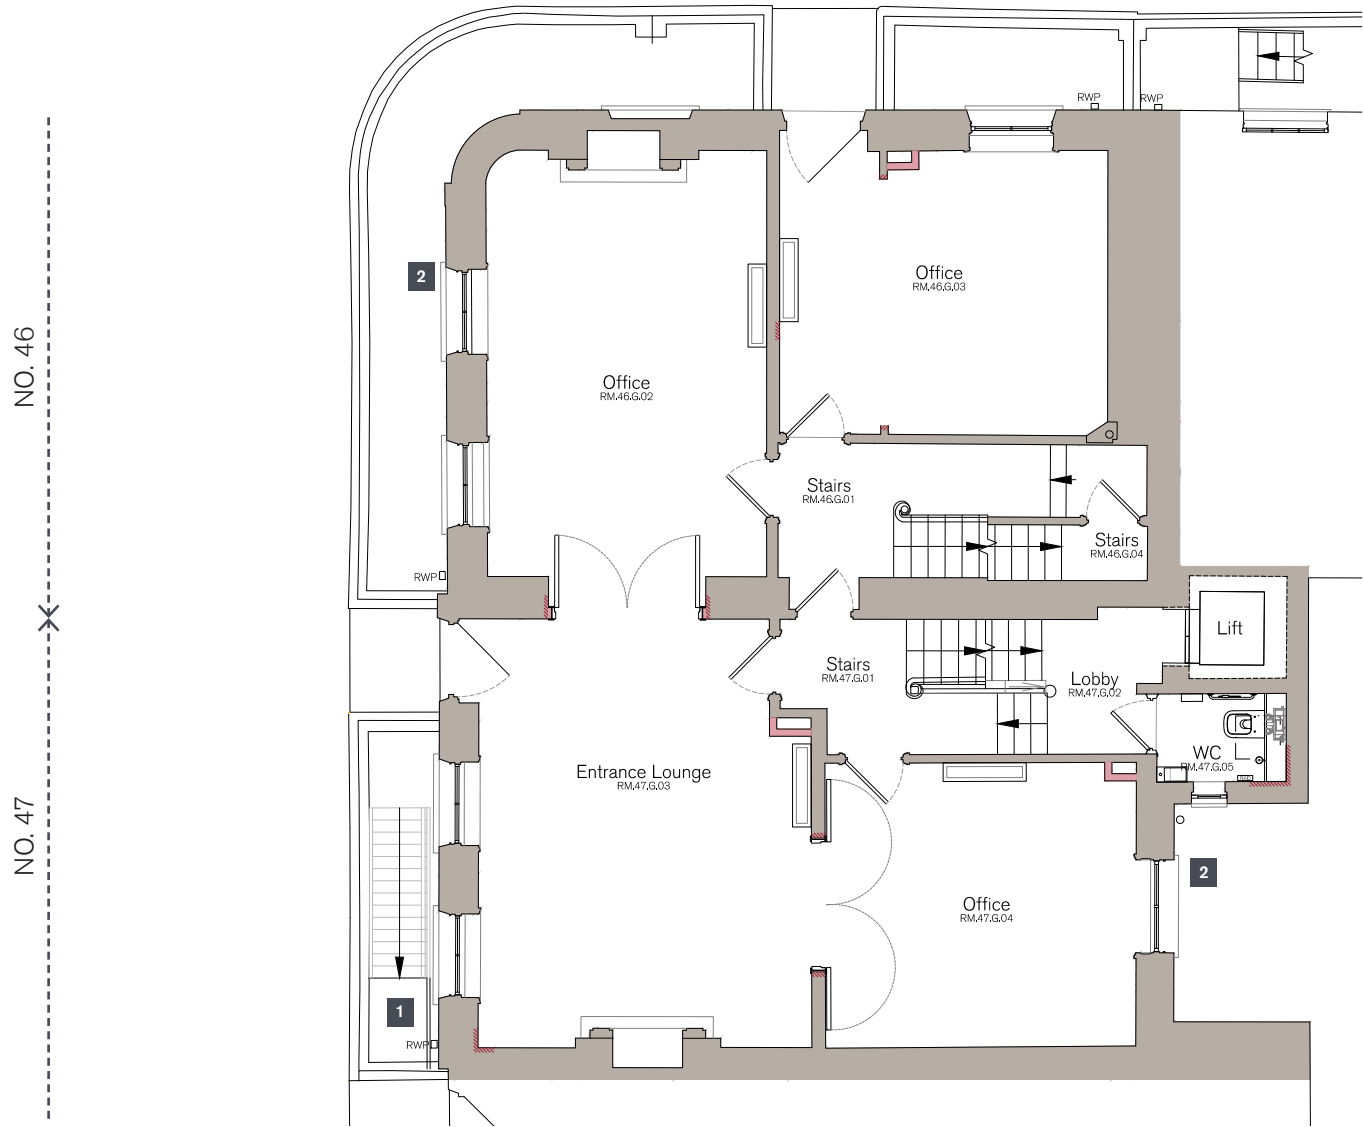
Proposed Ground Floor Plan

- 1 New stair to lower ground for bike access.
- 2 Existing windows refurbished and redecorated.

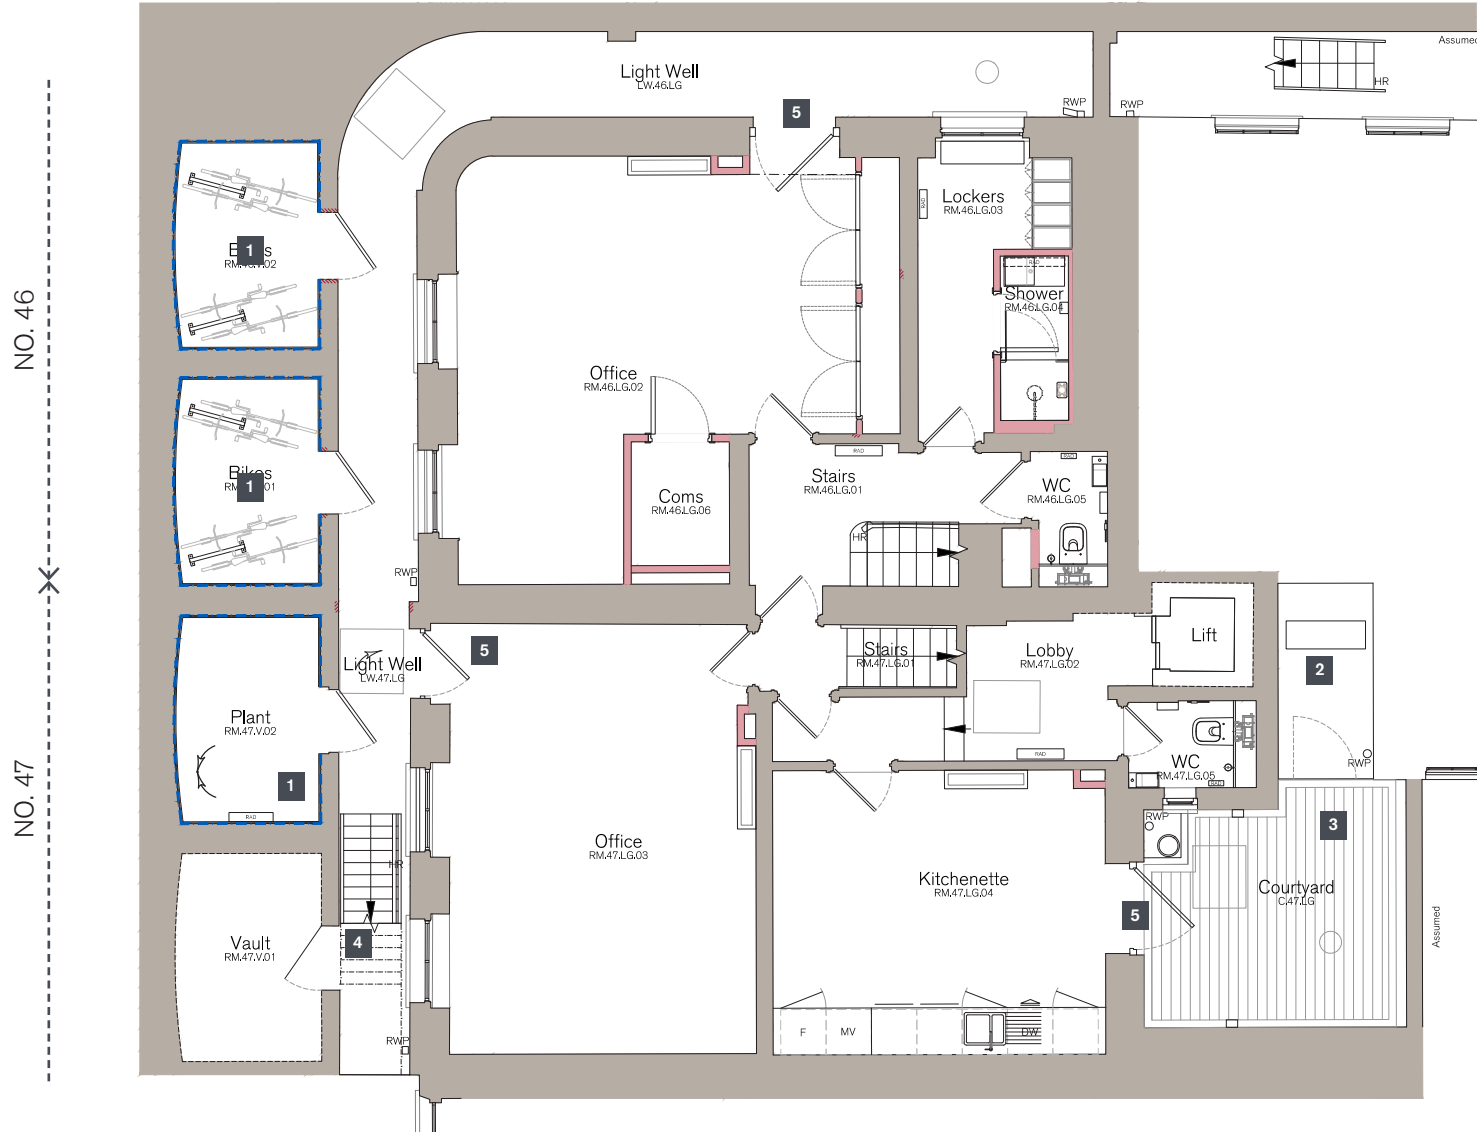
Proposed Lower Ground Floor Plan

- 1 Existing vaults refurbished and waterproofed fore bike storage and plant.
- 2 New condenser units and screening installed to courtyard recess
- 3 Courtyards refurbished with new decking
- 4 New external stairs.
- 5 Existing doors replaced with new.
