Job Title
Belmont Street, Camden

Roof Section Details - Sheet 2

LD504- ECE - ZZ - ZZ - DR - A - 2712 P02

Stage 3 - Suitable for Review and Comment

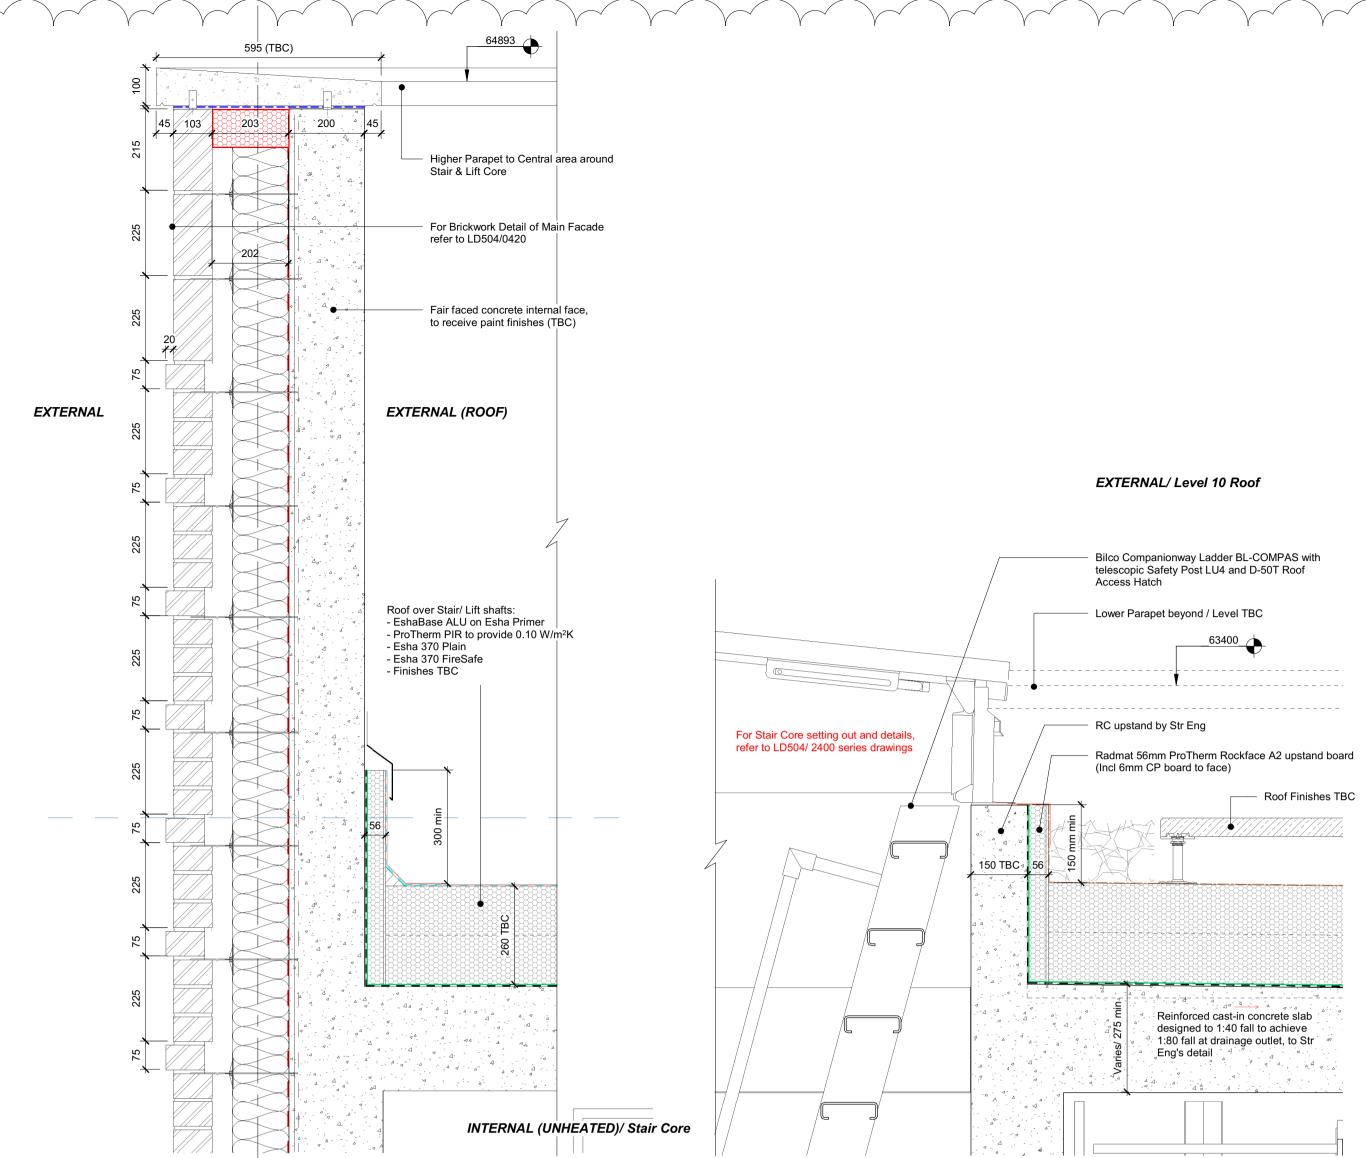
**Building B Stair - Roof Parapet**1:10

Building B Stair - Access to Roof
