Heritage Statement

125 Albert Street
Camden Town
London NW1 7NB

January 2023 | Project Ref 06662A

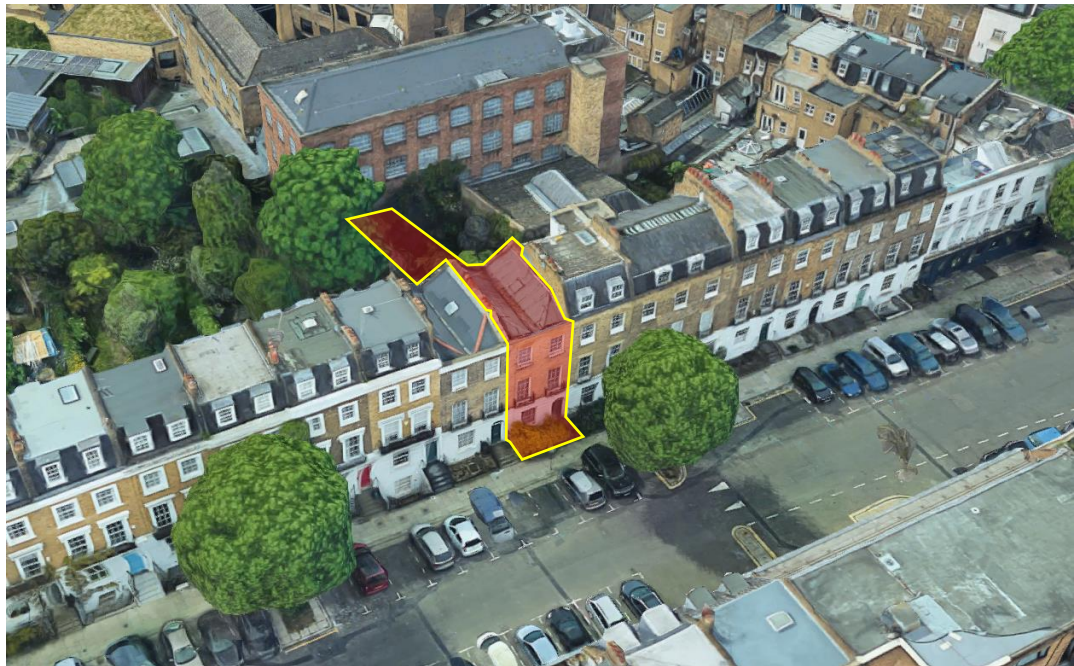
Figure 2: Bird's eye view of the Site (outlined in yellow with red shading) from the west
Source: Google Maps, accessed 15/02/2021

- 1.2** The Site comprises a three-storey town house built as part of a run of 9 similar terraced houses c. 1845 (**Figure 2**). The terrace is statutorily listed at grade II and comprises nos. 123-139 (NHLE ref: 1378643). Nos. 129-131 were amalgamated during the 20th Century - now the Jewish Museum London. No. 131 originally incorporated a carriage arch giving access to a small mews stable and associated accommodation. Nos. 129-131 now has a slightly wider frontage and differently spaced windows, so what was 9 houses now appears to be 8.
- 1.3** The finely detailed brick and stucco terraces were built in most part by George Bassett, surveyor to the Southampton Estate, in the years 1844-48. The terrace forms part of a high-quality townscape which, thanks to the greater width of Albert Street and its significant length, has the feel of a promenade with its tree lined

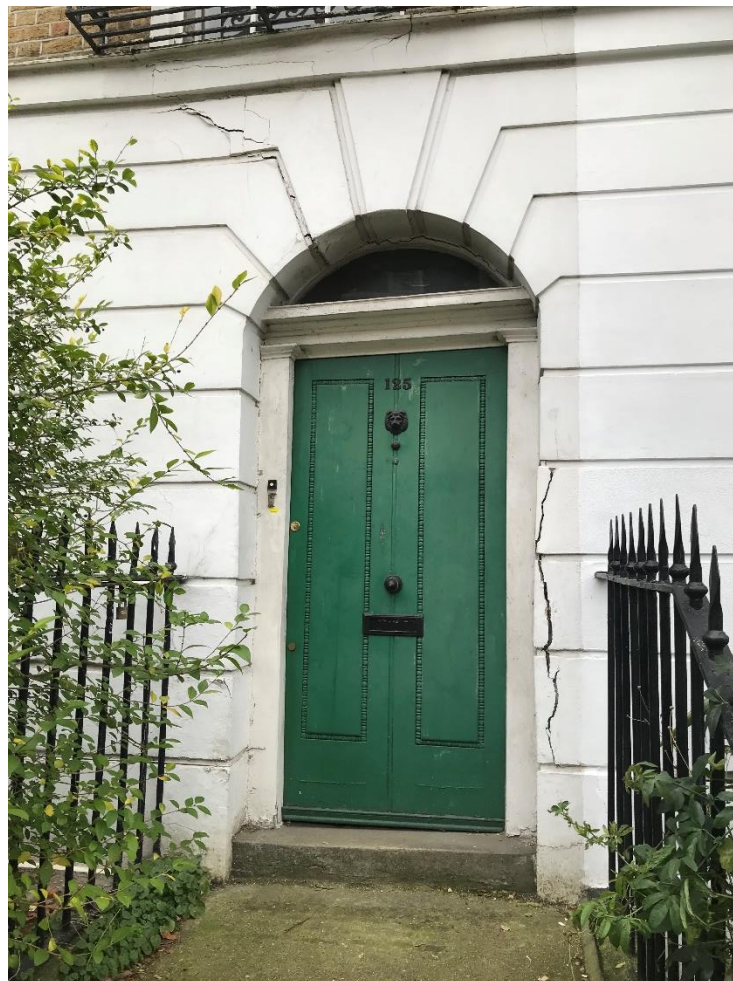
Figure 5: Entrance door to No. 125 showing evidence of settlement to the front masonry wall and cracking / movement to the stucco finishes.

1.4 The proposed structural repair and consolidation works relate to the main front elevation wall and adjoining sections of party wall abutting Nos. 123 and 127 Albert Street respectively. Significant structural repairs to the front wall of the house are urgently required in view of settlement and consequent deflection of the brickwork and cracking to the front elevation (**Figure 5**) and internal partition walls.

- 5.2** In terms of the justification for the under-pinning works, investigations into the underlying cause of the extensive cracking to both the internal and external faces of the front wall included bore holes and trial pits to analyse the soil substrate. The results of the laboratory tests show the clay is generally of a high plasticity and of high swell potential when classified in accordance with NHBC Chapter 4.2. This clay would therefore be subject to significant changes in volume due to any changes in its natural moisture content.

- 5.3** In trial pit No.1 and borehole No.1 the clay the was found to be desiccated from 1.4m to 1.9m deep, where tree roots are present to the underside of the foundation. As such that subsidence has likely taken place to the front of the property at 125 Albert Street and along the party walls to the property.

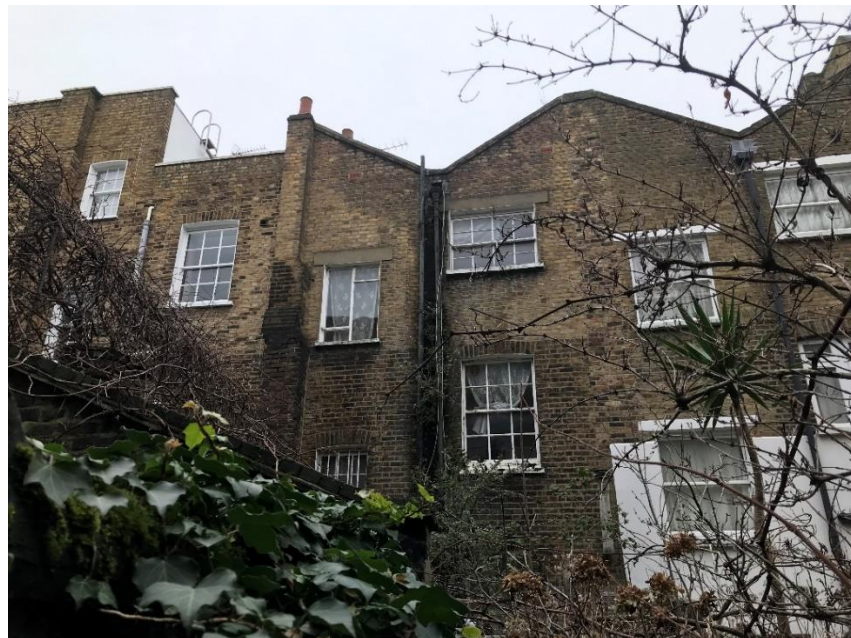
Figure 4: View of the rear elevation. No. 125 corresponds to the central two bays beneath the V-shaped parapet. Note the remodelled second floor / mezzanine windows with concrete lintels.

1.7 In spite of unsympathetic interventions made during the early-late 20th century, the building retains its original plan form to a substantial degree. However, the rear outrigger was completely rebuilt during the inter-war period (see Section 3 for full details) and now has approval for a replacement rear extension under 2021/5254/L, which is at the implementation stage. Changes to the rear elevation had previously been made, with an appreciable amount of the elevation rebuilt, probably around the same time the former outrigger was reconstructed (**Figure 4**).

3.15 The rear elevation of the property has been rebuilt from the upper first floor level using new buff brick and what looks like cement mortar. The rear window openings to the half landing and second floor are both early mid 20th century and of an alien typology. The upper half landing window is a pre-WW2 metal window. Interestingly, as the terrace did not sustain any bomb damage, the rebuilding may be due to inherent structural defects that were corrected, probably in the 1930s.

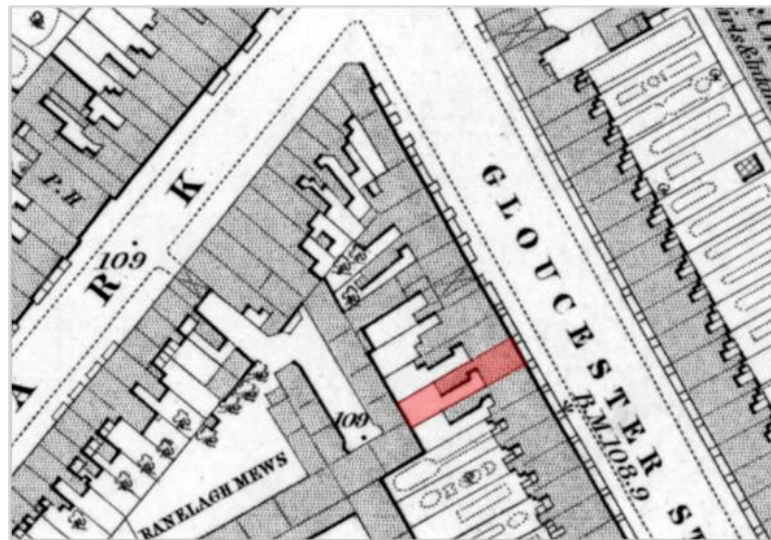
Figure 9: 1875 OS Map (25 inches to a mile), surveyed in 1870. No. 125 is highlighted in red.

The earliest map to show the footprints of the individual houses is the Ordnance Survey 1st Edition 25-inch scale map surveyed in 1870 and published in 1875 (**Figure 9**). At this date the stretch of road extending southwards from Park Way to Delancey Street was known as Gloucester Street. No. 125 (highlighted in red), together with its neighbours in the terrace to the south (No. 123) and north (Nos 127-139) show more extensive rear extensions, conventional outriggers with a narrow neck where these abutted the main house to maintain good lighting to the rear reception rooms. The widening of the outrigger is often curved in the form of a

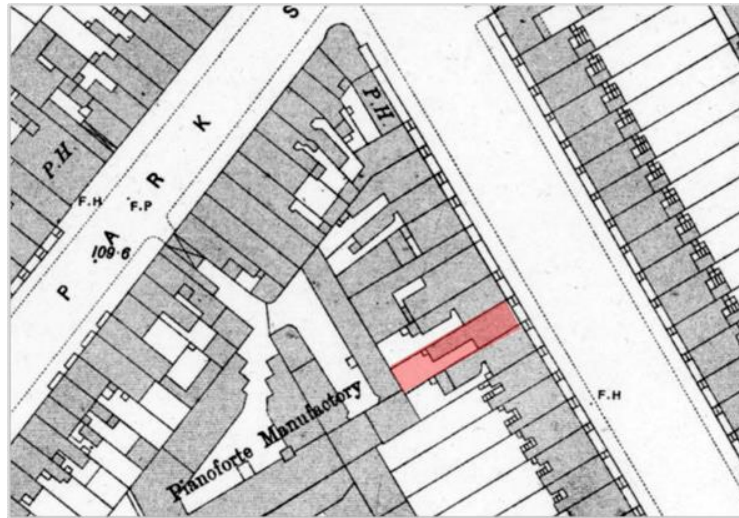
Figure 10: 1895 Ordnance Survey 1:1056 scale map (revised 1894) with No. 125 highlighted.

Comparison between the 1875 map and 1895 Ordnance Survey 1:1056 scale map (**Figure 10**) reveals minor changes to the footprint at the rear of the building. Essentially the outrigger was squared off. Buildings at the rear of the property, shown as Ranelagh Mews in 1875, were mapped in 1895 as a 'Piano Manufactory', one of the industries for which Camden was well-known. Gloucester Street had become the northern continuation of Albert Street by 1895.

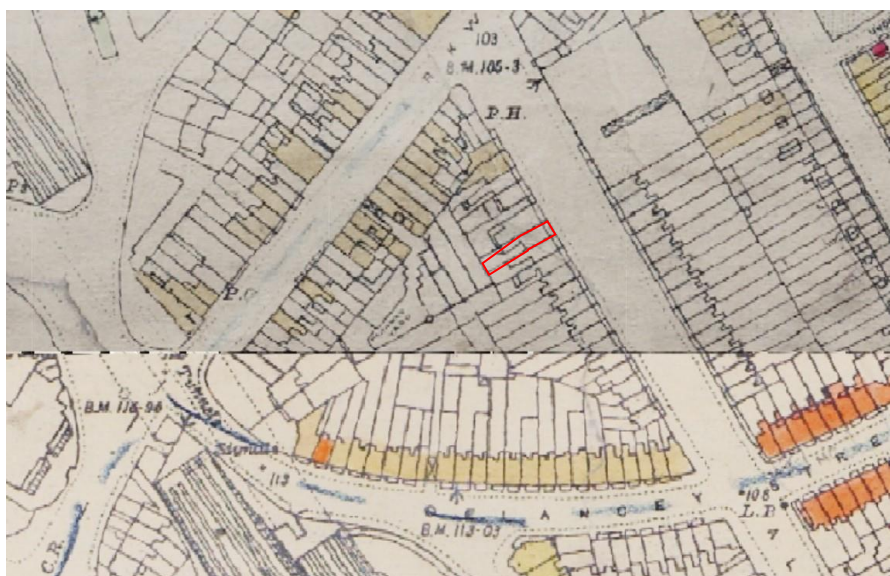
Figure 12: 1945 Bomb Damage Map. Source: Layers of London. The Site boundary is indicated by the red line.

3.11 Further map regression reveals the footprint of the outriggers to Nos. 123-129 changed markedly between 1945 (**Figure 12**) and 1953 (**Figure 13**) with the re-alignment of the rear boundaries. This is no longer perpendicular to the main terrace but slightly oblique and will have necessitated the complete rebuilding of the outrigger on the new alignment. The use of solid wall construction suggests that this may have occurred prior to 1945, however the configuration of the outrigger shown on the 1913 OS Map (**Figure 11**) is unchanged in 1945 according to the Bomb Damage Map.

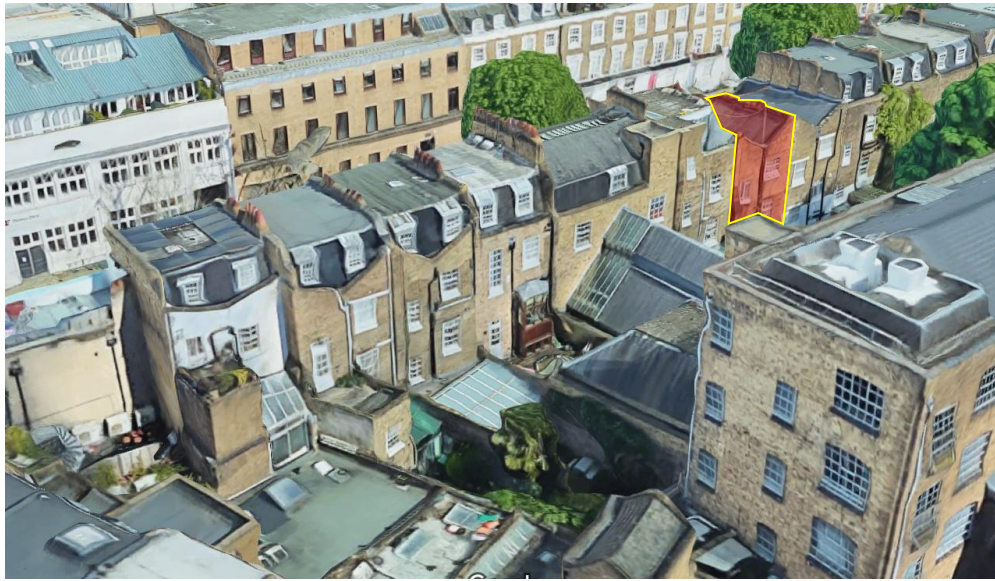
Figure 14: bird's eye view of the rear elevations of Nos. 123-139 Albert Street. The Site is outlined in yellow.

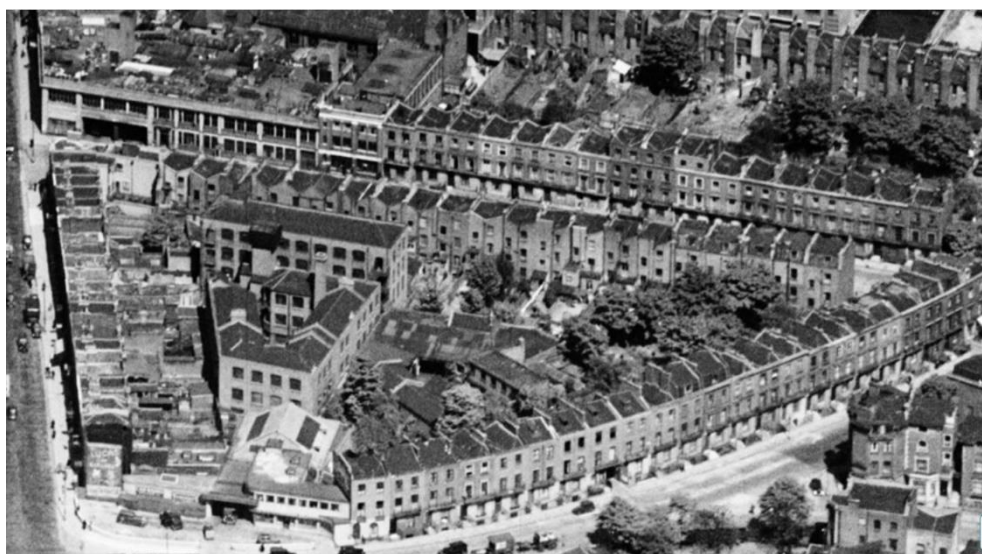
Figure 15: Aerial view of the Site and surroundings taken in 1946. Source: [EAW000624] A cityscape over Kentish Town, Camden Town, from the south-west, 1946 (Britain from Above)

3.13 An aerial photograph taken in 1946 (**Figure 15**) shows the roofscape to much of Albert Street and Delancey Street. This was characterised by half hipped butterfly roofs which was the prevalent roof form to these terraced townhouses.

3.14 Nos. 123 and 125 are the only houses on the entire terrace (Nos. 99-139) to retain their original roof structures, although the roof of the host property is very much degraded. The remainder of the terrace has been 'mansarded' since 1946 with projecting dormer windows (sashed).

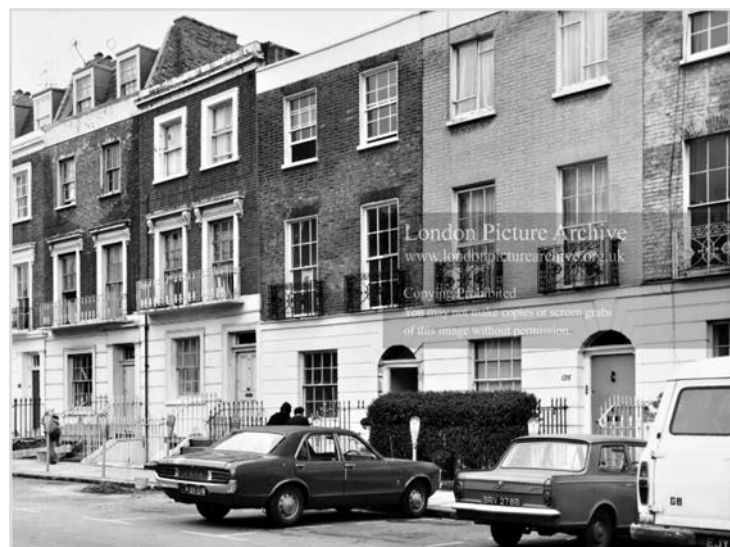
Figure 16: Front elevation in 1975 viewed from the north east. © London Picture Archive Collage Ref. 106216. Note painted brickwork to No. 125.

3.16 Photographs taken in 1975 show the front elevation, looking southeast (**Figure 16**), and northwest (**Figure 17**), together with the rear of the neighbouring house to the south (No. 123) (**Figure 18**). The contrast between Nos. 123-139 at the north end of the street and the remainder of the terrace to the south is marked by a clear height differential and lack of ornamental mouldings to the first-floor windows.

3.17 In 1975 the building was painted, and this is noted in the statutory list description of May 1974. The paint was evidently removed with an abrasive system, possibly sand blasting. This has resulted in the pitted appearance of the brickwork and its lighter colouring. This paint removal was carried out before 2008. The front parapet has clearly also been rebuilt in salvaged stock brick. All but one of the sash windows in the property are modern replacements. This is evident from the horn details and machine cut softwood profiles. None of the windows contain hand made cylinder glass.

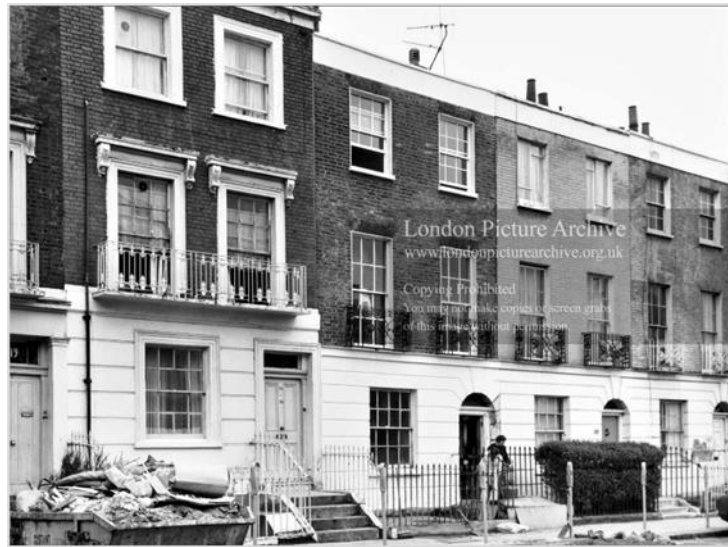
Figure 17: Front elevation in 1975 viewed from the south east. © London Picture Archive Collage Ref. 106217.

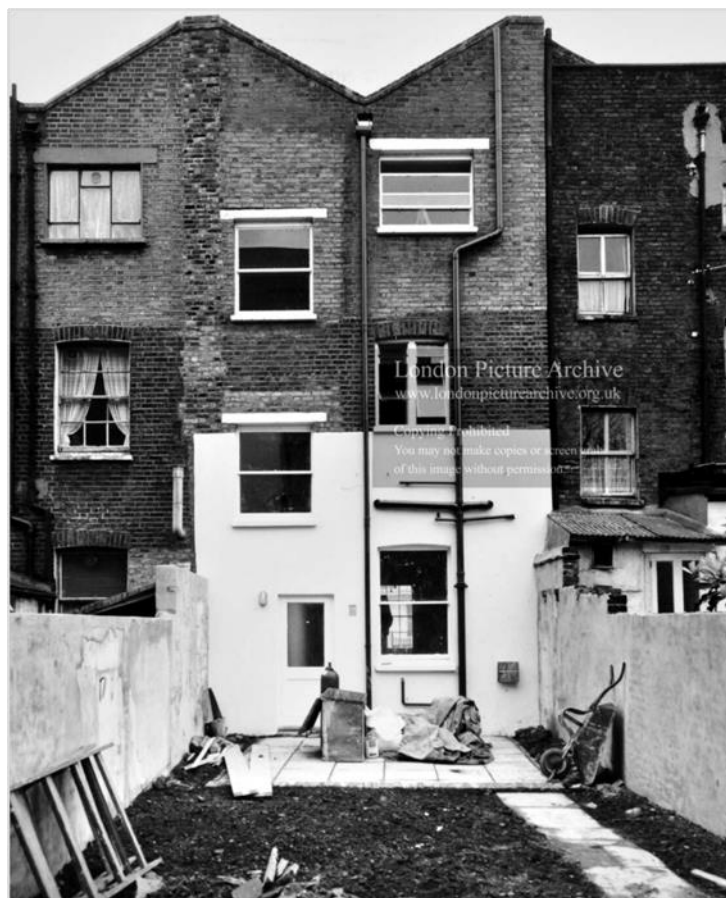
Figure 18: Rear elevation of No. 123 (No. 125 visible to the left) photographed in 1975 following the removal of the rear outrigger and party wall projecting end stack. The shadow of the chimney stack remains visible to the partition with No. 125 (note rough brickwork to former flue lining). © London Picture Archive Collage Ref. 106214.

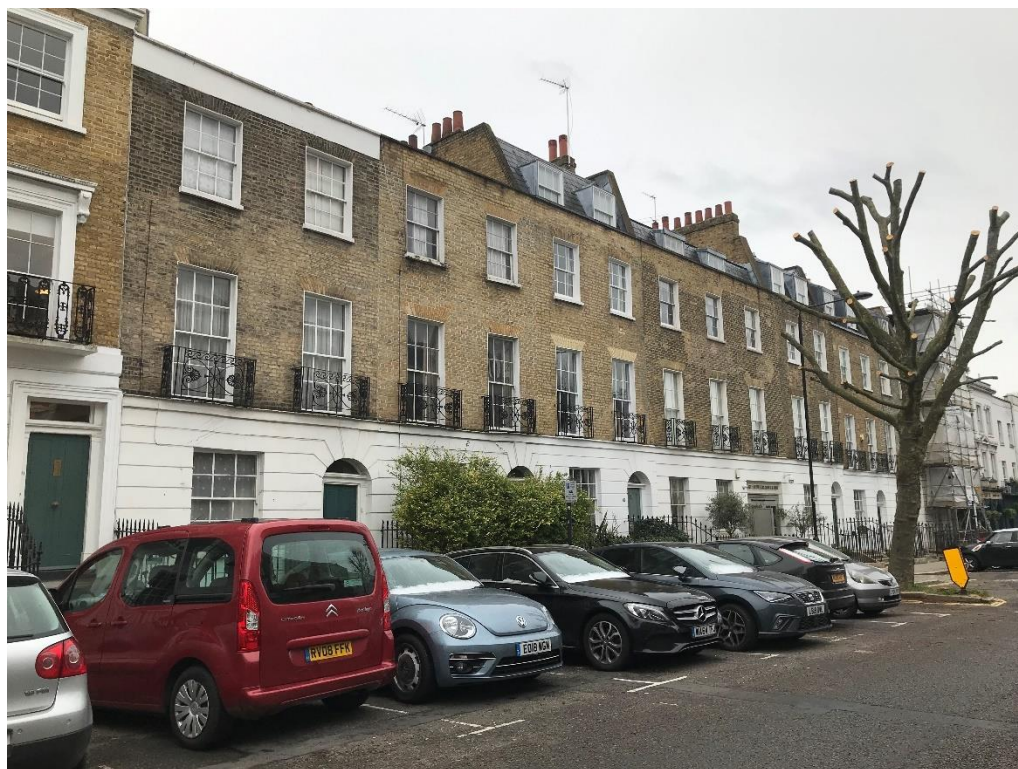
Figure 19: View of Nos. 123-139 Albert Street from the south east.

4.1 No. 125 Albert Street was built as part of a run of 9 town houses c. 1845 (early Victorian) and comprises nos. 123-139 (**Figure 19**). Nos. 129-131 were amalgamated during the 20th Century and is now the Jewish Museum London. No. 131 originally incorporated a carriage arch giving access to a small mews stable and associated accommodation. Nos. 129-131 now has a slightly wider frontage and differently spaced windows, so what was 9 houses now appears to be 8. The terrace was added to the National Heritage List for England on 14th May 1974. The Statutorily list entry describes the terrace as follows:

"Terrace of 9 houses. c1845. Multi-coloured and yellow stock brick, (No.125, painted), No.137, grey stock brick. Rusticated stucco ground floors. No.127, slate mansard roof with attic dormers. Nos 135-139, slightly recessed. 3 storeys and basements. 2 windows each. No.129 incorporated in No.131 with 3 windows. Round-arched doorways with pilaster-jambs carrying cornice-heads; fanlights (Nos 133-137, radial) and panelled doors. No.131, square-headed doorway with C20 door. Gauged brick flat arches to recessed sashes (except No.125 2nd floor, C20 metal-framed casements); 1st floors with cast-iron balconies. Parapets, Nos 123-127 with stucco facing. INTERIORS: not inspected. SUBSIDIARY FEATURES: attached cast-iron railings with spearhead finials."

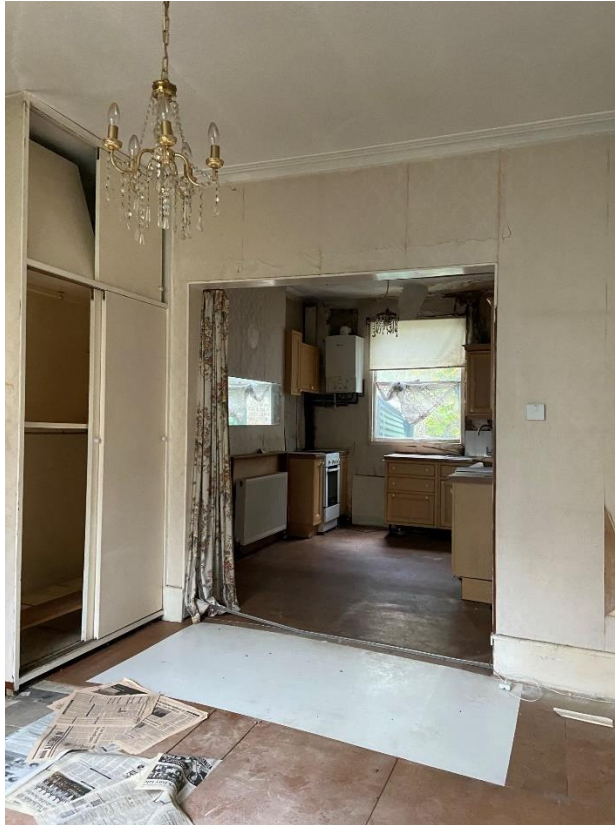
Figure 20: View west from the main ground floor reception room to the rear parlour. The large opening to the partition wall is late 20th century.

three levels alongside a lateral entrance hall, with dog-leg staircase to the rear corner (NW) of the house. The latter feature allows the 'front' room above ground floor to take up the full (two-bay) width of the property. This plan form remains legible at all levels, despite late 20th century interventions which eroded its integrity in places. These alterations included sealing up original doorways, replacement skirtings throughout, fire-boarding to the staircase balustrade, several new partitions and a large opening between the front and rear living rooms to the ground floor (**Figure 20**).

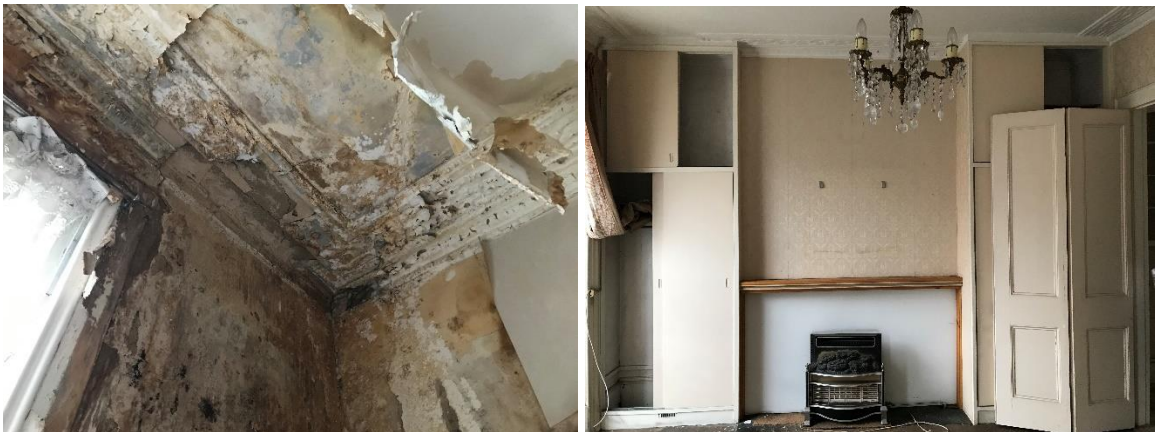
Figure 21: The most ornate plasterwork cornicing is at first floor level and is similar to the front and rear rooms. It has been heavily damaged by water ingress in the kitchen (left) or obscured by fitted cupboards in the bed-living room (right).

- The ground and first floor rooms retain original plasterwork cornices and ceiling enrichment. This is badly deteriorated where water ingress has occurred (**Figure 21**) and all of the detailing is heavily obscured by thick paint. Nonetheless, the plasterwork is original decorative treatment which contributes to the architectural and artistic interest of the listed building. The feature plasterwork is proposed to be reinstated and restored as part of the proposed refurbishment. The simple cornice detail to the second-floor rooms is not original, comprising off the shelf pre-fabricated lengths of plaster coving. There is no plasterwork detail to the entrance hall and stairwell.

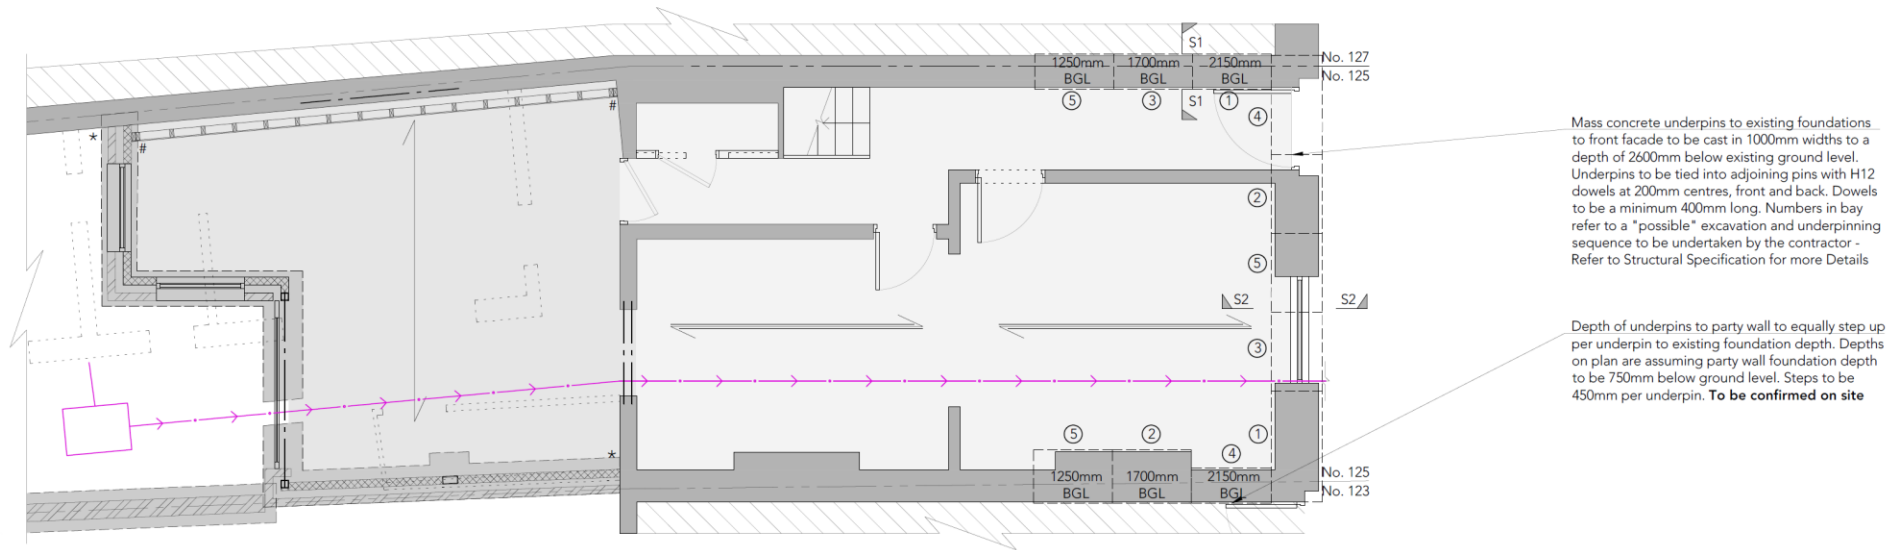
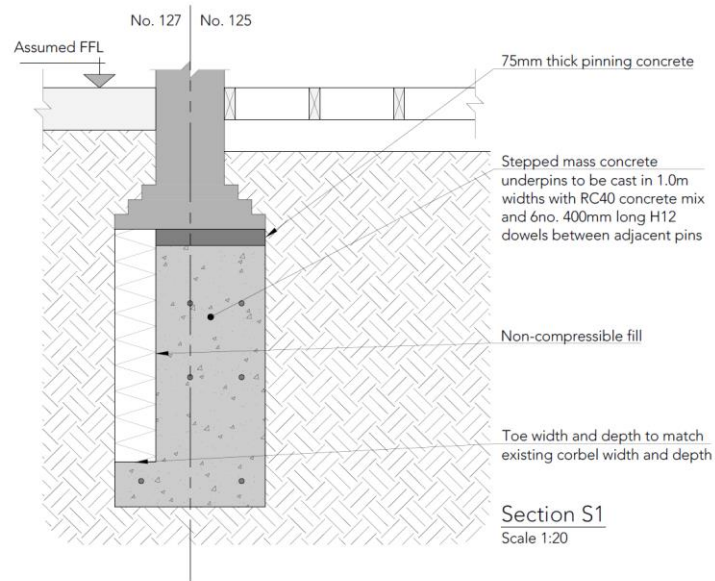
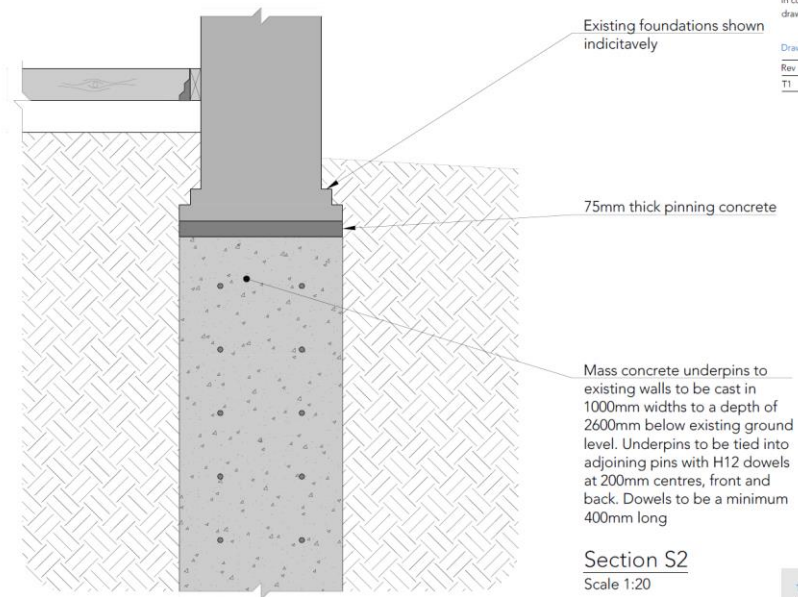
Proposed Scheme Details – Blue Engineering

It is therefore recommended that the front elevation and the front returns to the party wall be underpinned below the depth of the tree, we would recommend to a depth of 2.5m deep, to prevent this seasonal movement / subsidence occurring at the property, as the tree root analysis was unable to identify the tree causing the subsidence, and any tree removal has the potential to cause heave, which would further damage the existing property.

Mass concrete underpinning is a low-tech solution to addressing the movement seen at 125 Albert Street, it is less invasive than other methods of dealing with soil desiccation such as grout injection and has a long lifecycle in preventing further movement to the property. The cracking which has already occurred at the property is to a greater extent, than the scope of the cracking likely to occur from underpinning the front elevation and sections of

5.8 The proposed method of under-pinning does not involve the loss of any historic fabric, and that which is required to be removed in order to access the foundations and excavate beneath them to create the mass concrete sections of under-pinning, (e.g. the ground floor carpentry), is to be carefully removed and reinstated in its original location once the under-pinning is in place. The accompanying method statement for the works sets out the process of implementation at pages 3-4 (Activities 1-10).
