**178B ROYAL COLLEGE STREET &
ARCHES 73,74,75 RANDOLPH STREET,
CAMDEN, LONDON**
Bat Survey Report

September 2022

Bioscan Report No. E2152R1

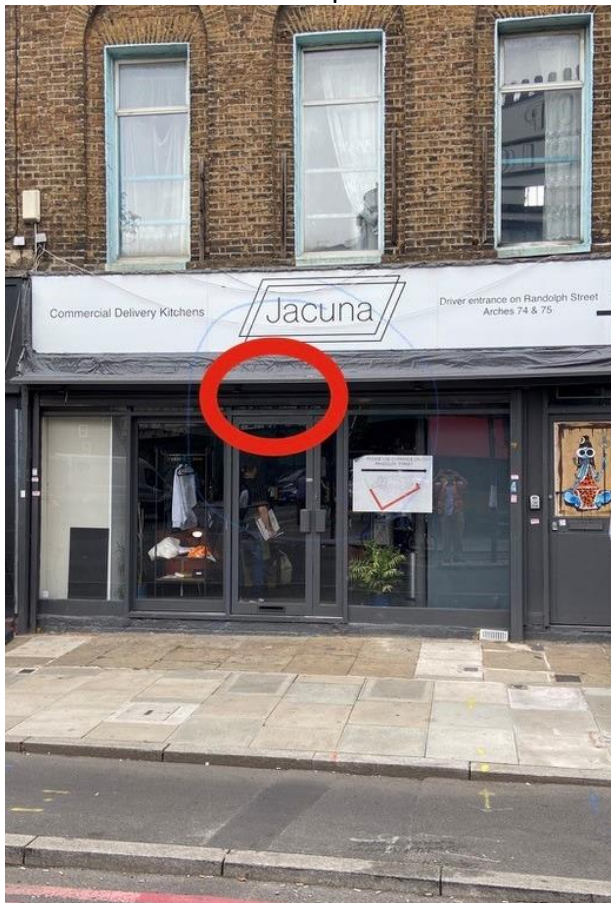
- 2.1.1 During the visit, a single bat dropping was found on a narrow metal ledge which is connected to the roller shutter mechanism along the external store frontage of 178B Royal College Steet (Photos 1 and 2). The dropping was located below a signage feature that would be considered highly sub-optimal for roosting and it was concluded that it is likely to have been deposited by a flying bat passing close to the building façade. The dropping has been sent for DNA analysis and the results are awaited, but it is deemed likely that it was from a common or soprano pipistrelle. The presence of the dropping indicates that bats either forage on the site, or use it for commuting purposes, but does not of itself indicate the presence of past or current roosting. It also indicates that such use continues despite the alterations made to the shopfront.

Photo 1: Approximate location of dropping circled

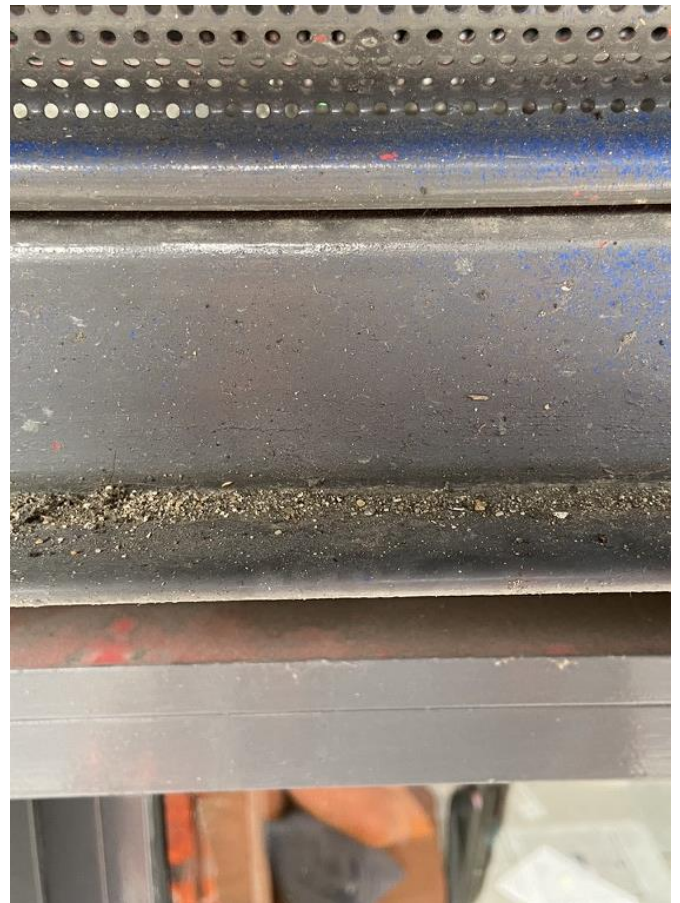
Photo 2: Ledge feature which held dropping

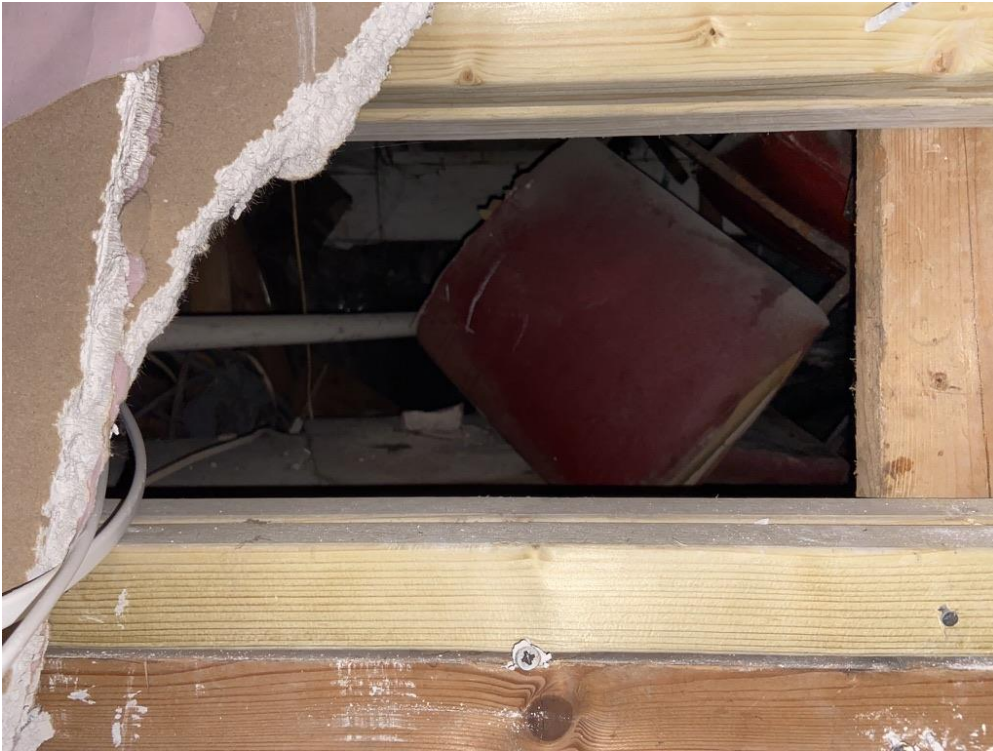
- 2.2.1 Internal inspection of arches 73, 74 and 75 confirmed that they have been lined, leaving a narrow void between the internal structure of the dark kitchen pods and

the original brickwork of the arches. This narrow void could not be fully examined albeit an appreciation of it could be gained at a number of locations via use of a ladder (Photo 3).

Photo 3: Roof void above conjunction of internal corridors

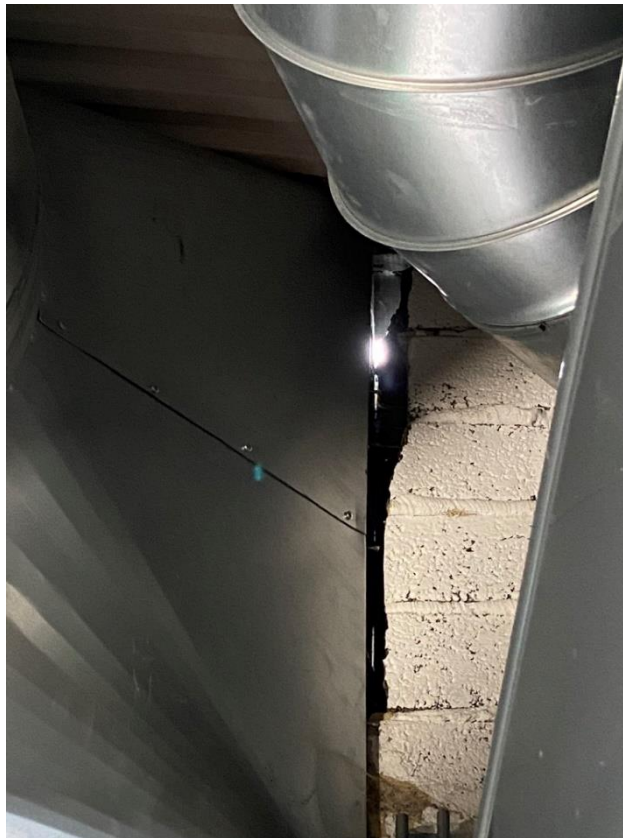
- 2.1.1 The survey confirmed that the sealed interior of the kitchen pods offered no roosting opportunities for bats. There were some small gaps around one ventilation tunnel which could allow for movement of bats in and out of the building although that is deemed very unlikely (Photo 4) and no evidence for this was present.

Photo 4: Small gap in wall next to ventilation tunnel
