16 Pilgrim's Lane London NW3 1SN

Site Investigation & Basement Impact Assessment

J22352 Rev 0

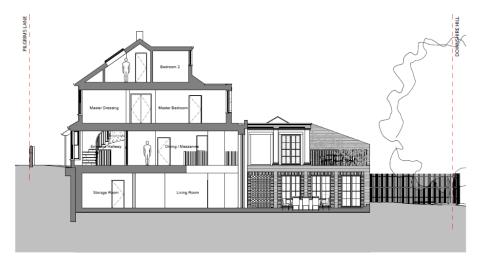
Proposed Section AA

It is understood that it is proposed to extend the existing lower ground floor level beneath the full footprint of the house, and construct a new rear extension and terrace, as part of alterations to the house. Formation level for the proposed lower ground floor level is understood to be approximately 3.60 m below the existing ground floor level, which is around 1.00 m below the existing lower ground floor level.

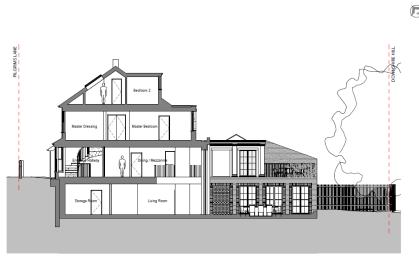
Proposed Section AA

It is understood that it is proposed to extend the existing lower ground floor level beneath the full footprint of the house, and construct a new rear extension and terrace, as part of alterations to the house. Formation level for the proposed lower ground floor level is understood to be approximately 3.60 m below the existing ground floor level, which is around 1.00 m below the existing lower ground floor level, at roughly 79.00 m above Ordnance Datum (OD).

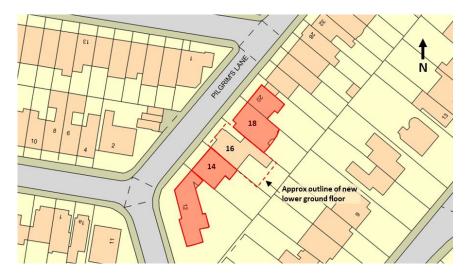
Nearby sensitive structures comprise the adjoining 18 and 20 Pilgrims Lane to the northeast and the adjoining 14 and 12 Pilgrims Lane to the southwest, as shown on the plan below.

The heights of the buildings have been estimated from observations, and from drawings provided by the consulting engineers. The underside of the foundations of 12 and 14 Pilgrims Lane have been determined based on the trial pitting completed at 12 Pilgrims Lane, the findings of which were found during a recent search of planning records held by Camden Council, and the foundations of 18 and 20 Pilgrims Lane have been assumed to be the same. Trial Pit No 2, excavated alongside the southeast flank wall of 18 Pilgrims Lane did not reveal the base of the foundation to this wall within the 1.39 m depth excavated, but the foundations to 18 Pilgrims Lane have been conservatively modelled at a depth of 0.70 m, as per 12, 14 and 20 Pilgrims Lane. The heights and underside of foundations are summarised in the table below.
