## **Appendix 2: Site Invetigation Data**

# REPORT ON A SITE INVESTIGATION

**20 HOWITT ROAD, BELSIZE PARK,  
LONDON NW3 4LL**

**22/12510/GO**

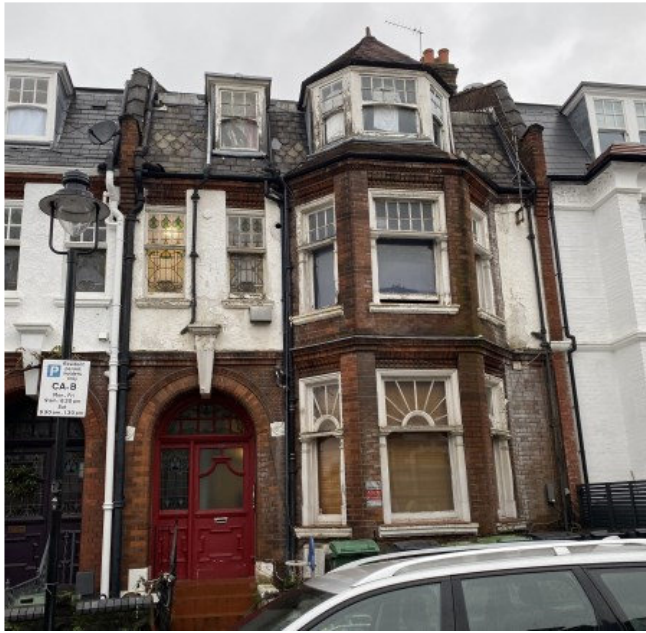
*Front*

The depths and descriptions of the strata encountered in the boreholes and trial pits are given on the records which comprise Appendix 1 to this report. These records note the depths at which samples were taken, the results of in situ tests and the groundwater observations noted at the time of the fieldworks. Photographs which give a general impression of the site at the time of the fieldworks are included below.

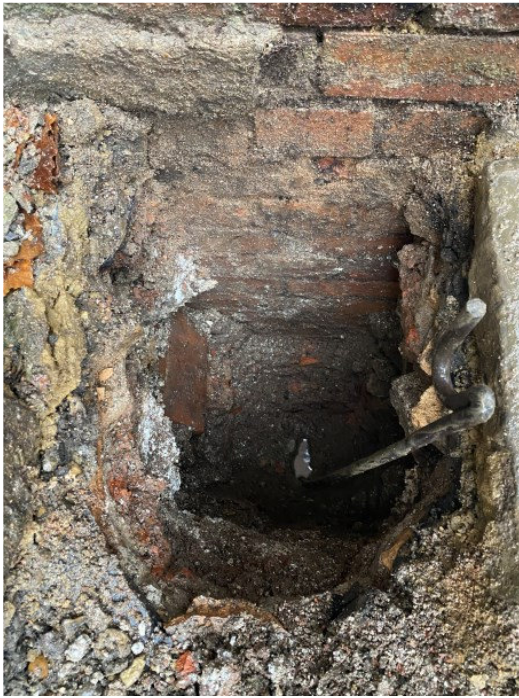
A

The existing foundations exposed in the trial pits are depicted in the sectional drawing no's. 22/12510/2 and 3 presented in Figure 2 to this report. The excavations revealed that the existing foundations comprise corbelled brickwork, which extended to 1.10m and 1.25m below ground level. Photographs of the trial pit excavations are included below.
