11a Heath Drive
London NW3 7SN

Typical Window Details

Drawing PL-26 Revision B

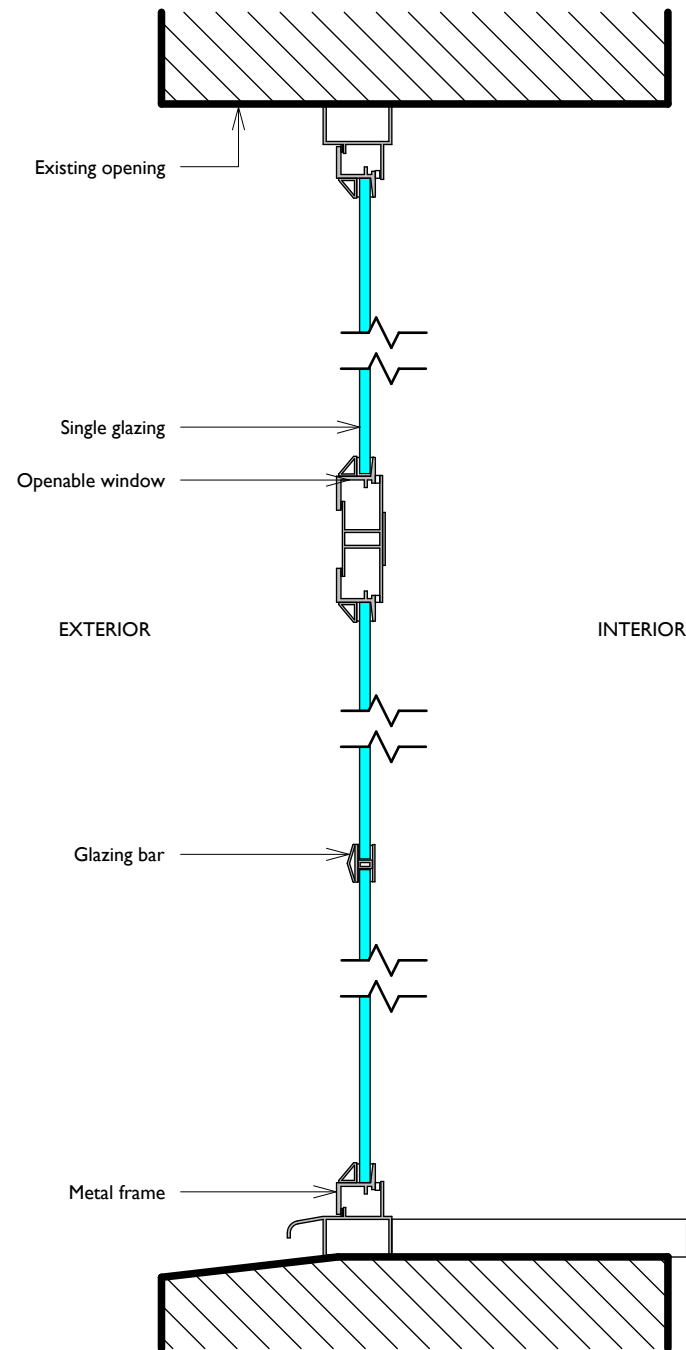
1 Existing Window Typical Detail
1 : 5

Section of window is assumed based on photographs of existing condition.

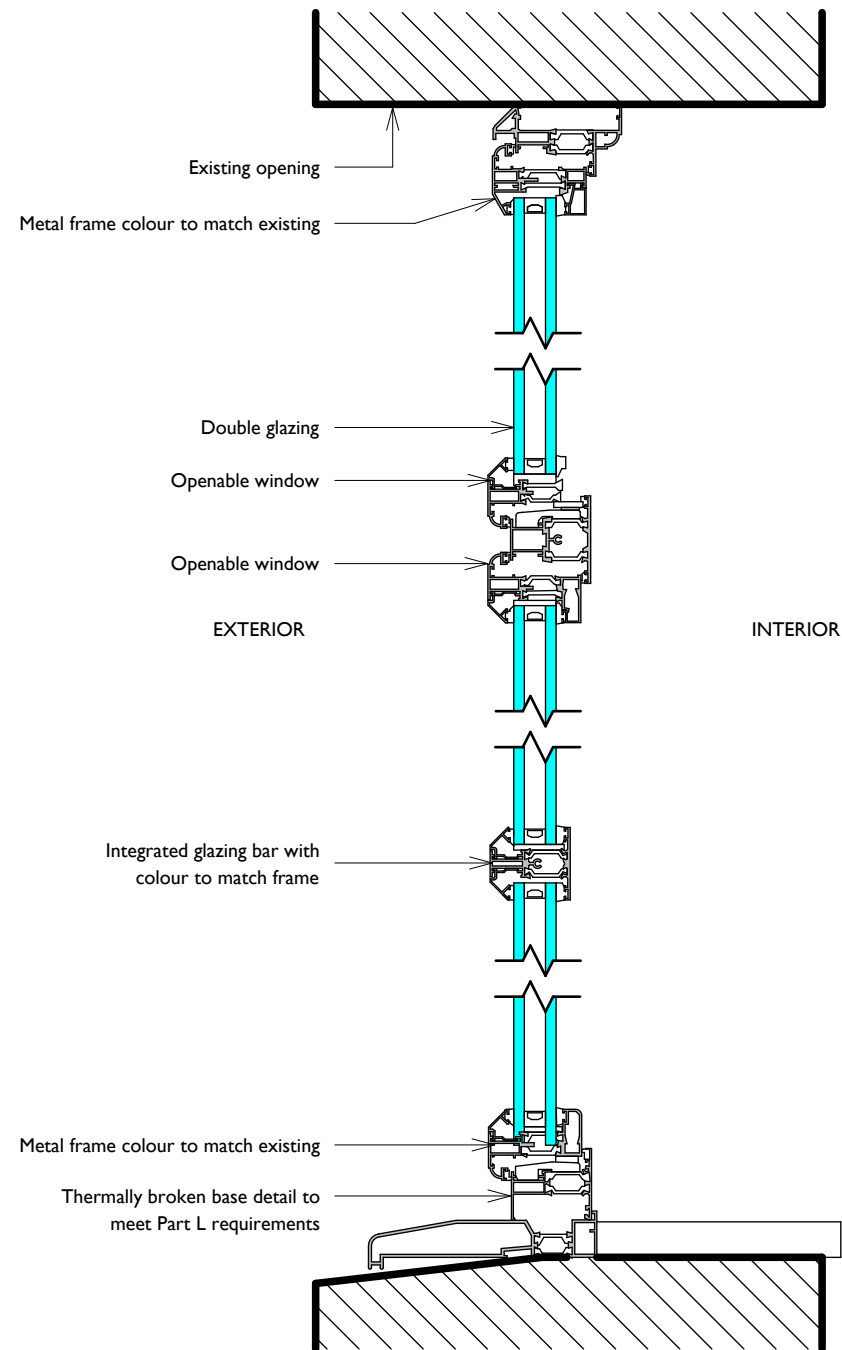
2 Proposed Window Typical Detail
1 : 5

Section of window based on thermally broken Alitherm 300 system.

1. Proposed window and door frames to be thermally broken aluminium to meet Approved Documents Part L minimum thermal requirements.
2. Proposed window ironmongery to be black monkey tail style to match existing.
3. Drawing issued for planning purposes only. Window manufacturer to provide drawings and specifications prior to fabrication based on typical details.
