Existing Internal Elevations  
Window Stack 07

BW125 - BW - ## - XX - DR - E3007

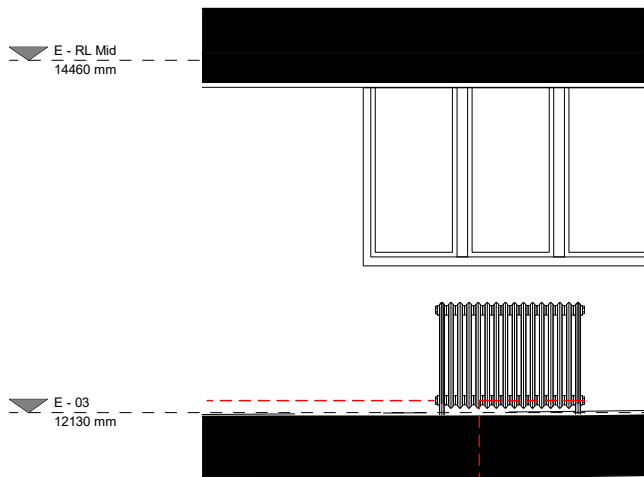
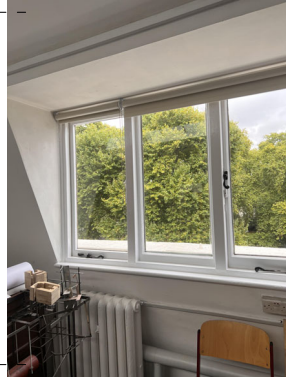
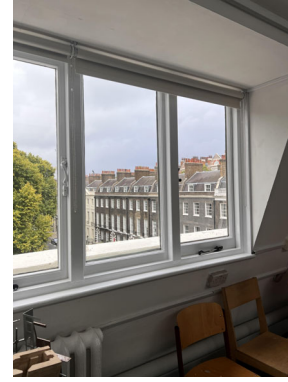
### W.03.02

Modern casement  
Post condition  
Manually operated blinds

Modern casement window.  
Lowest significance.  
No related detail of historic interest.  
No related detail of interest.  
Non original  
dormer (widened pre-existing).

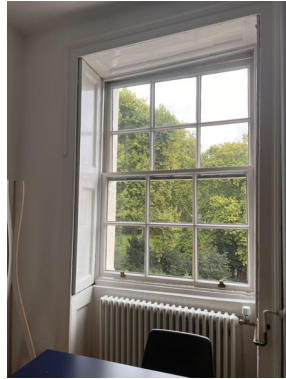
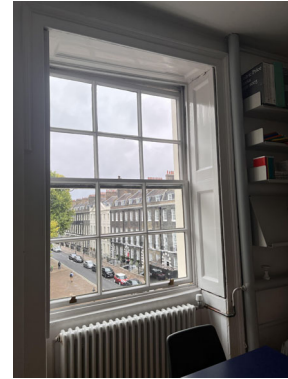
### W.02.03

Weighted sash  
6 panel sashes  
OK condition

Original shutters and architrave with simple panelled linings beneath window.  
Openable shutters in good condition. Highest significance.  
Early 20th century window with horns and flatter glazing bars. Medium significance.

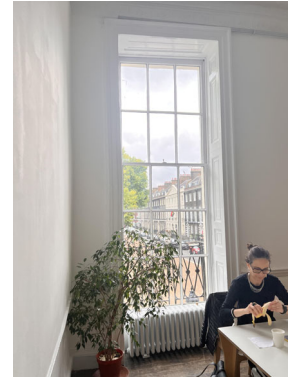
### W.01.03

Weighted sash  
6 over 9 panel sashes  
Painted shutters  
Pipework through the panel

Shutters in square reveals with mouldings similar to no. 35. Appear to be original. Both sides fixed shut and painted over with signs of repair and much overpainted. Historic plans show RHS opened up for pipework in 1926. Highest significance.  
Six over nine sash window with rounded glazing bars.  
No horns. Highest significance.

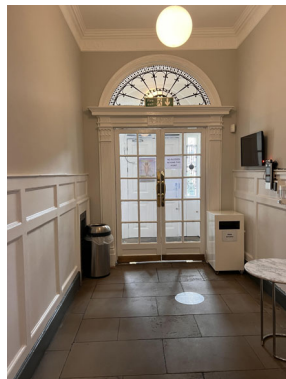
### XD.00.01

Original entrance to number 36

Modern doors of the early-mid 20th century. Matching central window to no. 35. Medium significance.

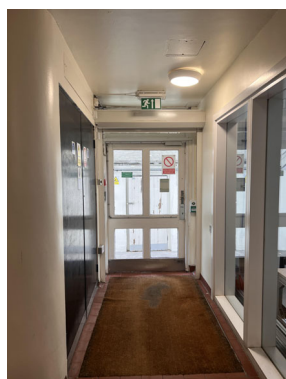
### D.B1.12

Modern door - lowest significance.
