Drawing Name
**Existing Internal Elevations
 Window Stack 10**

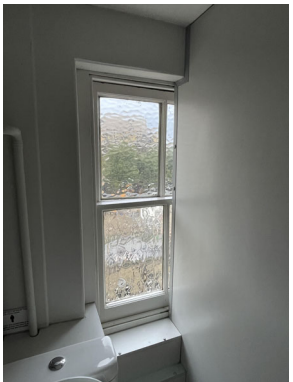
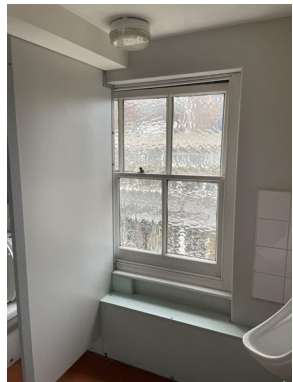
W.03.07

Modern casement
 Post condition
 Frosted glass

1920s sash window with
 obscured glazing. No panelling
 or
 other detail beyond modest
 architrave.

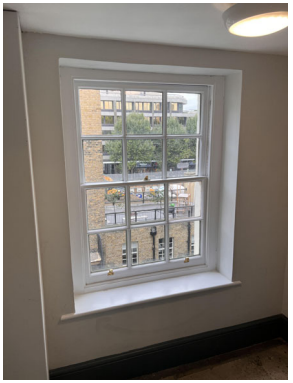
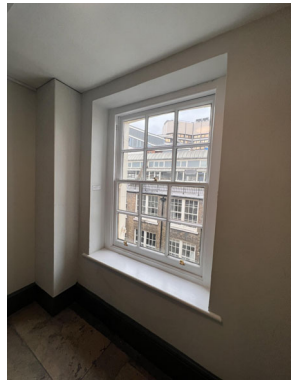
W.02.10

Weighted sash
 6 panel sashes
 OK condition

1920s window with horns in new
 opening. The stair windows to
 no. 34 appear to have been
 reconfigured. No panelling or
 other detail of interest.

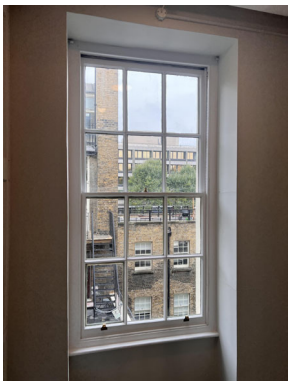
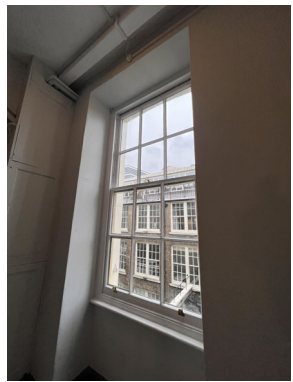
W.01.10

Weighted sash
 6 panel sashes
 Painted sashes

1920s window with horns in new
 opening. The stair windows to
 no. 34 appear to have been
 reconfigured. No panelling or
 other detail of interest.

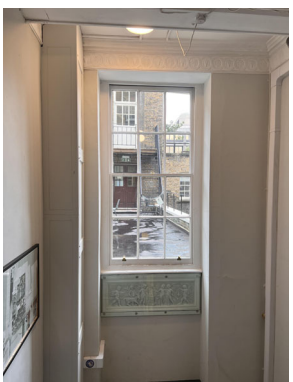
W.01.88

Weighted sash
 6 panel sashes
 Painted sashes

1920s window with horns in new
 opening. The stair windows to
 no. 34 appear to have been
 reconfigured. No panelling or
 other detail of interest.
