Drawing Name
**Existing Internal Elevations
Window Stack 11**

Drawing Number Revision
BW125 - BW - ## - XX - DR - E3011

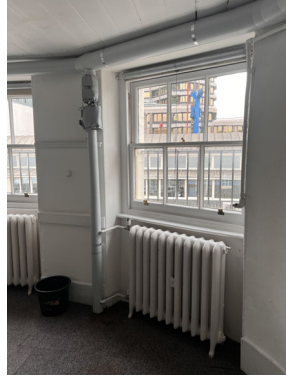
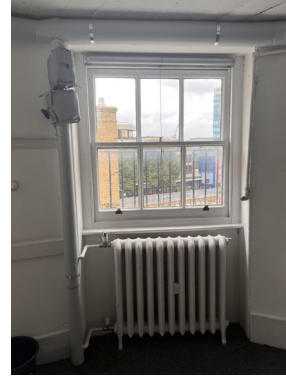
W.03.08

Modern casement
Post condition
Studwall cuts across
3 panel sash

1920s sash window with horns.
No panelling or other detail
beyond modest architrave.

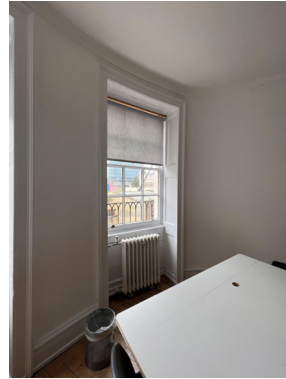
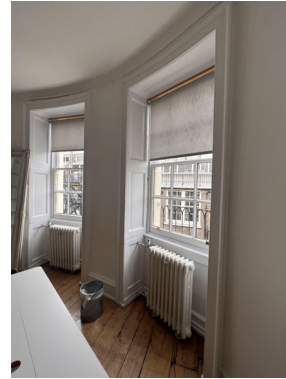
W.02.11

Weighted sash
6 panel sashes
OK condition
Manually operated blinds

1920s sash windows with horns.
Original shutter and simple
panelling below window. Much
painted over, fixed and filled.
Lost definition.
Medium to high significance.

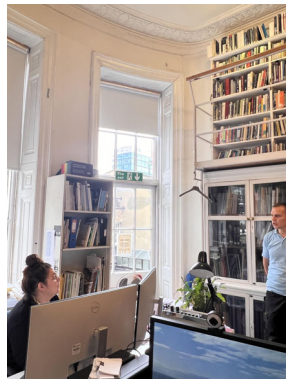
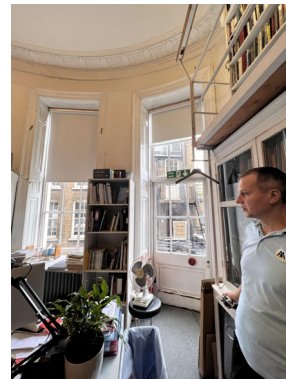
D.01.14

Weighted sash
Fire Escape Door
Manually operated blinds

Window opening converted to a door
opening with modern door.
Lowest significance.
Shutters painted over and fixed shut.
Mouldings to shutters do not
match those to the front room but instead
are closer in character to
the front room shutters of 35 and 36.
Medium to high significance.

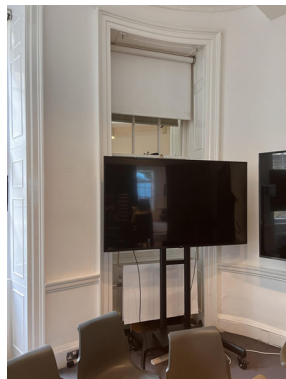
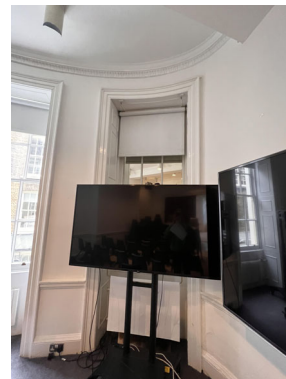
W.00.07

Weighted sash
6 panel sashes
Mirror
Electric operated blinds

20th century window with
mirrored glazing.
Shutters painted over and fixed
shut. Mouldings do not match
others in the building and
appear to lack detail indicative
of later replacement.

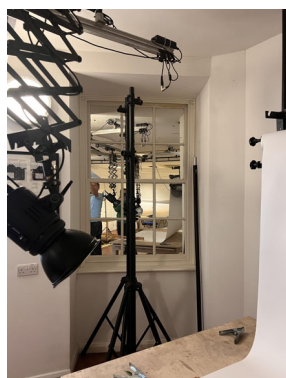
W.B1.07

Window has been blanked
Timber frame remains with
glazing removed.

Not inspected.
