Existing Internal Elevations
Window Stack 12

BW125 - BW - ## - XX - DR - E3012

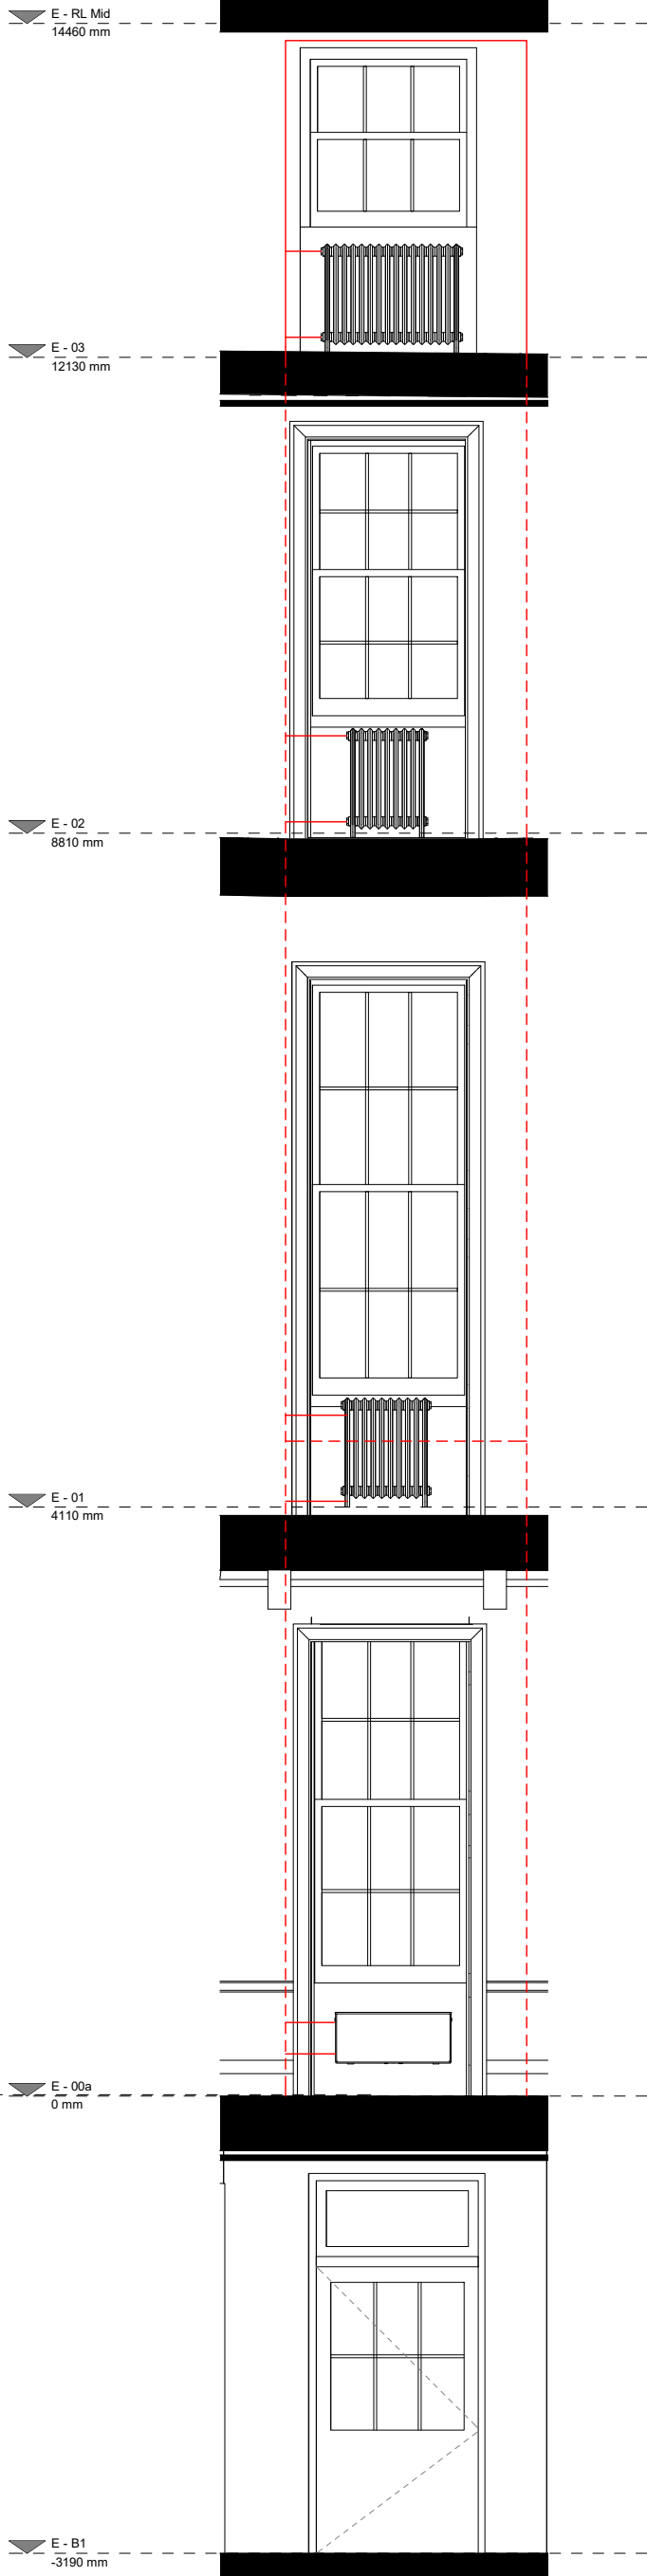
W.03.09

Modern casement
Post condition
3 panel sashes

1920s sash window with horns.
No panelling or other detail
beyond modest architrave.

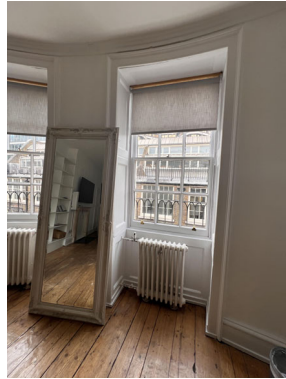
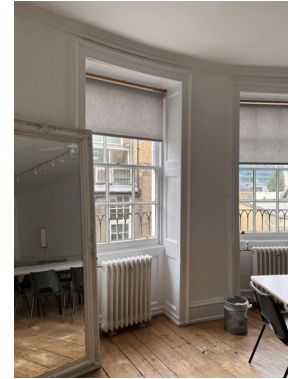
W.02.12

Weighted sash
6 panel sashes
OK condition
Manually operated blinds

1920s sash windows with horns.
Original shutter and simple
panelling below window. Much
painted over, fixed and filled.
Lost definition.
Medium to high significance.

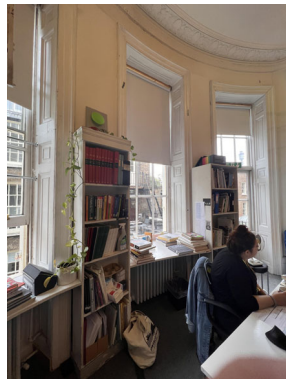
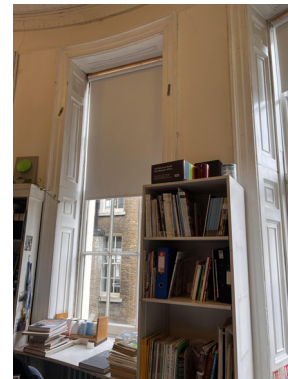
W.01.11

Weighted sash
Painted shutters
Manually operated blinds shut
Pipework through panels
6 panel sashes

Windows with horns and glazing bars
matching all others during
the 20th century (see front elevation and
Morwell Street). Medium
significance.
Shutters painted over and fixed shut.
Linings beneath cills original
but in a poor condition. Highest
significance.

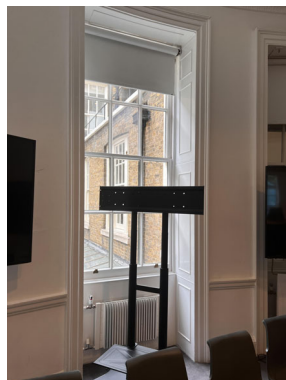
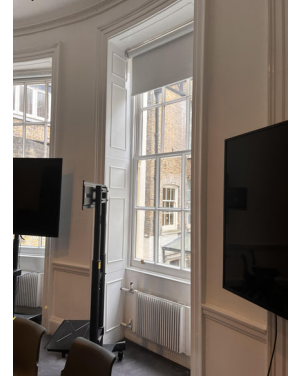
W.00.08

Weighted sash
6 panel sashes
OK condition
Pipes through panelling
Electric operated blinds

Windows with horns and
glazing bars matching all
others during
the 20th century (see front
elevation and Morwell Street).
Medium
significance.
Shutters painted over and fixed
shut. Mouldings to shutters do
not
match those to the front room
but instead are closer in
character to
the front room shutters of 35
and 36. Medium to high
significance.

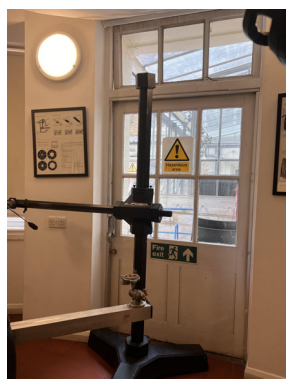
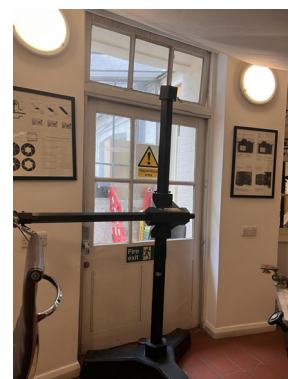
D.B1.41

1920s door with fanlight.
Low-medium significance.
