**Existing Internal Elevations Window Stack 15**

BW125 - BW - ## - XX - DR - E3015

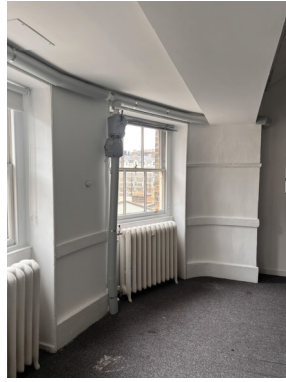
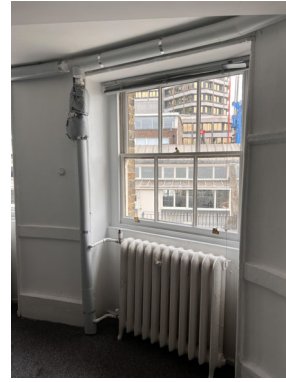
**W.03.12**

Modern casement  
Post condition  
3 panel sashes

1920s sash with horns. Historic modest panel behind radiator reflecting floor hierarchy. Medium to high significance.

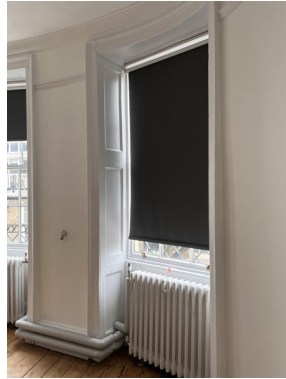
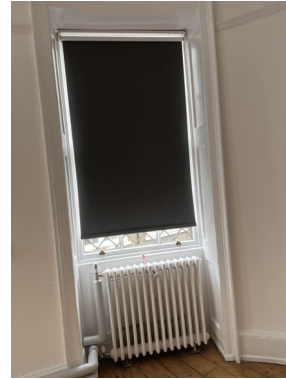
**W.02.15**

Weighted sash  
6 panel sashes  
Shutter box non functioning  
OK condition

Original window much painted over and repaired shutter boxes. No horns. Panelling below good architrave. Reasonable condition. Highest Significance.

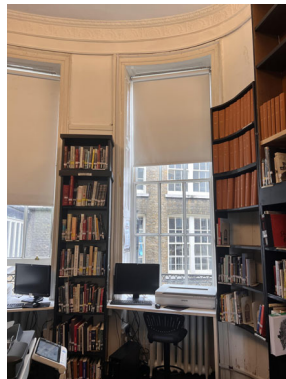
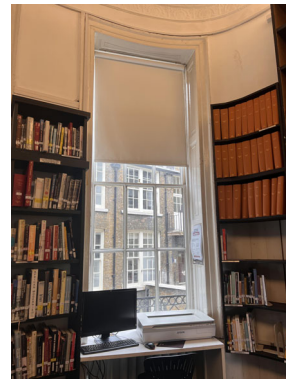
**W.01.14**

Weighted sash  
6 panel sashes  
Painted shutters  
Manually operated blinds

**FURTHER INSPECTION REQUIRED**

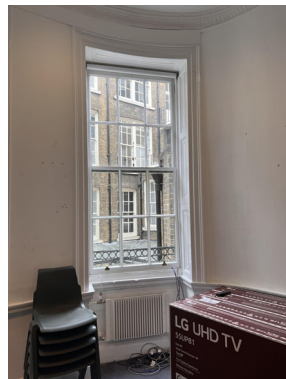
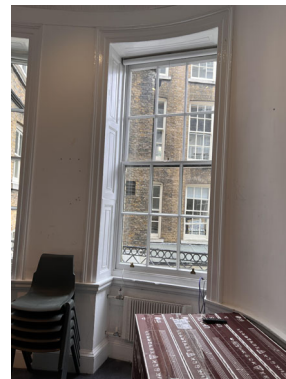
**W.00.11**

Weighted sash  
6 panel sashes  
OK condition  
Manually operated blinds

Good quality historic window shutters painted shut with no lining below. New panel to side below cill with pipe fitting. High significance despite later alteration. Good glazing bars and probably original sashes. Highest significance.
