Existing Internal Elevations
Window Stack 19

Drawing Number Revision
BW125 - BW - ## - XX - DR - E3019

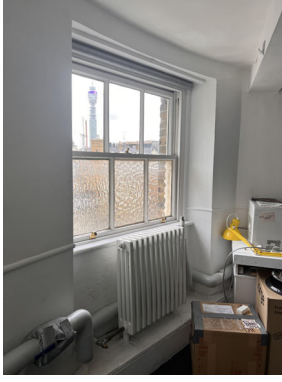
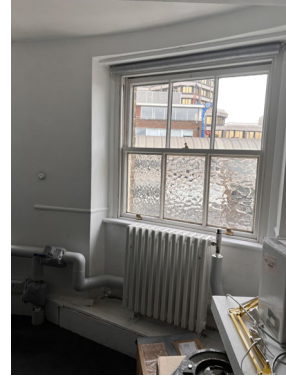
W.03.16

Modern casement
Post condition
Manually operated blinds

1920s sash with horns. Historic modest panel behind radiator reflecting floor hierarchy. Medium to high significance. Bay rebuilt 1926.

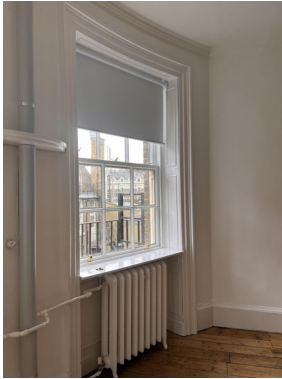
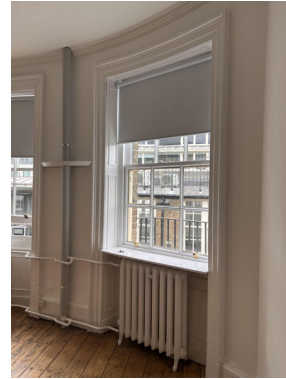
W.02.18

Weighted sash
6 panel sashes
Shutter box non functioning
Concealed radiator below
OK condition
Manually operated blinds

Rear bay rebuilt 1926 - 1926 windows and shutter boxes matching rear bay on other levels. Low to medium significance.

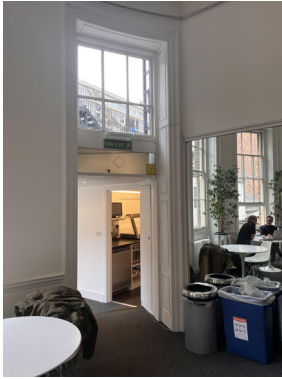
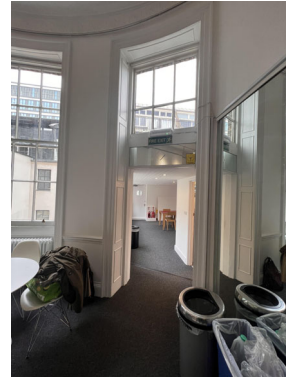
D.01.12

Doorway
Opening adapted for doorway to outrigger and fixed six light window to roof terrace
Timber framed

Window converted to a door by 1928. 1920s window over and modern window linings have replaced shutter boxes. Low to medium significance.

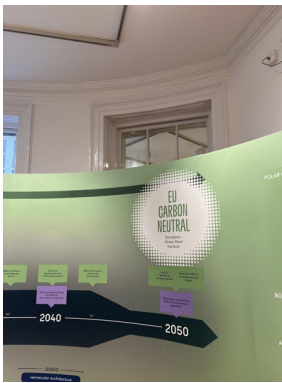
W.00.14

Window blocked 1926 because of rear extension. No shutters but instead simple linings with modest detailing. 1926 in date. Glazing bars of 1920s date. Mirrored glazing. Low to medium significance.
