GROUND INVESTIGATION REPORT

Tybalds Estate
Camden
London WC1

J15072

May 2015

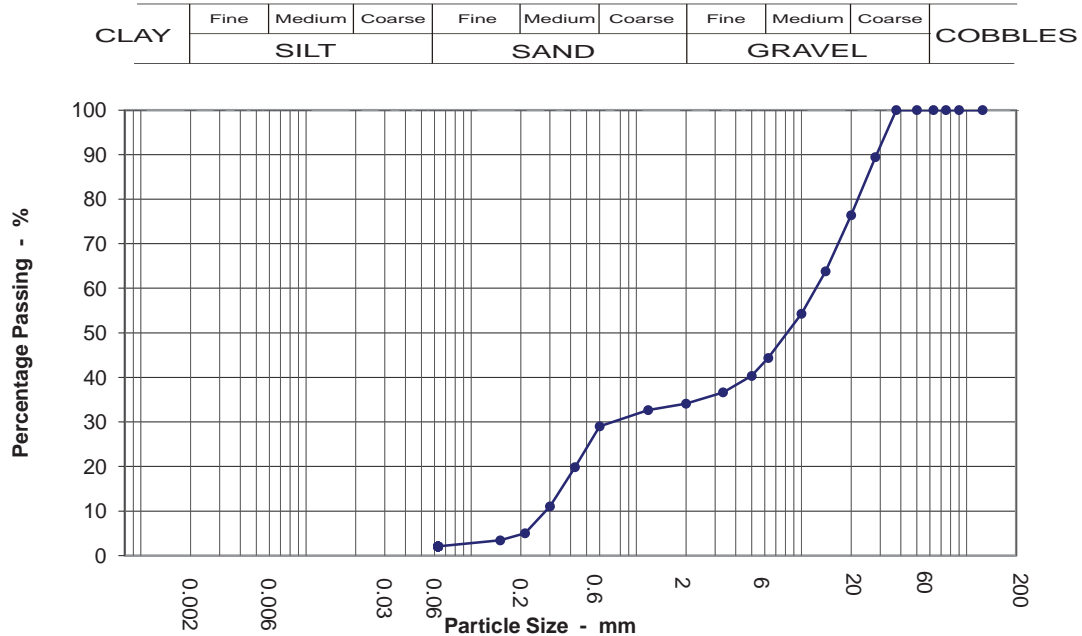
PARTICLE SIZE DISTRIBUTION BS 1377 : Part 2 : 1990 : Clause 9	Our Report No:	18691
		Project No:	J15072
Location	Tybalds Estate, London WC1N 3JT	Borehole / Trial Pit No:	TP2
Visual Soil Description		Brown slightly clayey very sandy GRAVEL (gravel is fmc and sub-angular to rounded)	Depth
	Sample Type/No		D - 2

Sieving		Sedimentation	
Particle Size mm	% Passing	Particle Size mm	% Passing
125	100		
90	100		
75	100		
63	100		
50	100		
37.5	100		
28	89		
20	76		
14	64		
10	54		
6.3	44		
5	40		
3.35	37		
2	34		
1.18	33		
0.6	29		
0.425	20		
0.3	11		
0.212	5		
0.15	3		
0.063	2

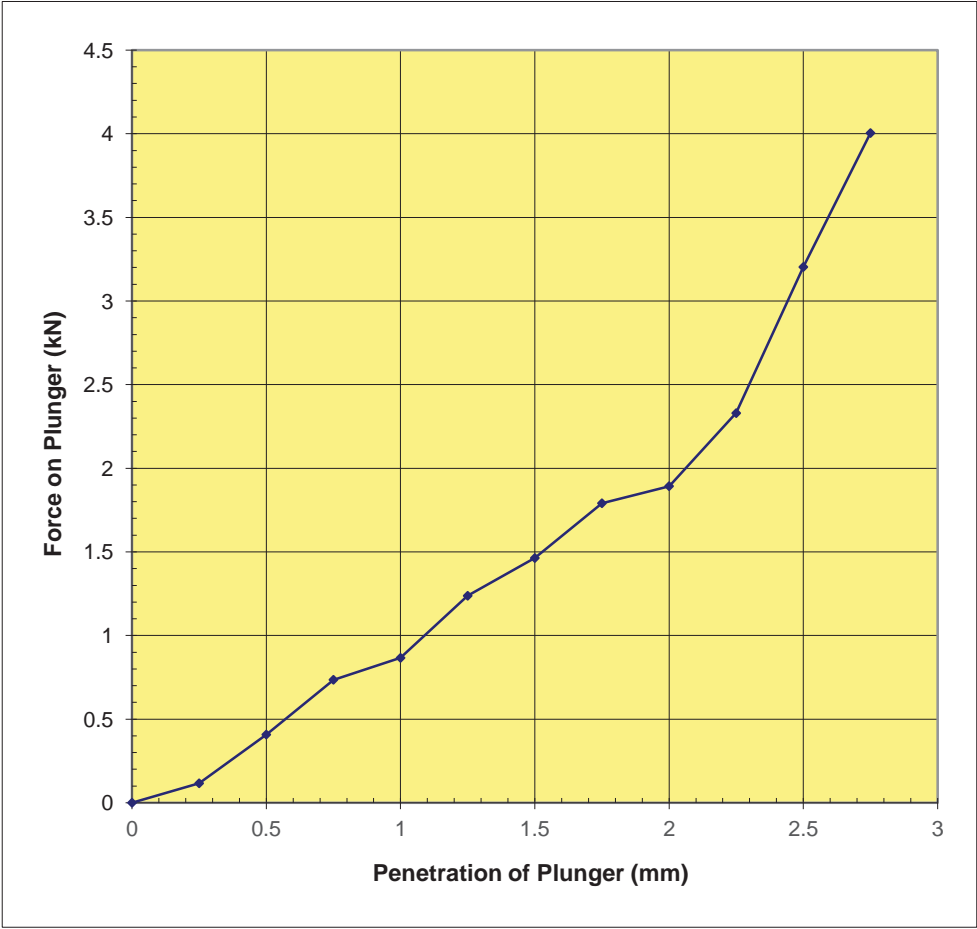
Penetration of Plunger mm	Force on Plunger	
	Dial Reading	Load kN
0	0	0
0.25	16	0.12
0.50	56	0.41
0.75	101	0.74
1.00	119	0.87
1.25	170	1.24
1.50	201	1.46
1.75	246	1.79
2.00	260	1.89
2.25	320	2.33
2.50	440	3.20
2.75	550	4.00

Moisture content (%) 12	Penetration mm	Force kN	Standard Force kN	CBR %
	2.5	3.20	13.2	24.27
In-situ CBR value % 24	5	-	20	-

Formation level for new roads and pavements are likely to be in the made ground. California bearing ratio tests have been carried out and suggest that a CBR values of 4% is appropriate where made ground comprising of clay is encountered, where sandy made ground is found a CBR value of 10% could be achieved. It should however be noted that made

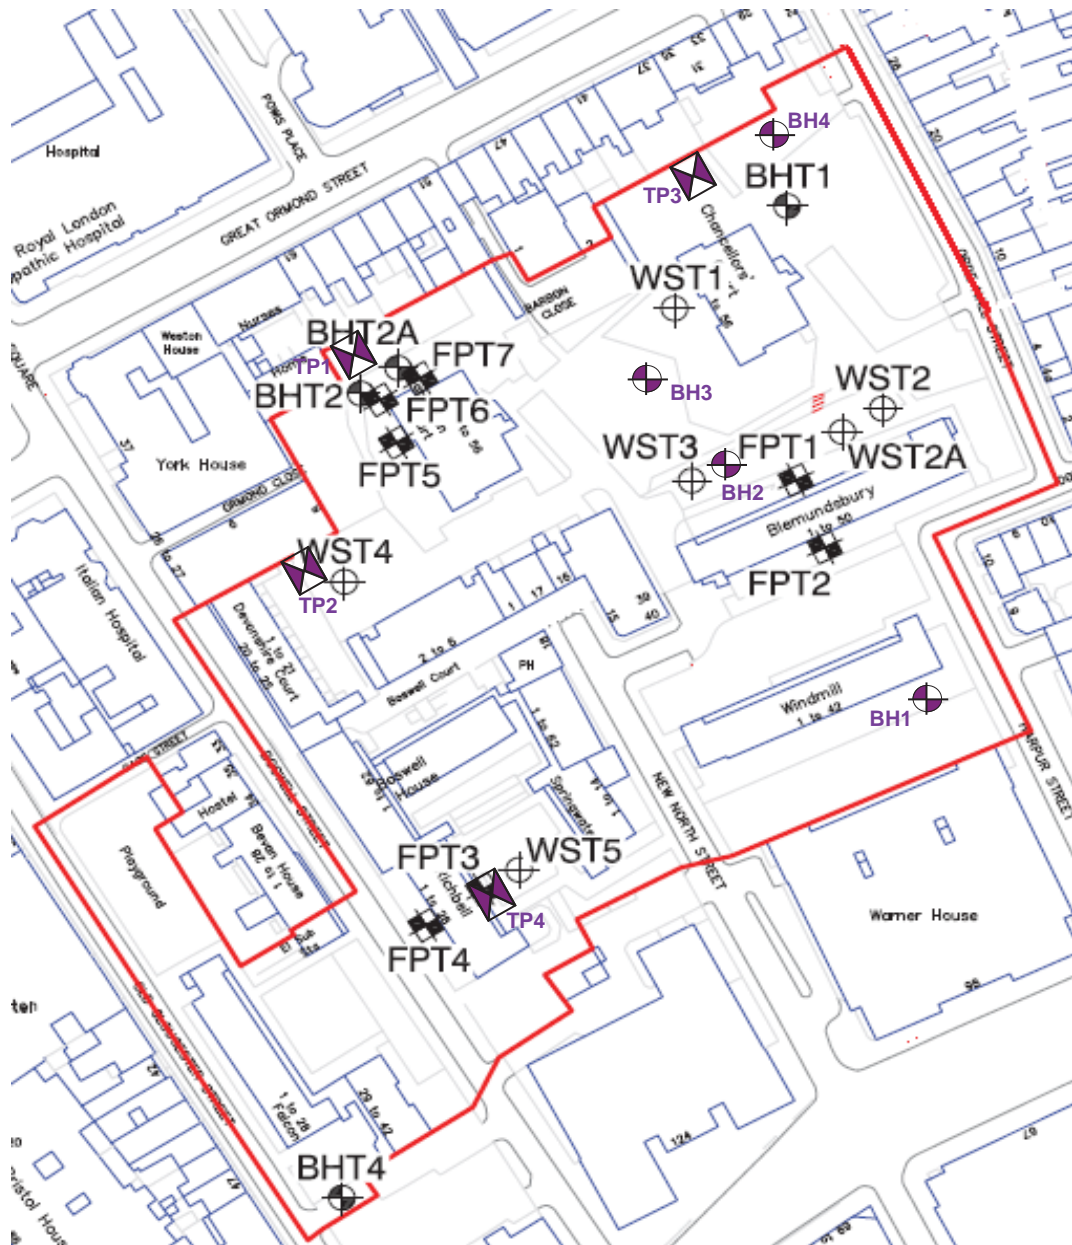
Exploratory positions undertaken by Harrison Group

Exploratory positions undertaken by GEA

The boreholes were positioned on site by an engineer from GEA to provide additional coverage of the site. The trial pit locations were specified by the consulting engineers, although the presence of basements or sunken ground floor at many of the proposed locations rendered the use of hand dug trial pits ineffective. The previous investigation included hand dug trial pits which were not able to prove the base of foundations, in light of which a mini-excavator was used to assist the excavation. Access suitable for a small tracked excavator to all but the four trial pit locations undertaken was restricted by the presence of steps or cast iron gates.
