PROJECT:
**2 & 3 CHARRINGTON STREET
LONDON NW1 1RS**

TITLE:
**FLOOR PLANS SHOWING
PROPOSED CRACK REPAIR DETAILS**

STATUS:
PROPOSED DWG FOR TENDER

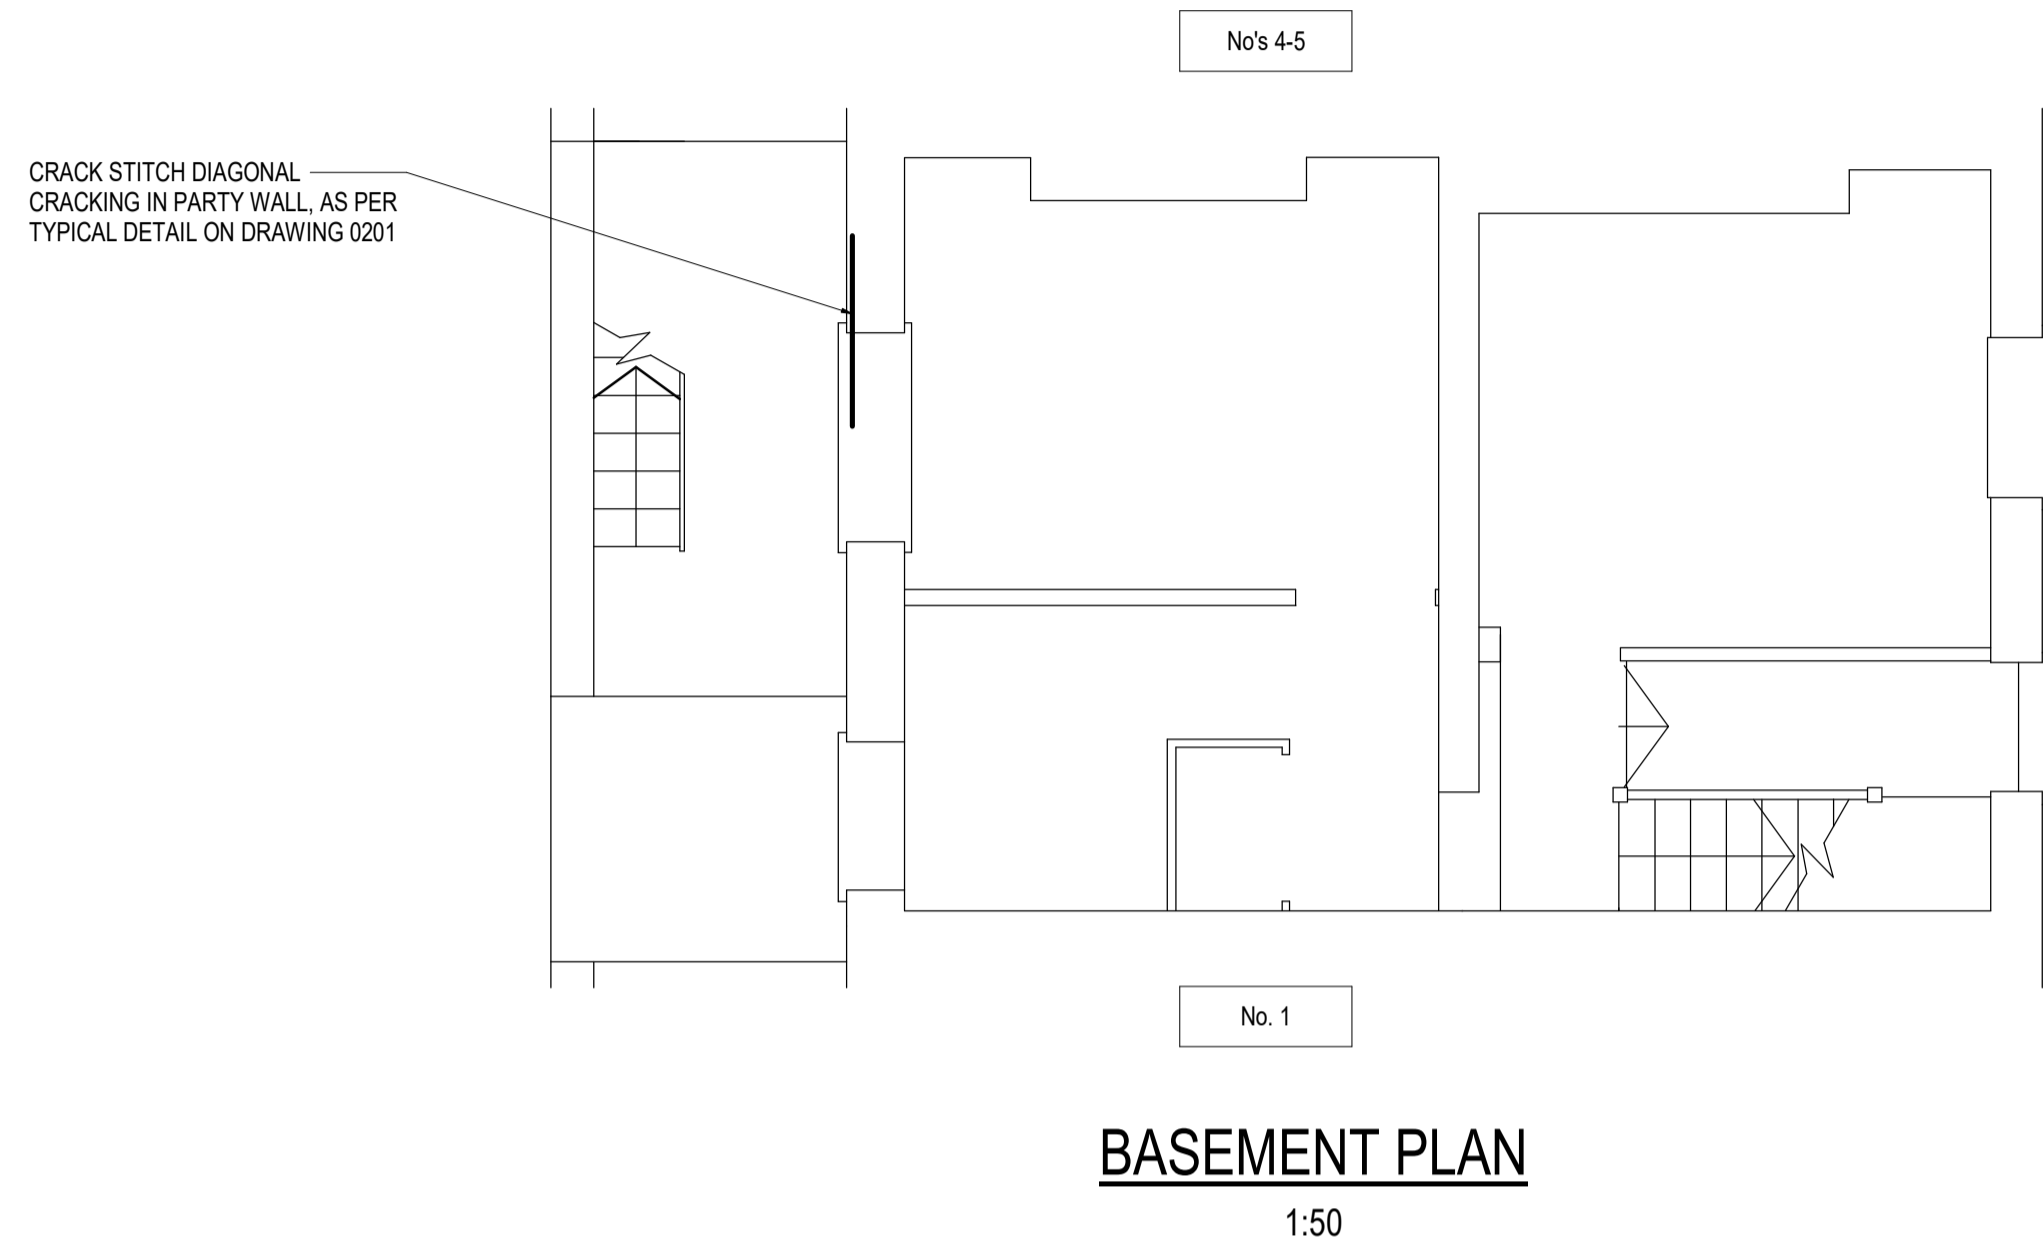
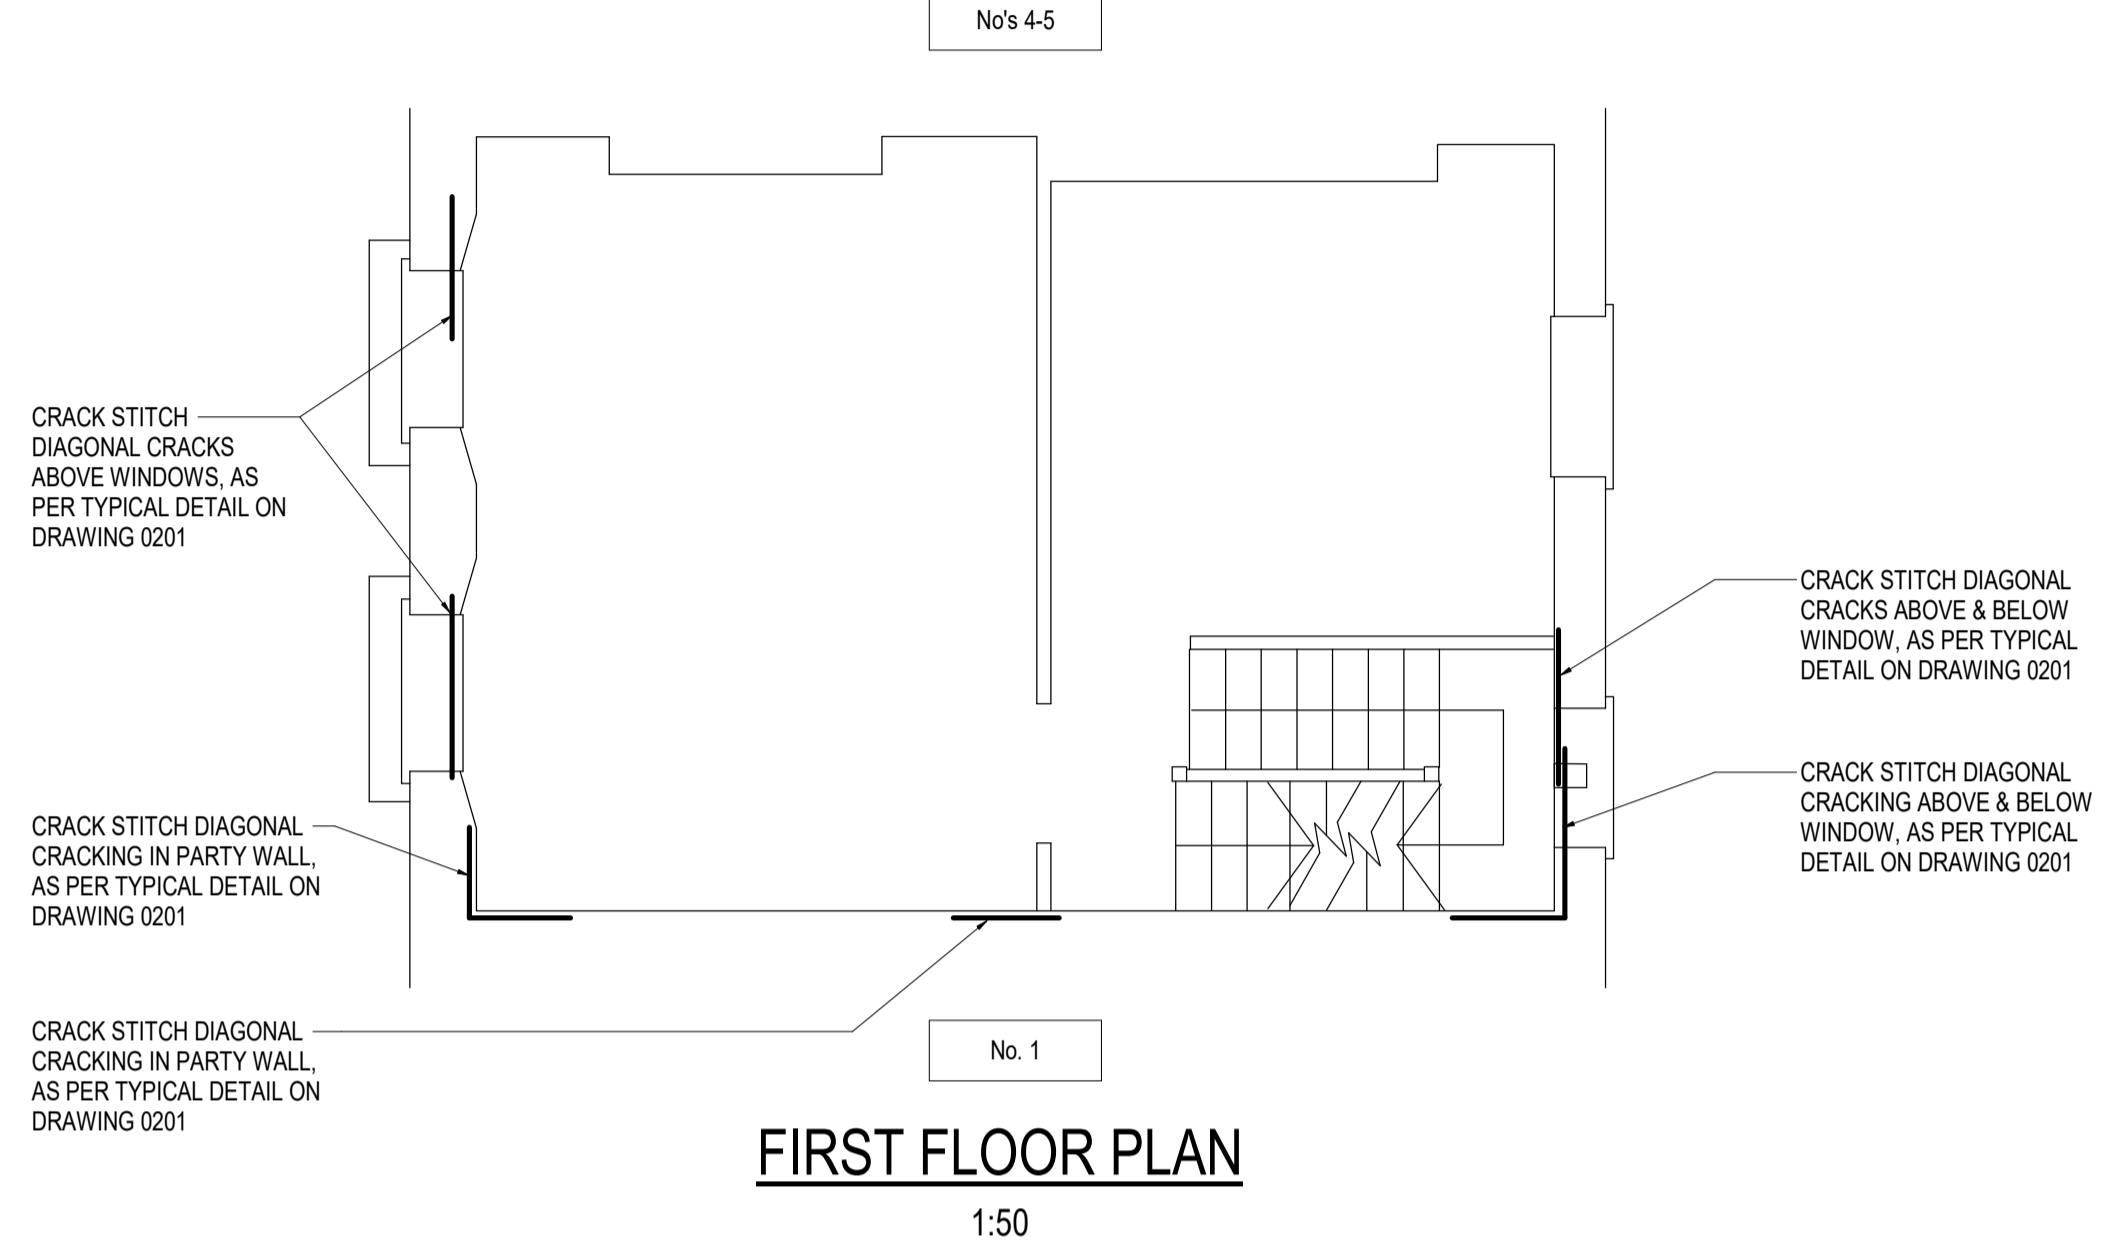
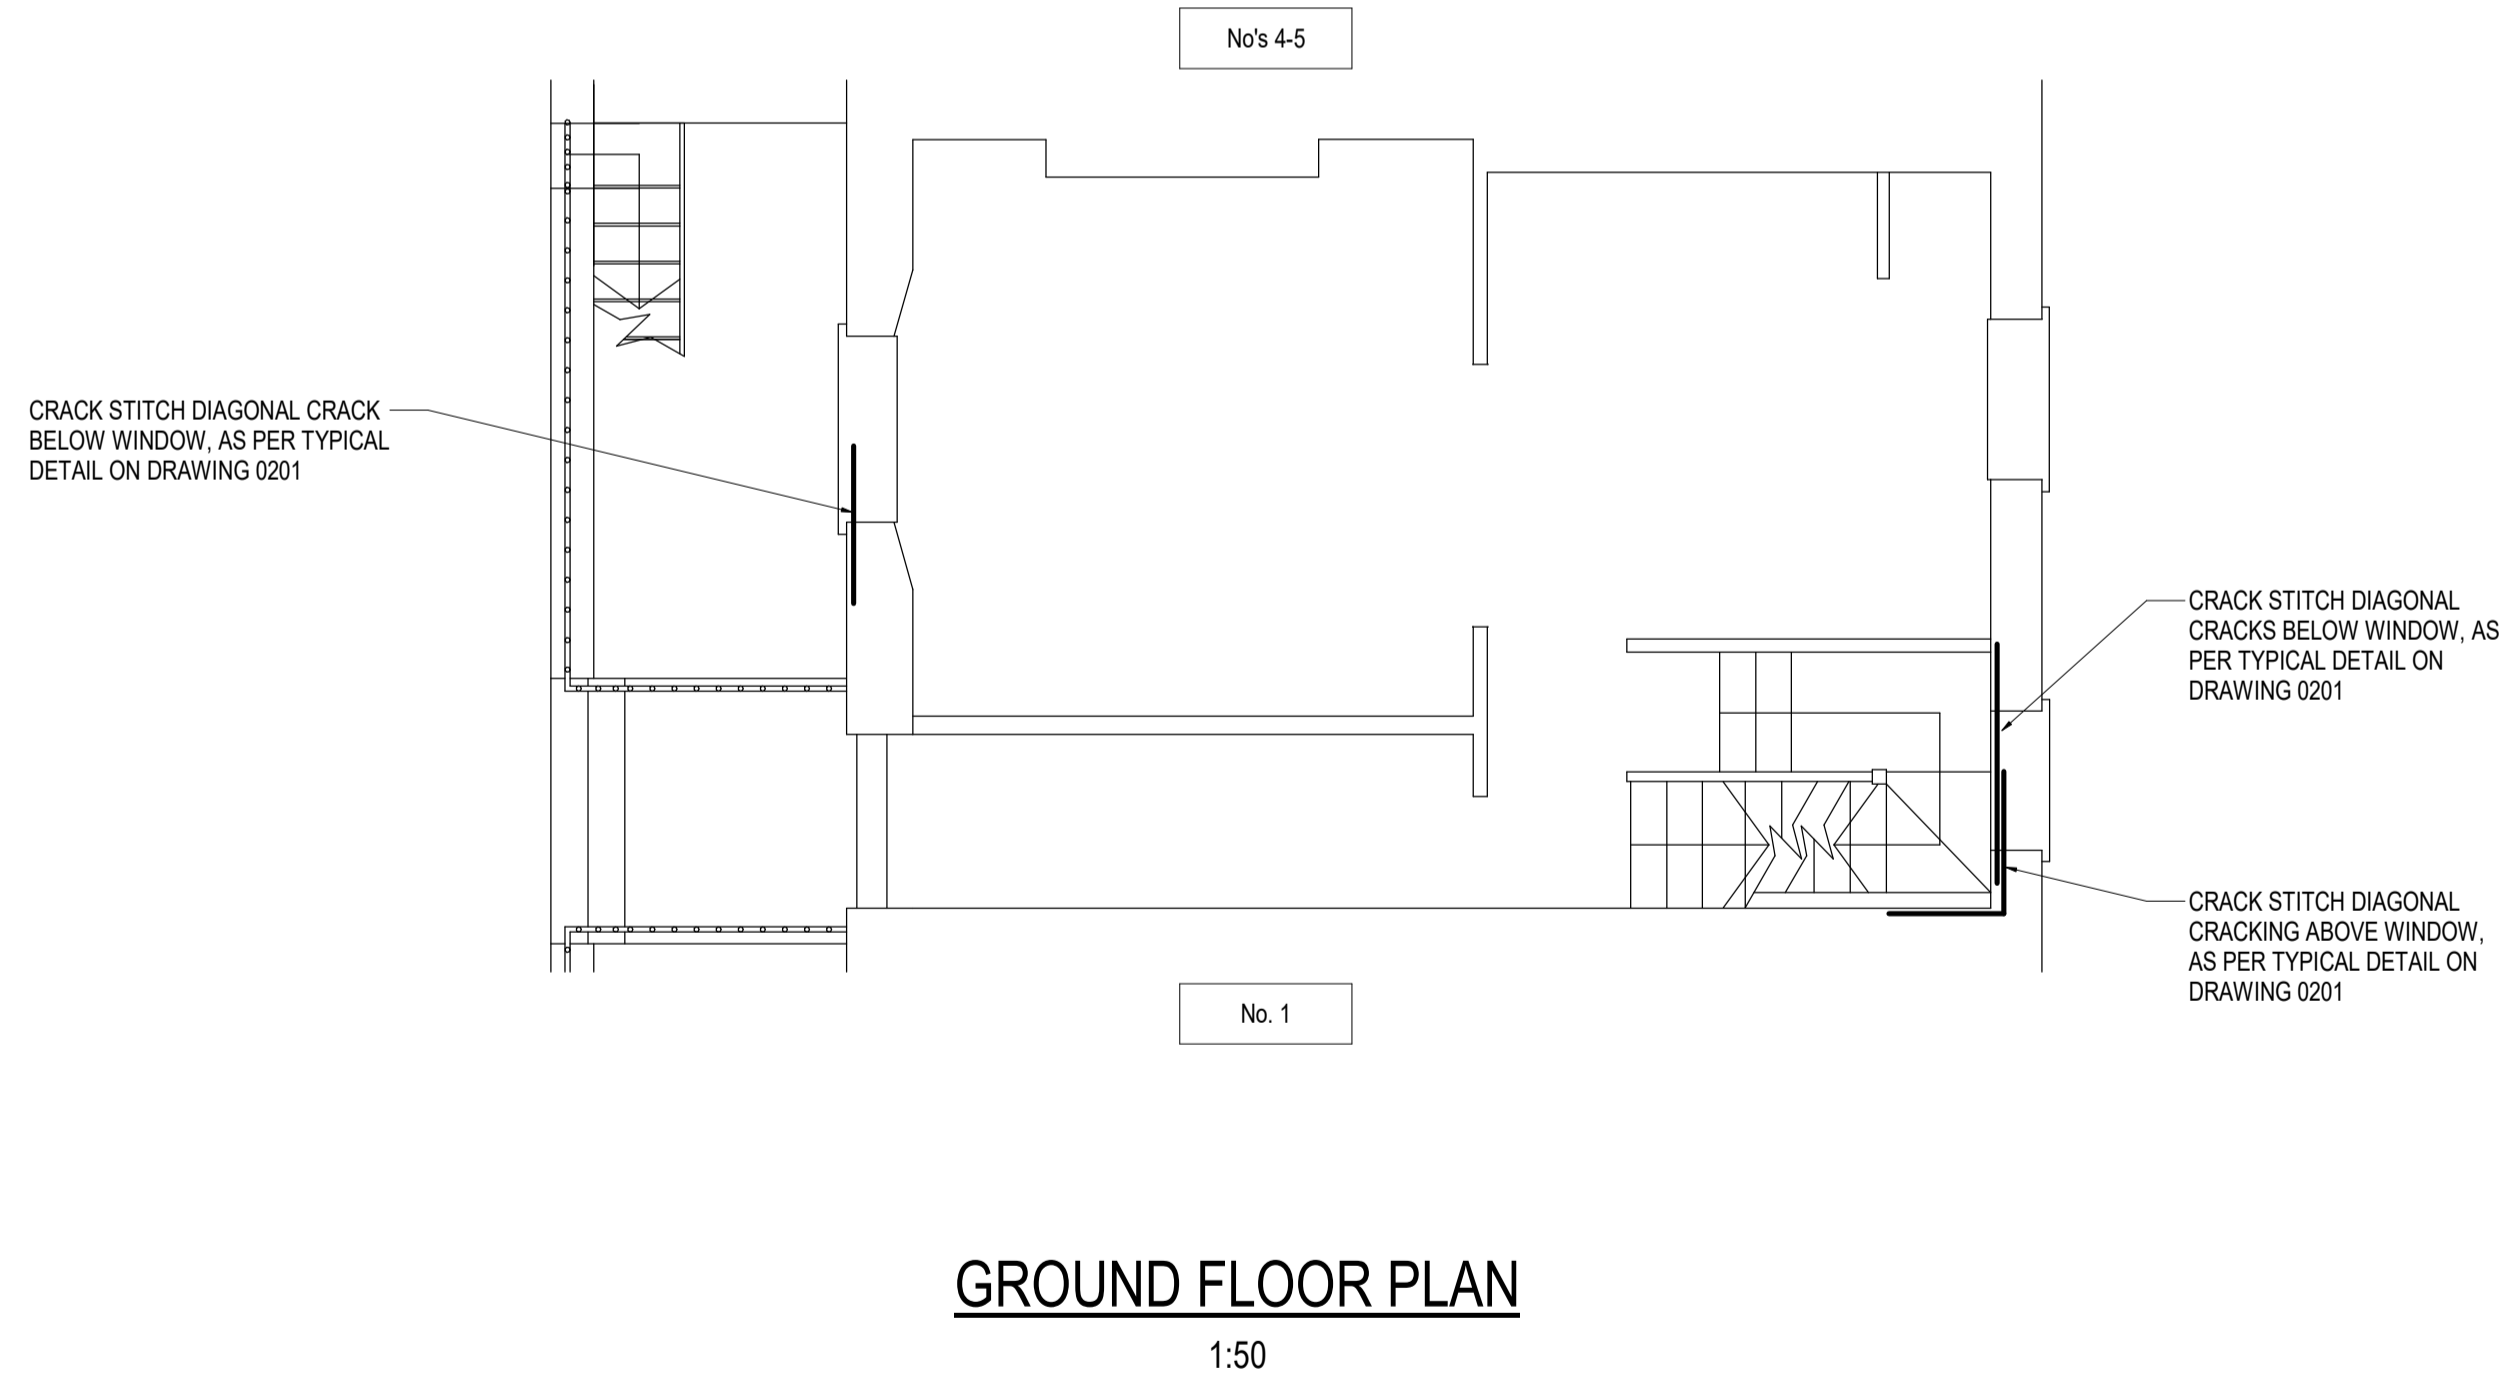
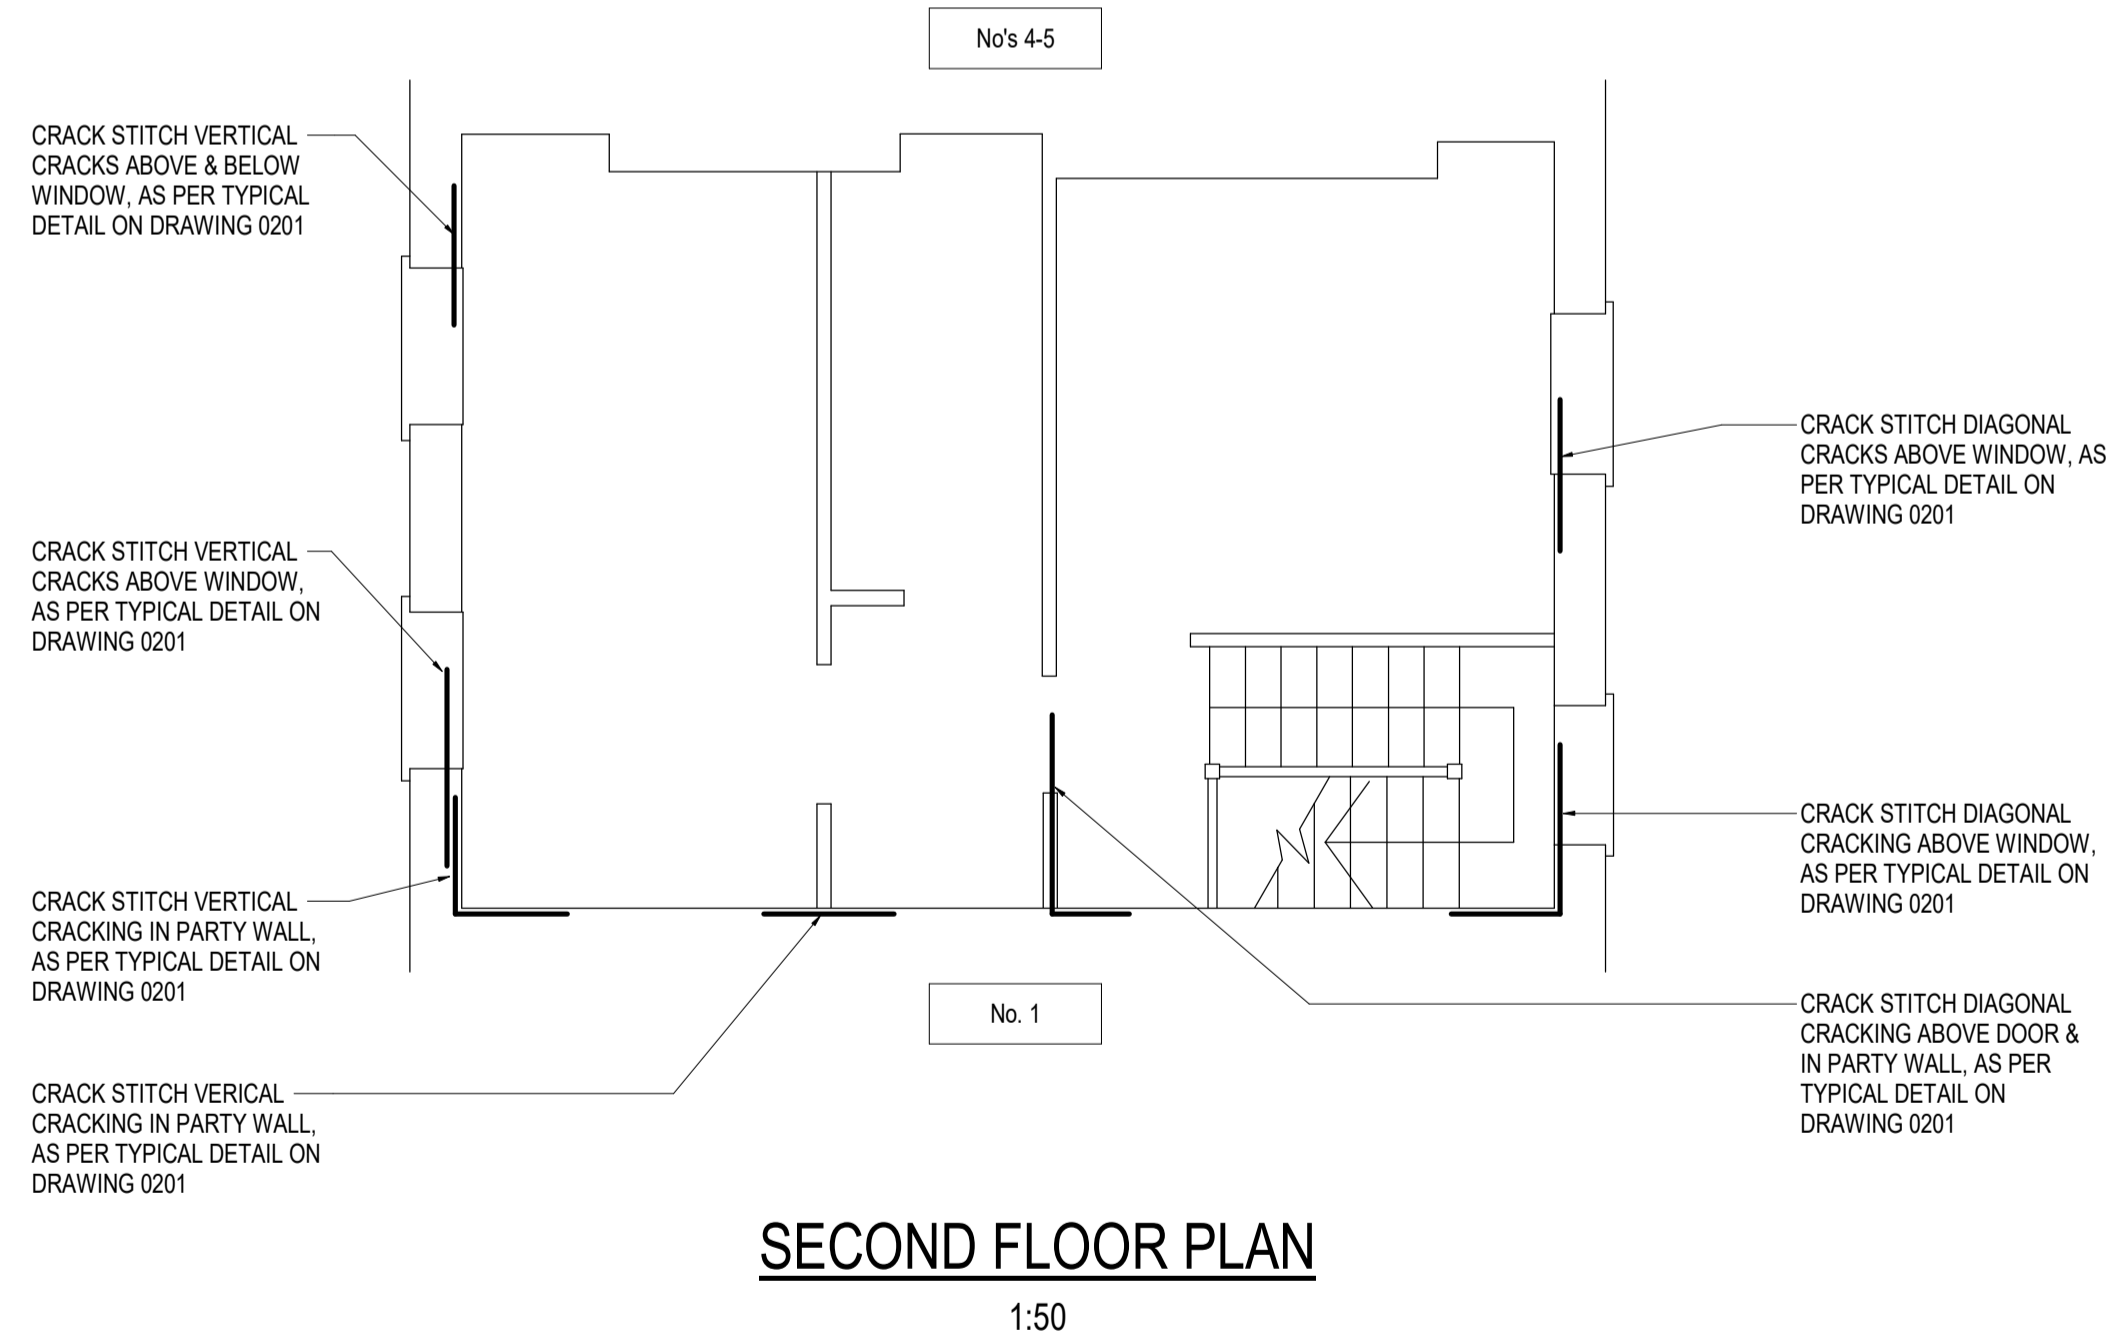
ALL PERIMETER WALLS TO BE TIED TO FLOORS
AT GF, 1ST AND 2ND FLOOR LEVELS, USING
TYPICAL STRAPPING DETAILS ON DRAWING 0201
