PROJECT:  
**1 CHARRINGTON STREET  
LONDON NW1 1RS**

TITLE:  
**FLOOR PLANS SHOWING  
PROPOSED CRACK REPAIR DETAILS**

**PROPOSED DWG FOR TENDER**

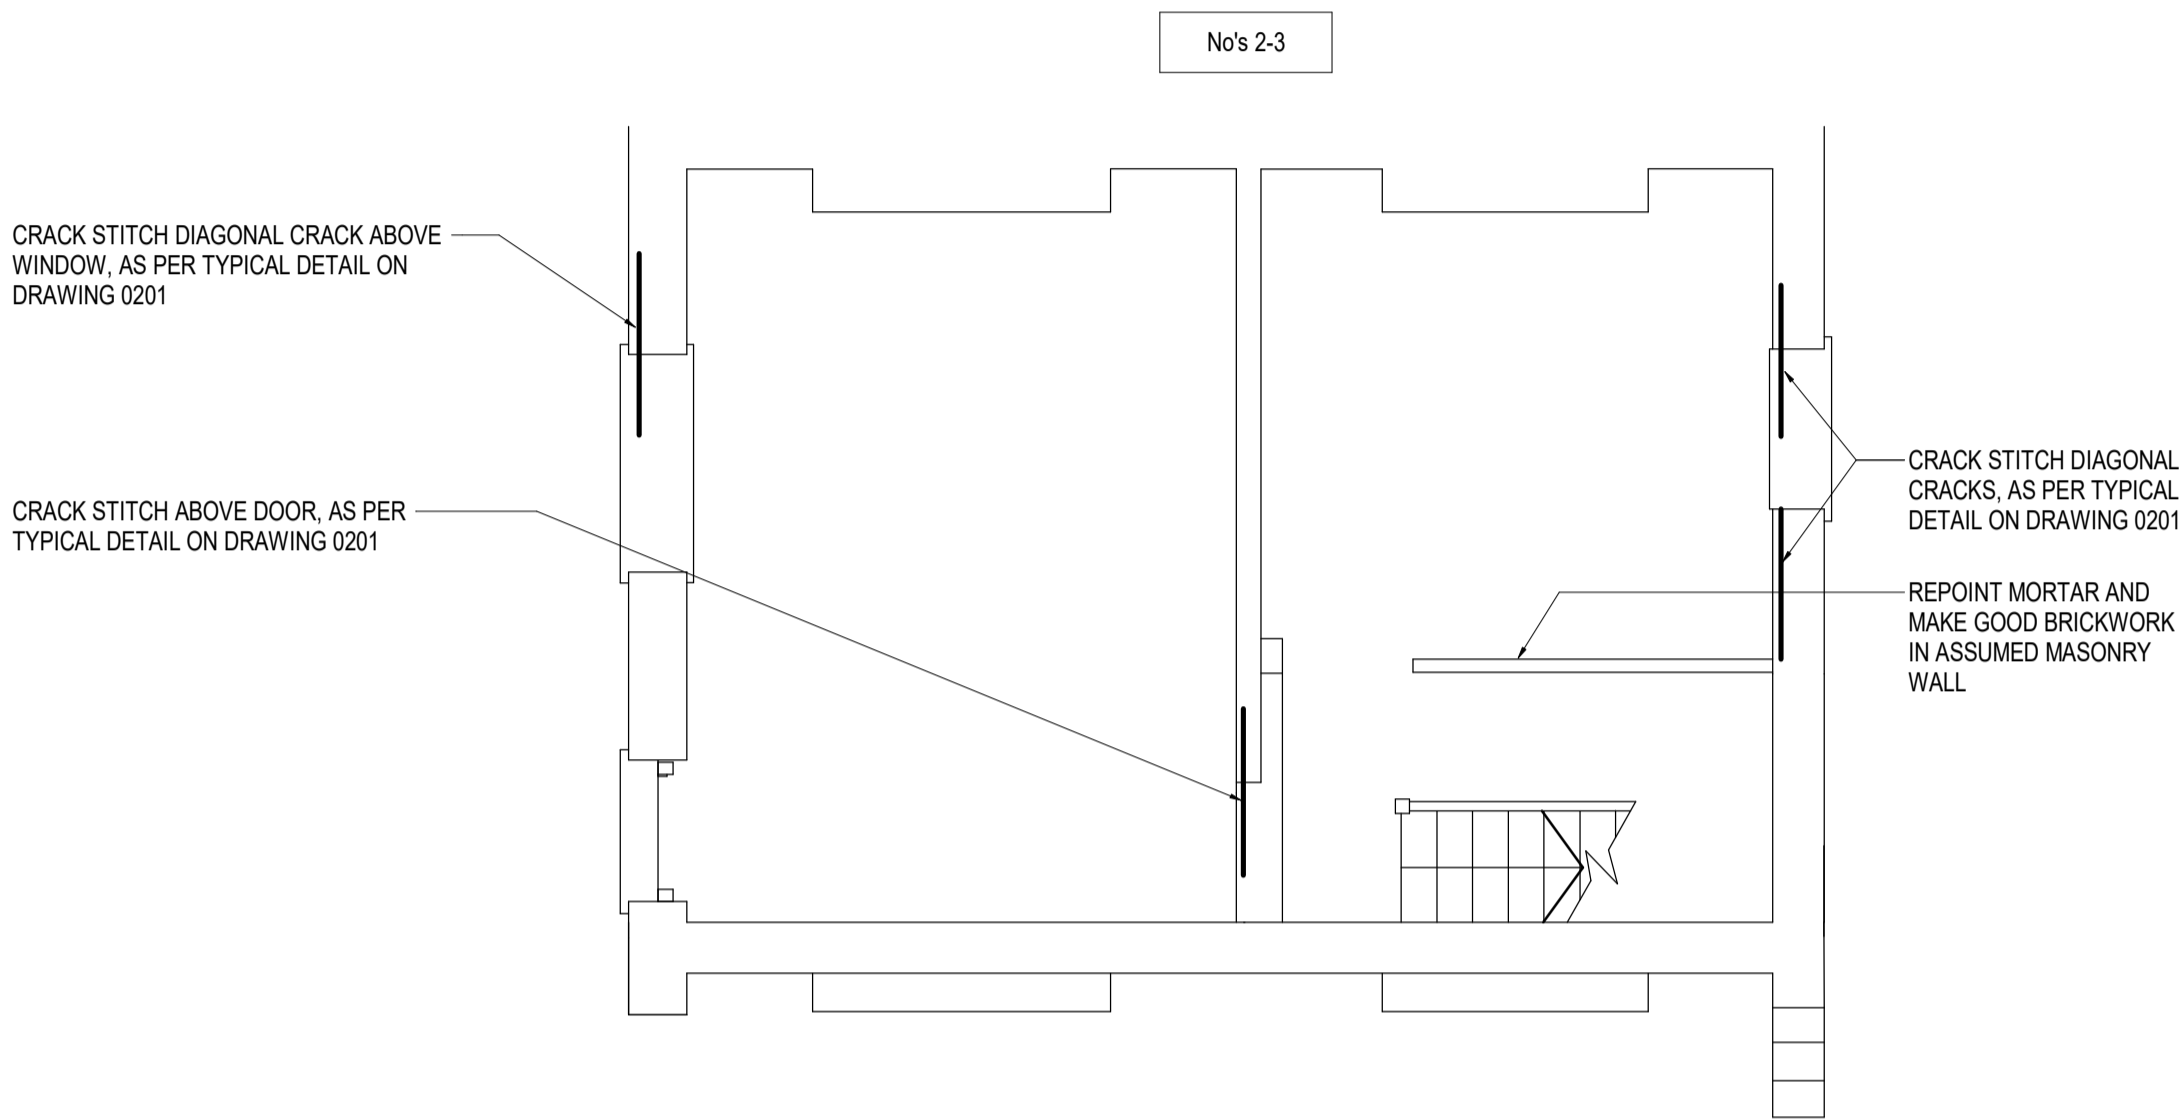
**BASEMENT PLAN**

ALL PERIMETER WALLS TO BE TIED TO FLOORS  
AT GF, 1ST AND 2ND FLOOR LEVELS, USING  
TYPICAL STRAPPING DETAILS ON DRAWING 0201
