PROJECT:  
**4 & 5 CHARRINGTON STREET  
LONDON NW1 1RS**

TITLE:  
**FLOOR PLANS SHOWING  
PROPOSED CRACK REPAIR DETAILS**

DRAWING No:							
PROJECT:	ORG:	ZONE:	LEVEL:	TYPE:	ROLE:	NUMBER:	REV:
5016334	RDG	XX	XX	PL	S	0100	T1

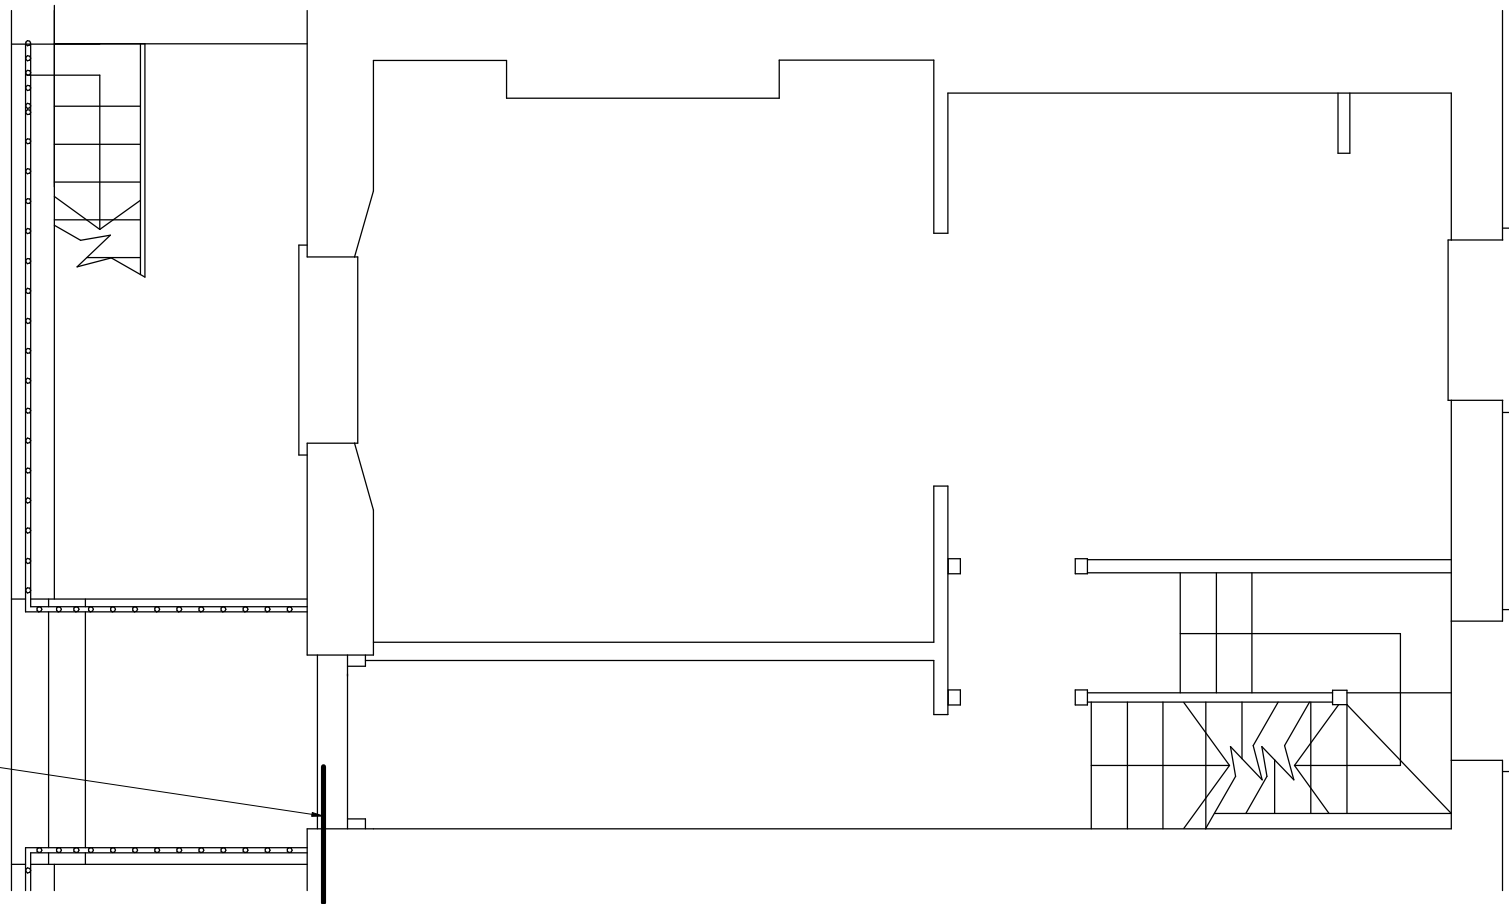
**GROUND FLOOR PLAN**

ALL PERIMETER WALLS TO BE TIED TO FLOORS  
AT GF, 1ST AND 2ND FLOOR LEVELS, USING  
TYPICAL STRAPPING DETAILS ON DRAWING 0201
