Design and Access Statement

73-75 Kenton Street
WC1N 1NN

Prepared on behalf of BKDM LLP • 2023

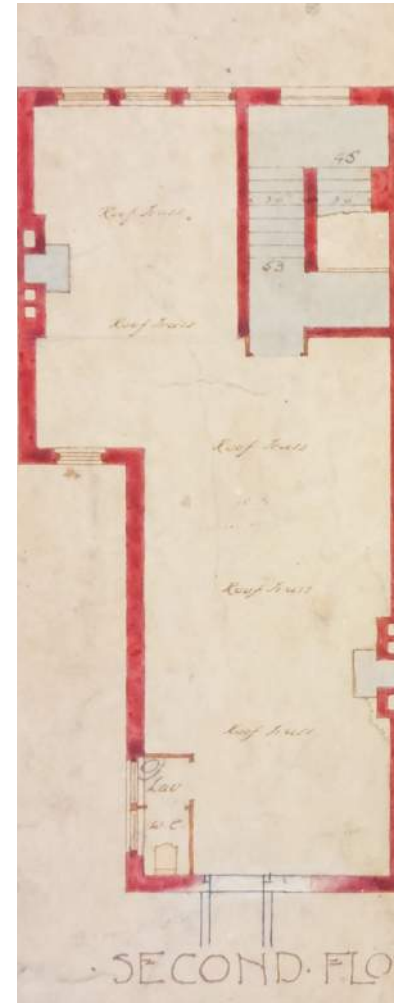
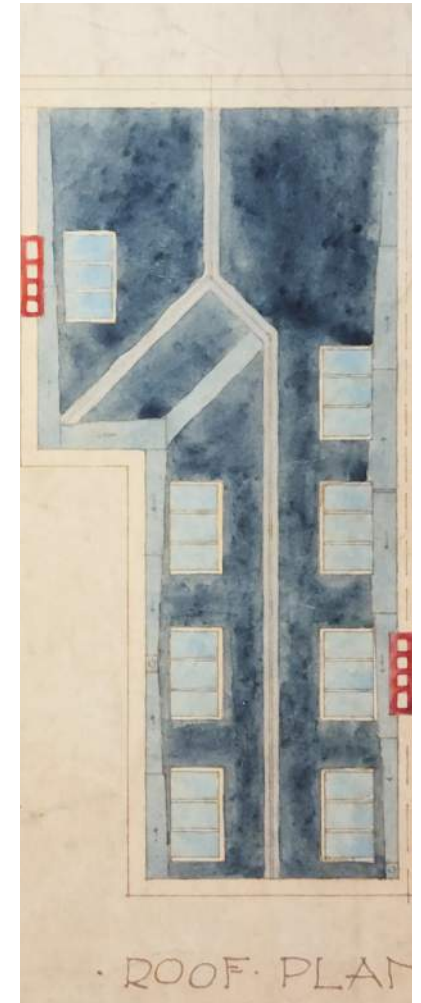
Fig. 20. Excerpt from *Plans, Section and Elevation of factory in Kenton Street for Messrs Jaques and Son, 1905*
Source: London Metropolitan Archives

LAYOUT: The original design drawings for Messrs Jaques and Sons, dated 1905, demonstrated an open plan layout across all floors. Aside from the main stairwell, a secondary stair connected the ground floor to lower ground floor. The ground floor plan indicated continuous, pitched skylight on the low roof. On the rear side of the first and second floors, doors lead out to exterior egress passageways (steel egress bridges).

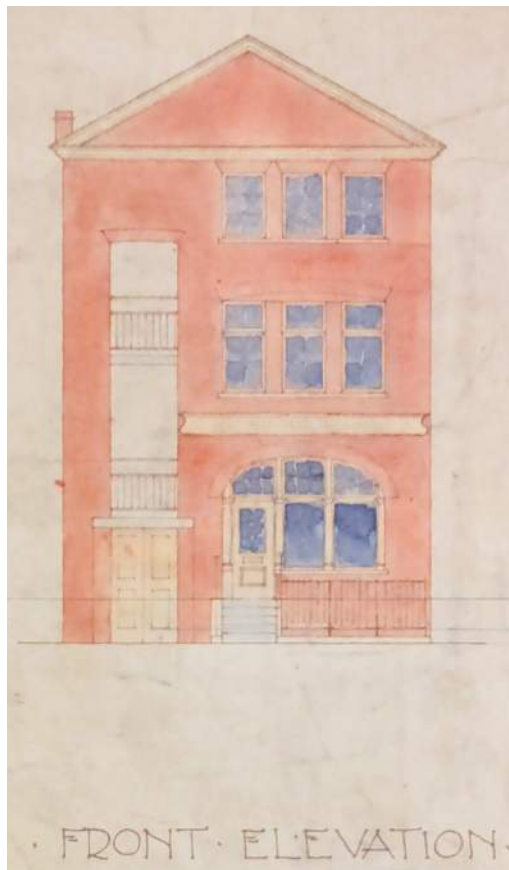
Fig. 21. Excerpt from *Plans, Section and Elevation of factory in Kenton Street for Messrs Jaques and Son, 1905*
Source: London Metropolitan Archives

WINDOWS: The section and elevation drawings display several types of windows, including large crittal windows facing north and west, double hung windows facing north, and smaller hinged windows facing east and west.

STRUCTURE: The building is of masonry structure, with steel columns on the lower ground floor level to support the northern envelope wall above ground. Except for the lower ground floor slab and staircase, which are cast in concrete, the other slabs were built of simple timber structure. The roof was supported by timber fink trusses with tensioned steel rods.

VERTICAL CIRCULATION: The main stairwell opened to the outside with large openings, which were framed by concrete lintels and protected by metal railings.

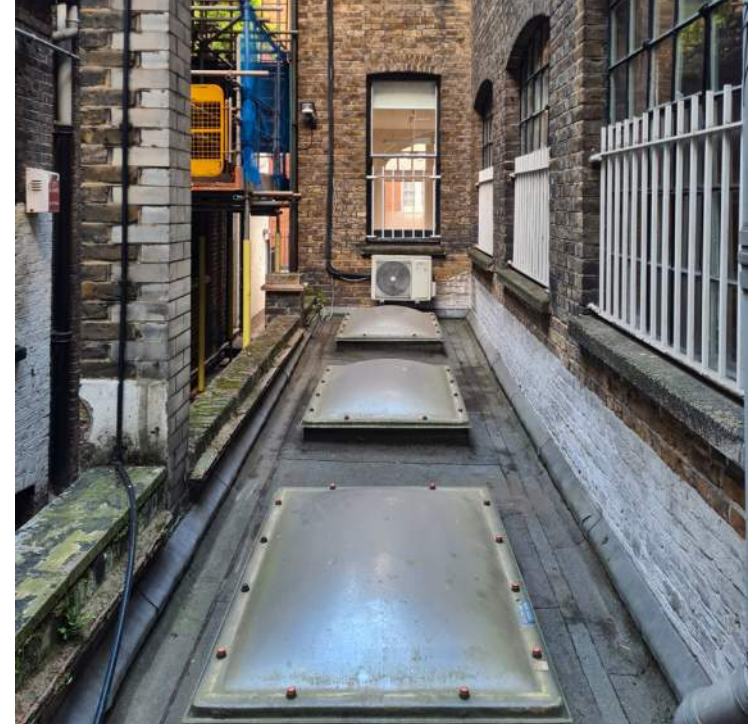
Fig. 25. View from lower roof looking East

The low roof currently has five polycarbonate skylights (*Fig. 25*), as opposed to the continuous pitched skylight low roof indicated in the original drawings. Though not characteristic of the building, these skylights perform the basic function of waterproofing fairly well.

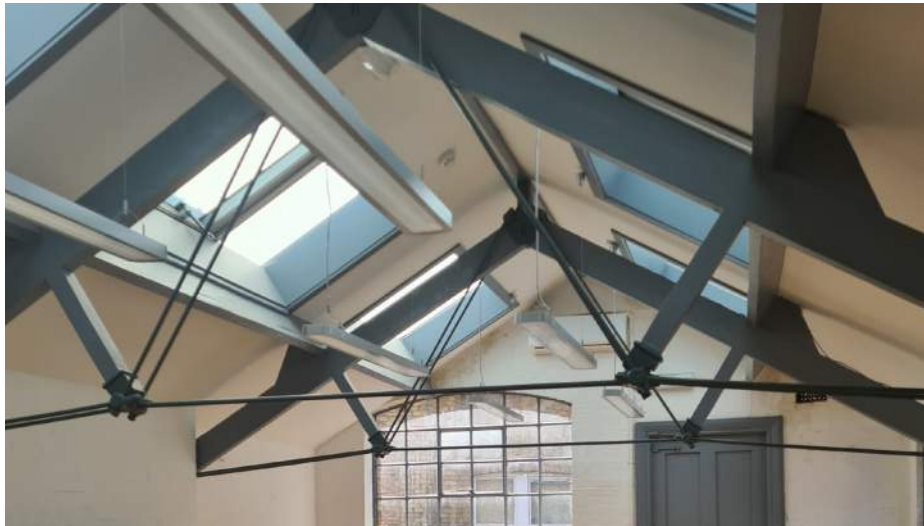
Fig. 24. Second floor - Roof Skylights and Timber Fink Truss Roof

All eight roof skylights (*Fig. 24*) have been upgraded to modern specifications but remain in their original location. These skylights are of the waterproof kind, though in recent storms they have shown signs of leakage.

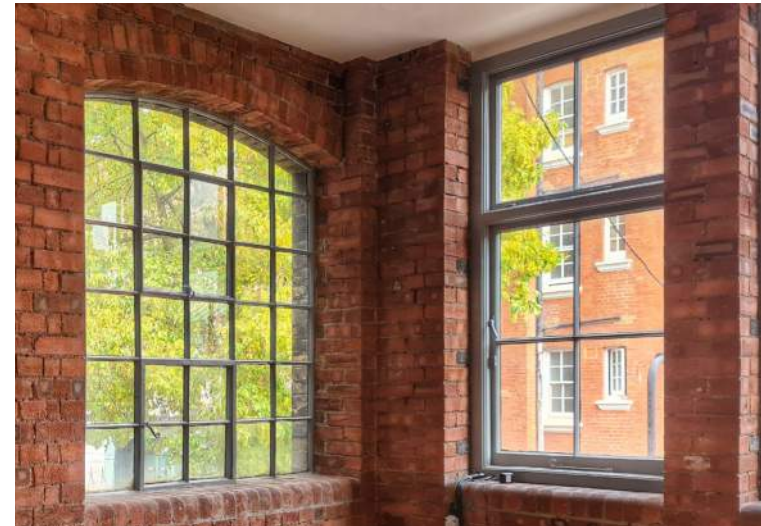
Fig. 26. Original Windows

Throughout the building, most of the windows have remained original, maintaining their single-pane glass and wooden mullions construction (*Fig. 26*). The crittal windows are overall well preserved; however, the thermal performance of these windows are not meeting the modern-day energy efficiency needs.

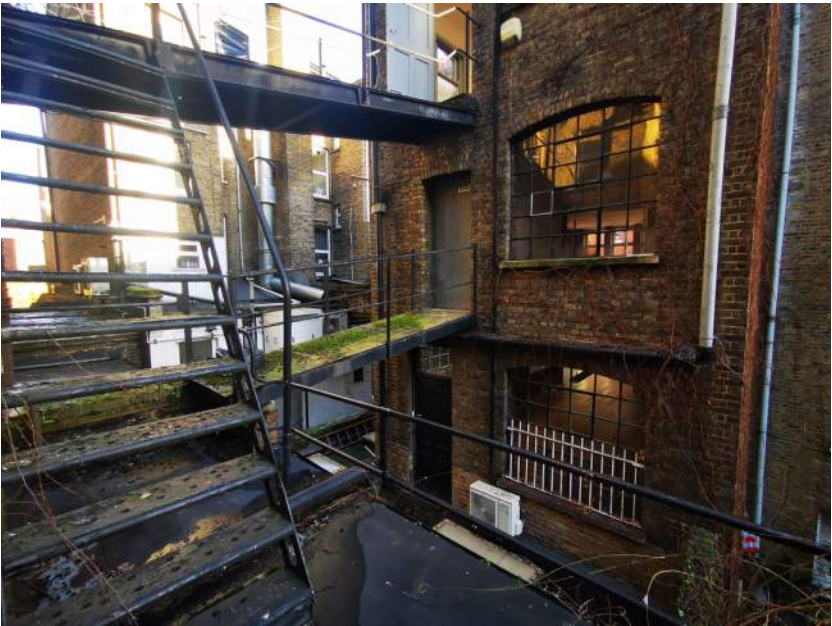
Fig. 28. dilapidated egress bridges pose dangers to occupants and neighbours

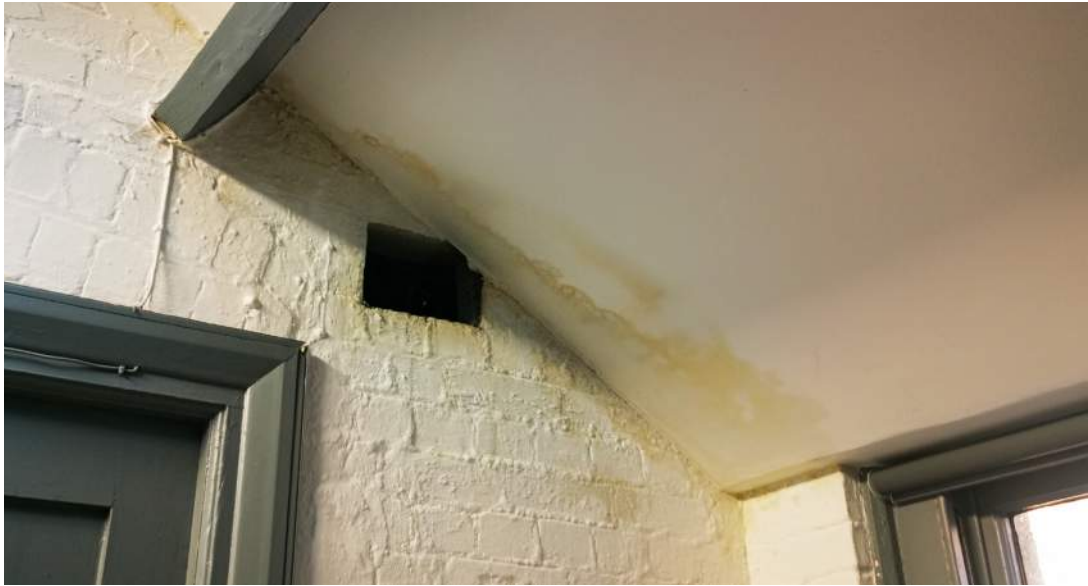
Fig. 27. water ingress inside roof, picture taken two weeks after fresh paint

Two significant problems are identified at 73-75 Kenton Street: one is localized water ingress at roof level (Fig. 27), and the other is a horizontal crack to the flank wall at lower ground floor level (Fig. 30), due to leaking lower roof and poor rainwater drainage (Fig. 29). The previous lower ground floor tenant had reported flood damage in 2019. Both issues will likely require structural interventions in the near future. As an exposed brick masonry building, 73-75 Kenton Street is poorly insulated, resulting in very low energy efficiency in winter months; due to the lack of proper insulation, heating appliances work inefficiently despite causing surges in energy usage.

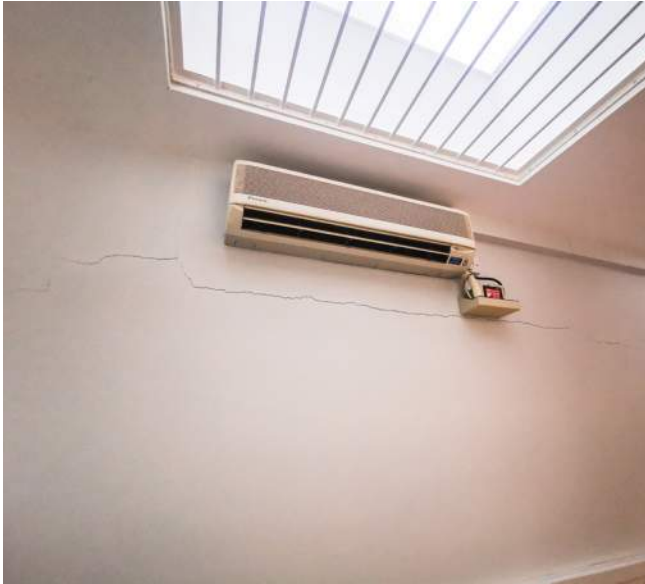
Fig. 30. horizontal crack on lower ground floor flank wall

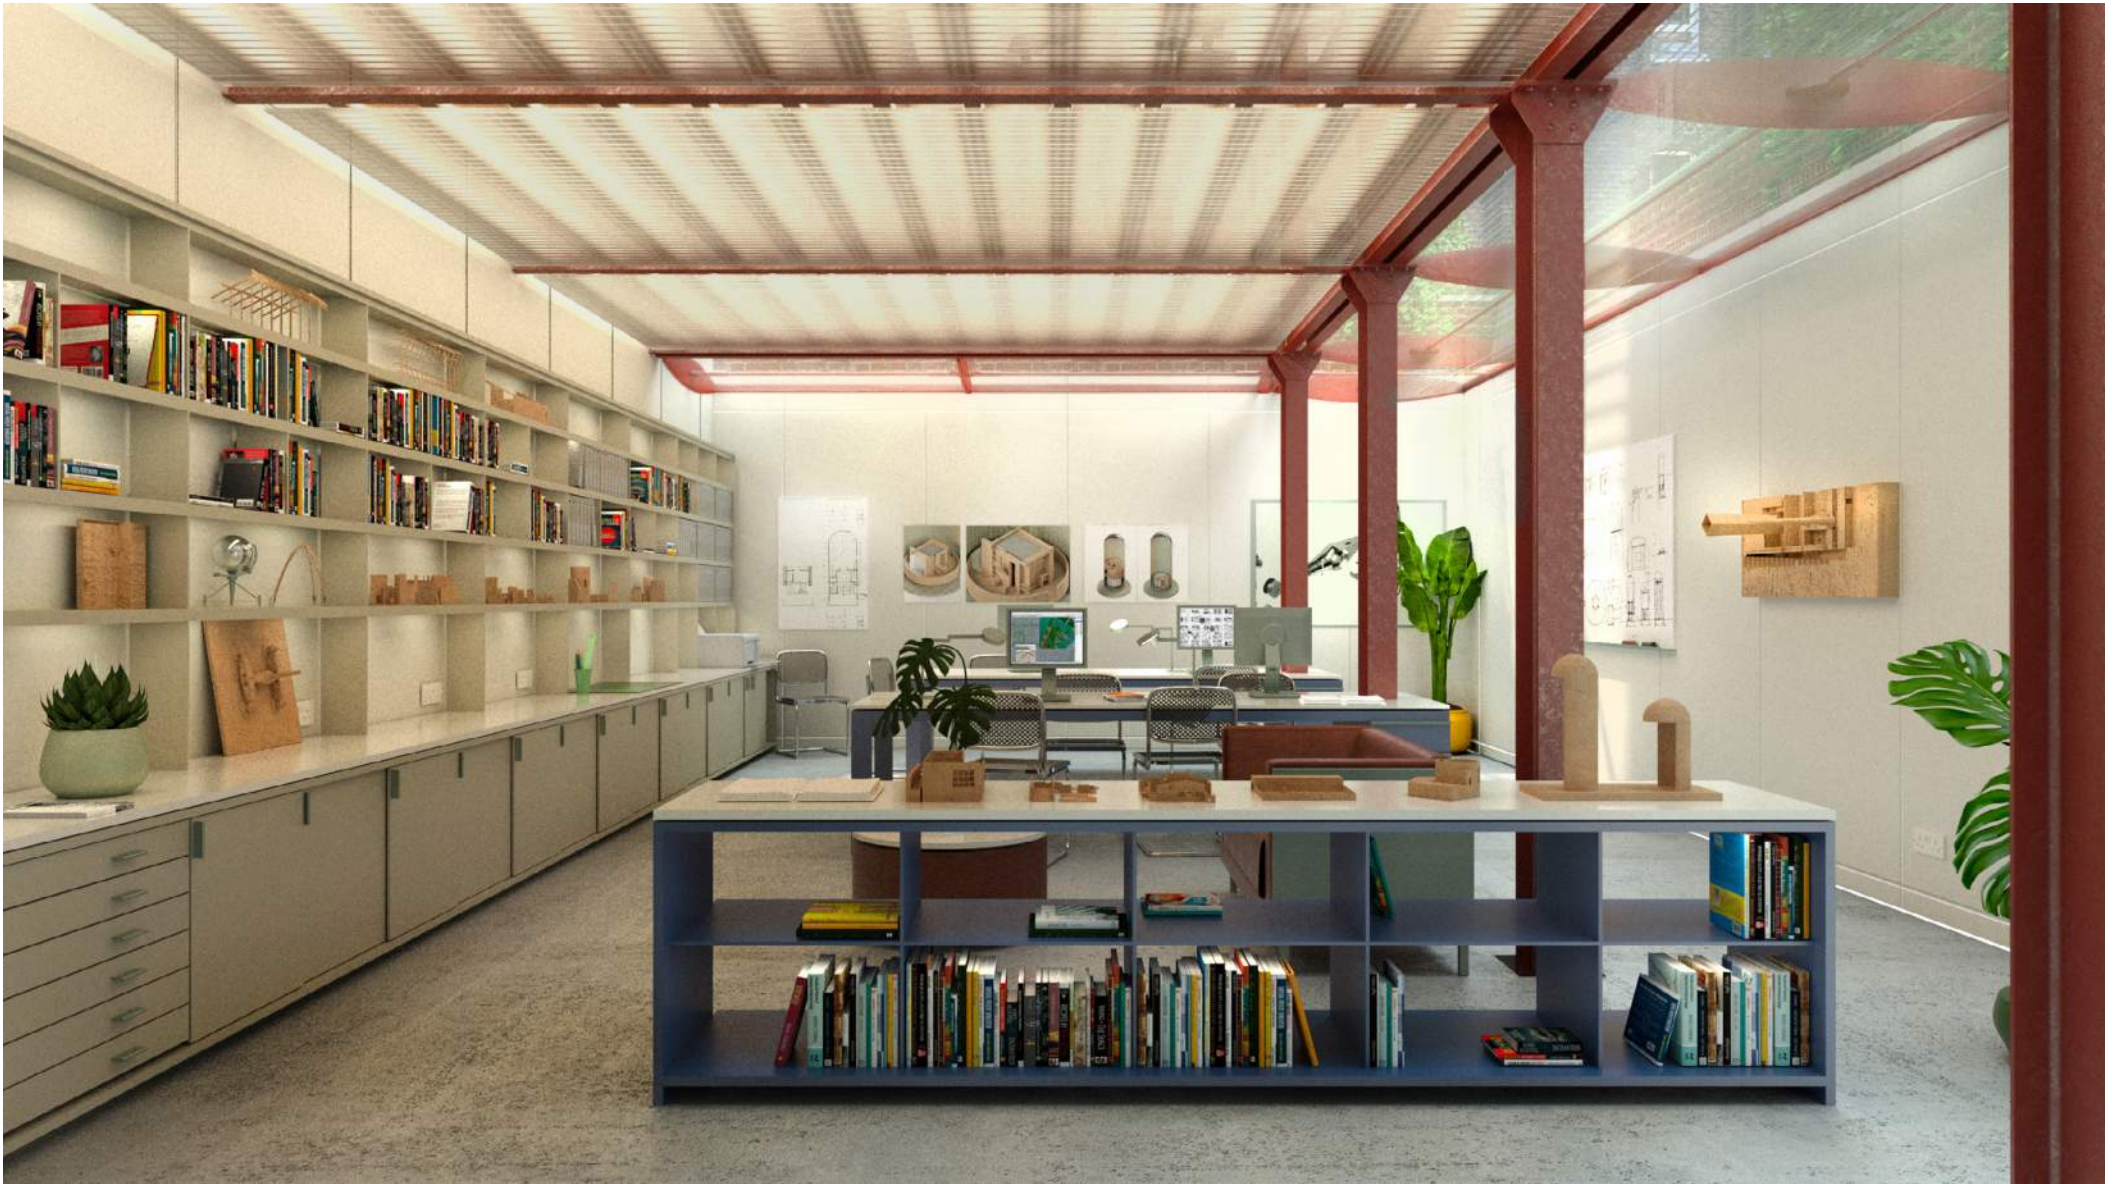
Lower Ground Level
Office Space
Proposed

The lower ground level office space benefits from ample natural light from a continuous skylight on the low roof (as indicated in the original design) and diffused LED lighting on the ceiling. The space is designed to accommodate 8 to 10 people, and will be fitted to the highest office standard, both architecturally and environmentally. With a high degree of lighting, acoustic, and environmental control, the office space shall cater especially to creative industries.
