Job Title: Kings Cross Station Redevelopment Programme Package 2

Drawing Title: Survey and Defects Spine Wall West Face South End

Job No	Drawing No	Issue
B40234	MSR-CSS-0110	03

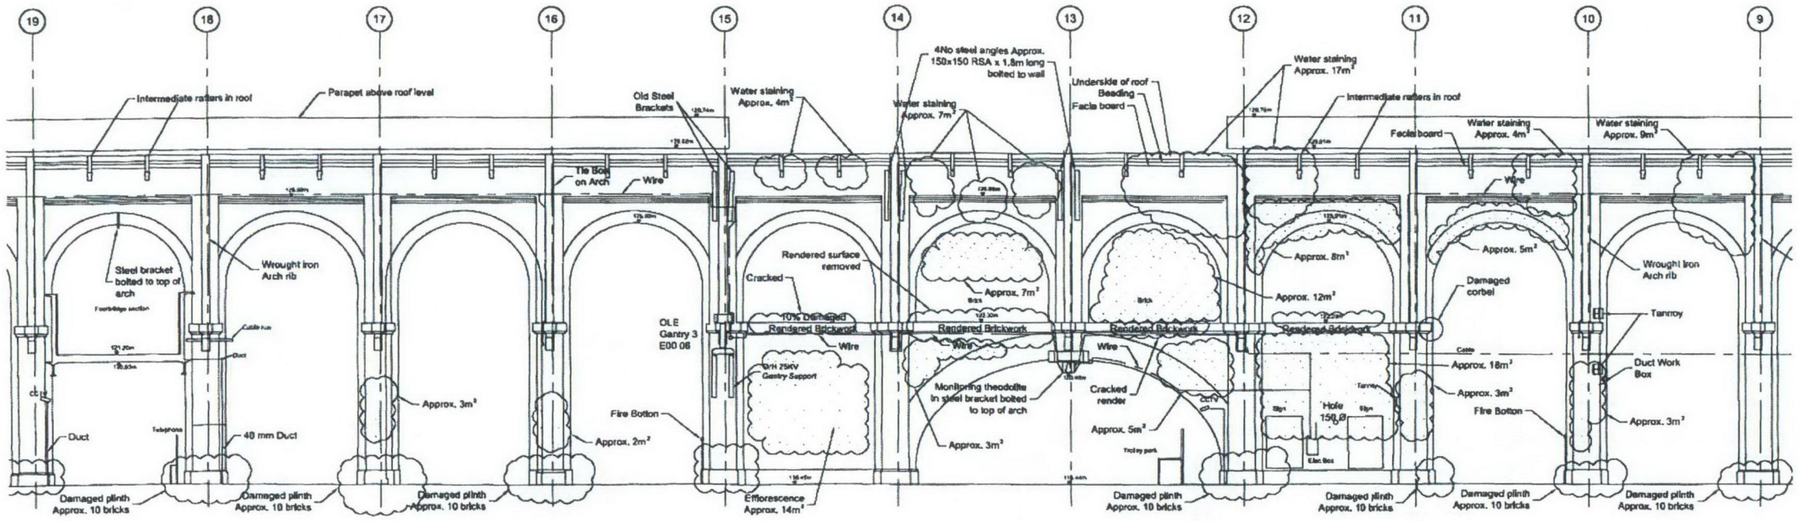
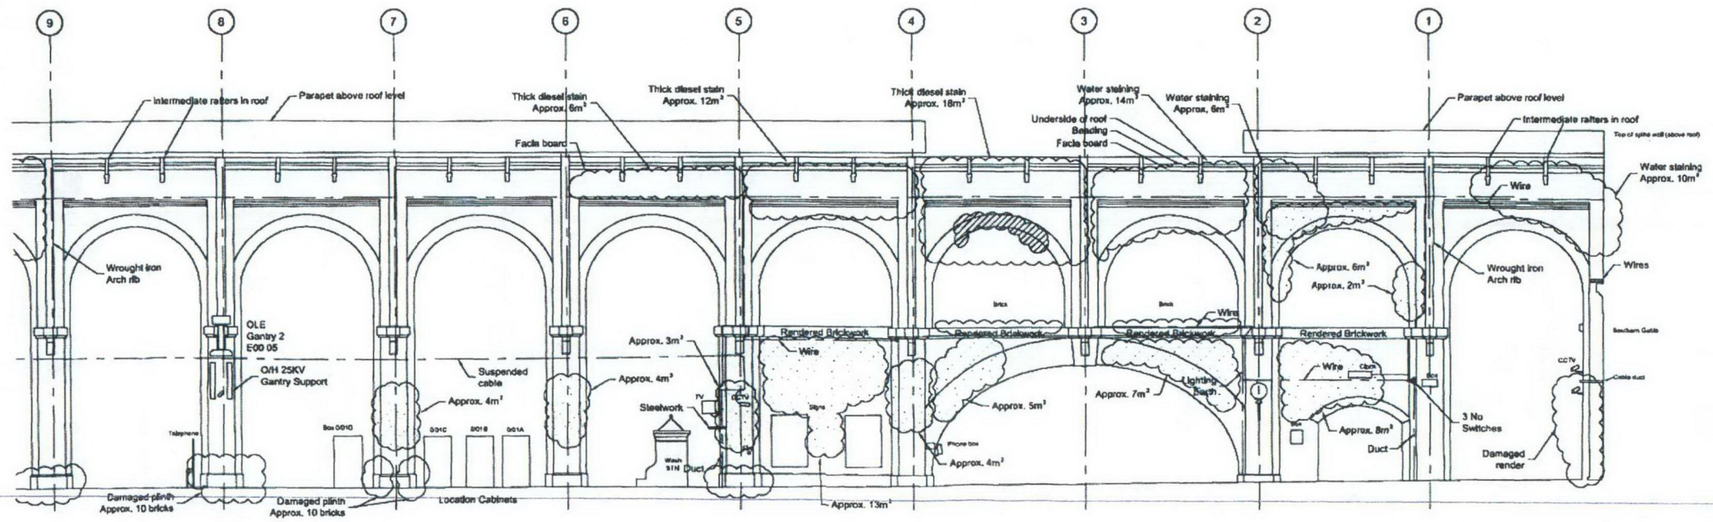
Defective brickwork requiring remedial works

Frost damaged bricks
