Stage 2: Site Investigation

53 Agar Grove,
London Borough of Camden,
London
NW1 9UE

Job No. 13.7883
February 2014 Rev 1

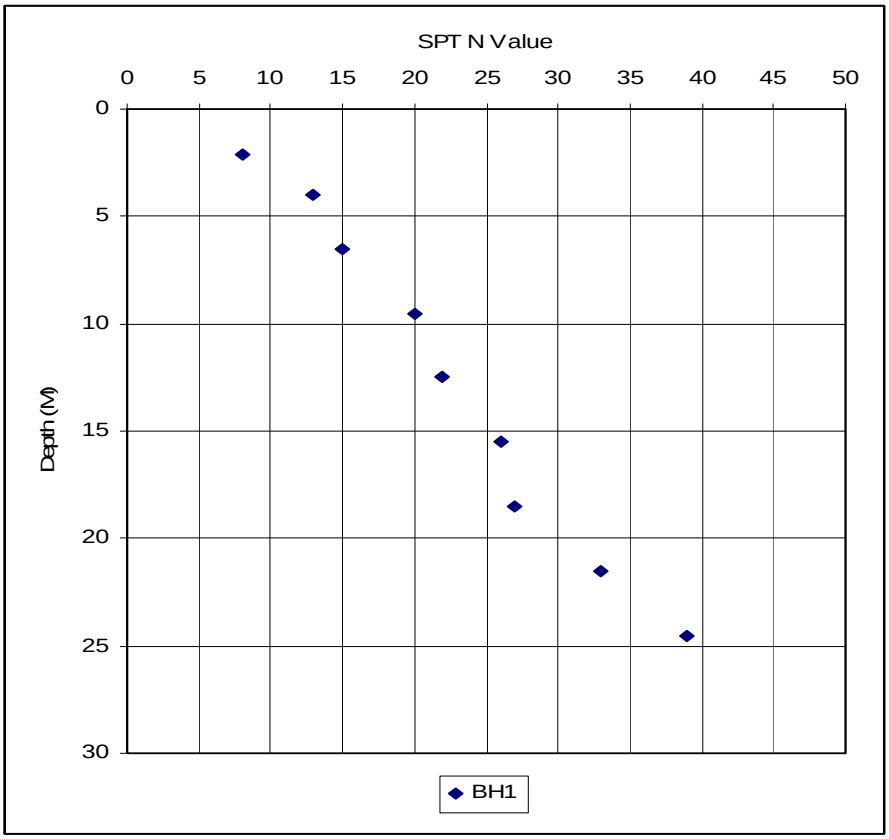
The testing within the London Clay Formation shows N values of N=8 at 2.10mbgl increasing to N=39 at 24.50mbgl indicative of firm consistency increasing to very stiff/hard consistency clay soils.

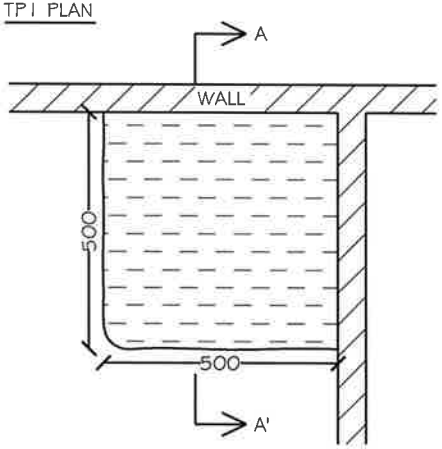
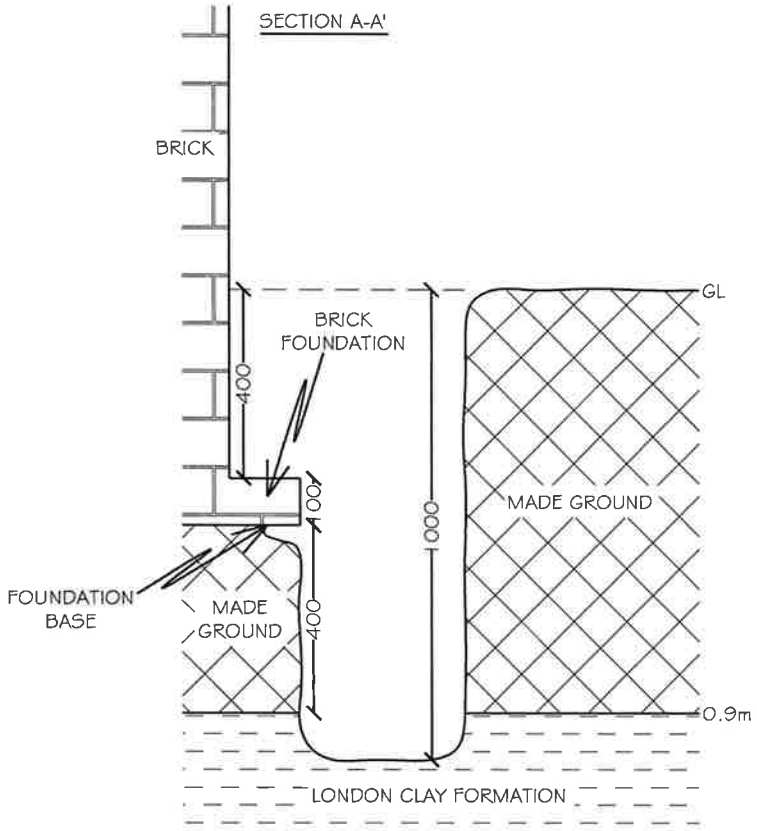
TP1 PLAN

Pit Reference	Structure Investigated	Foundation Type	Base Depth (mm)	Projection (mm)	Founding Material
TP1	Garden boundary Wall	Brick Corbel	500	150	Firm Clay
TP2	Garden Boundary Wall	Brick Corbel	760	~ 170	Firm Clay

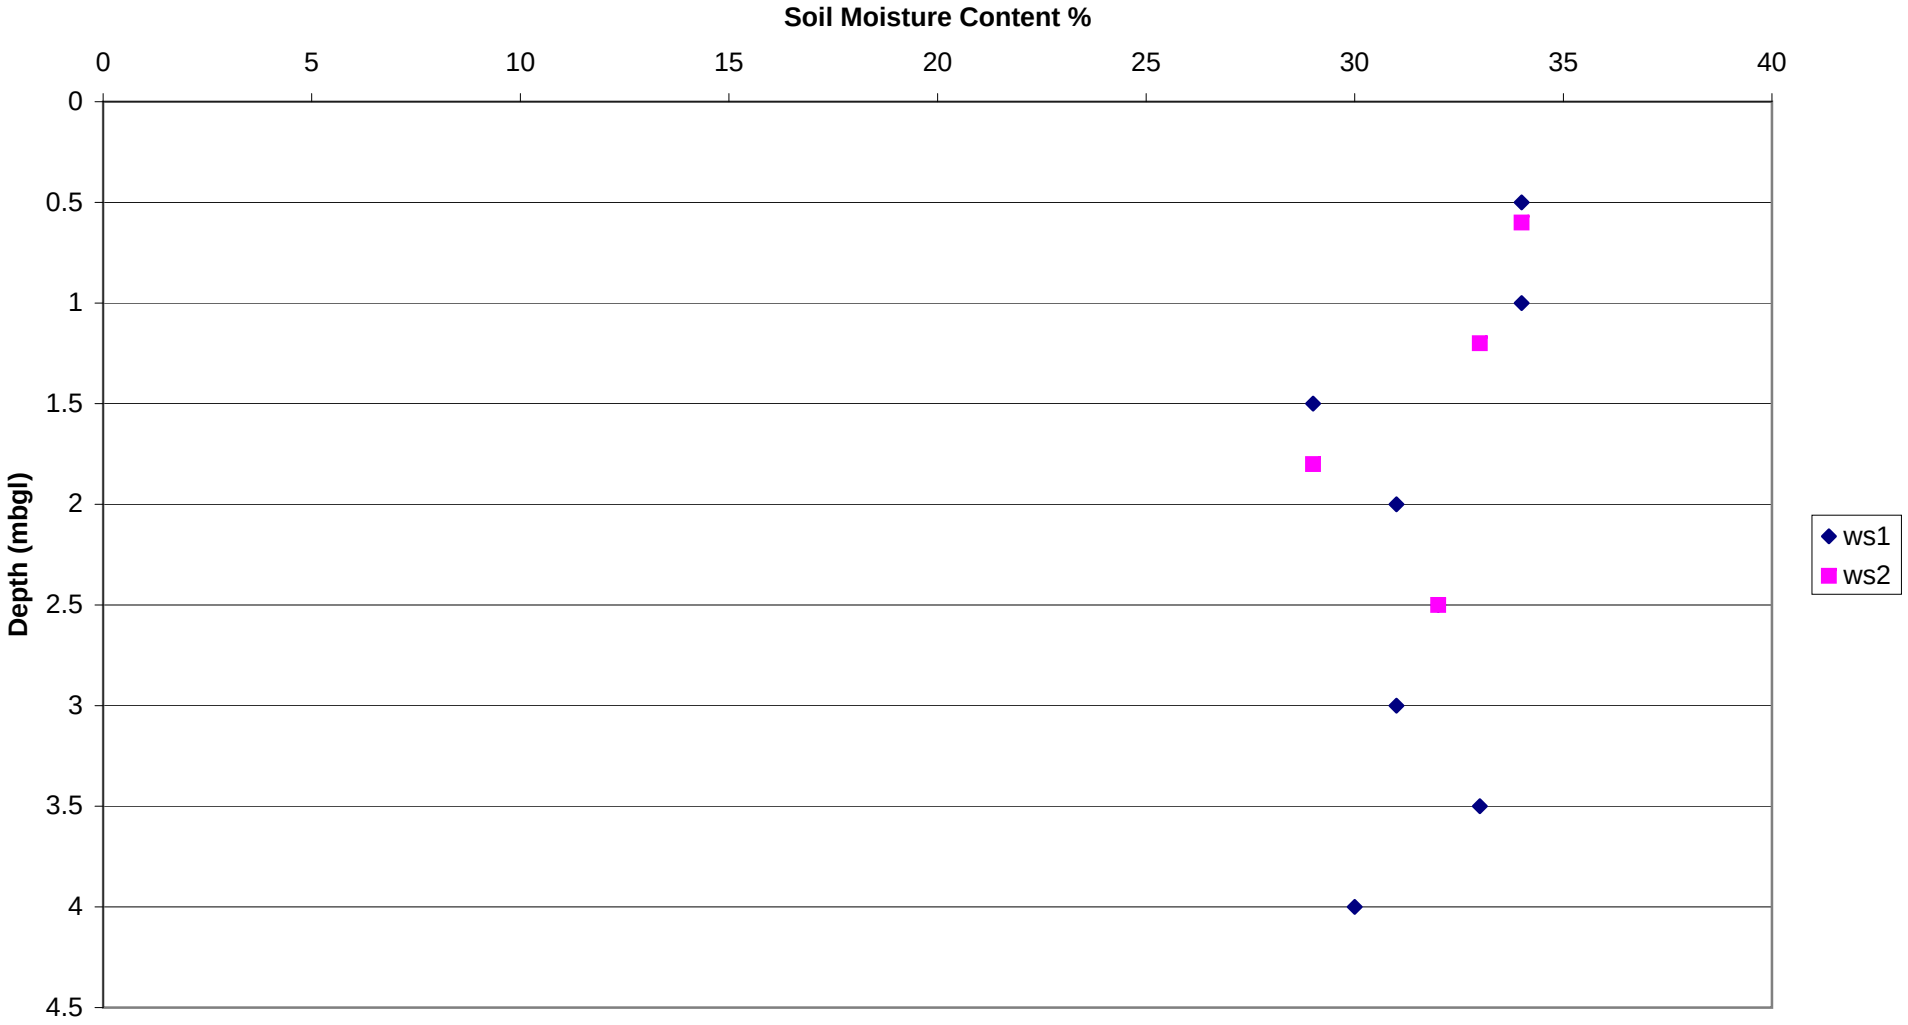
Plot of Soil Moisture Content % v Depth (m)

The Natural Moisture Content values were found to range from 29% to 34% and a detailed plot showing these results against sample depth is shown in appendix C.

The latter observations are confirmed by the higher soil moisture contents for the soils down to 1.50m ranging between 30% and 35%. Below this depth the soil moistures are found to equal 29% before slowly increasing with depth. It is felt the recent heavy rainfall has resulted in the upper, high plasticity, clays to swell. A plot of the moisture content values against depth is shown in appendix C.

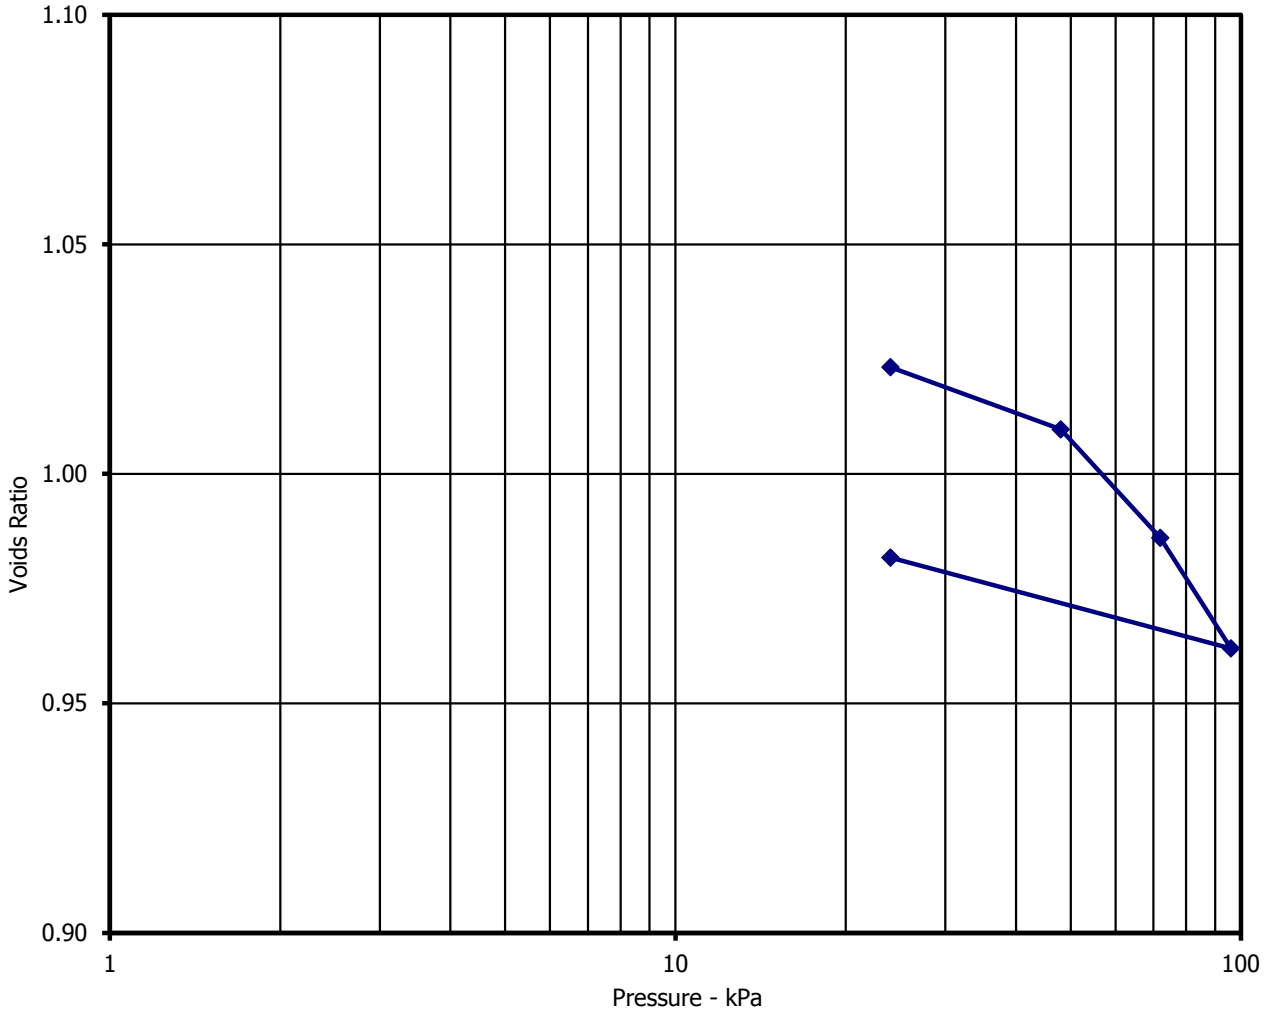
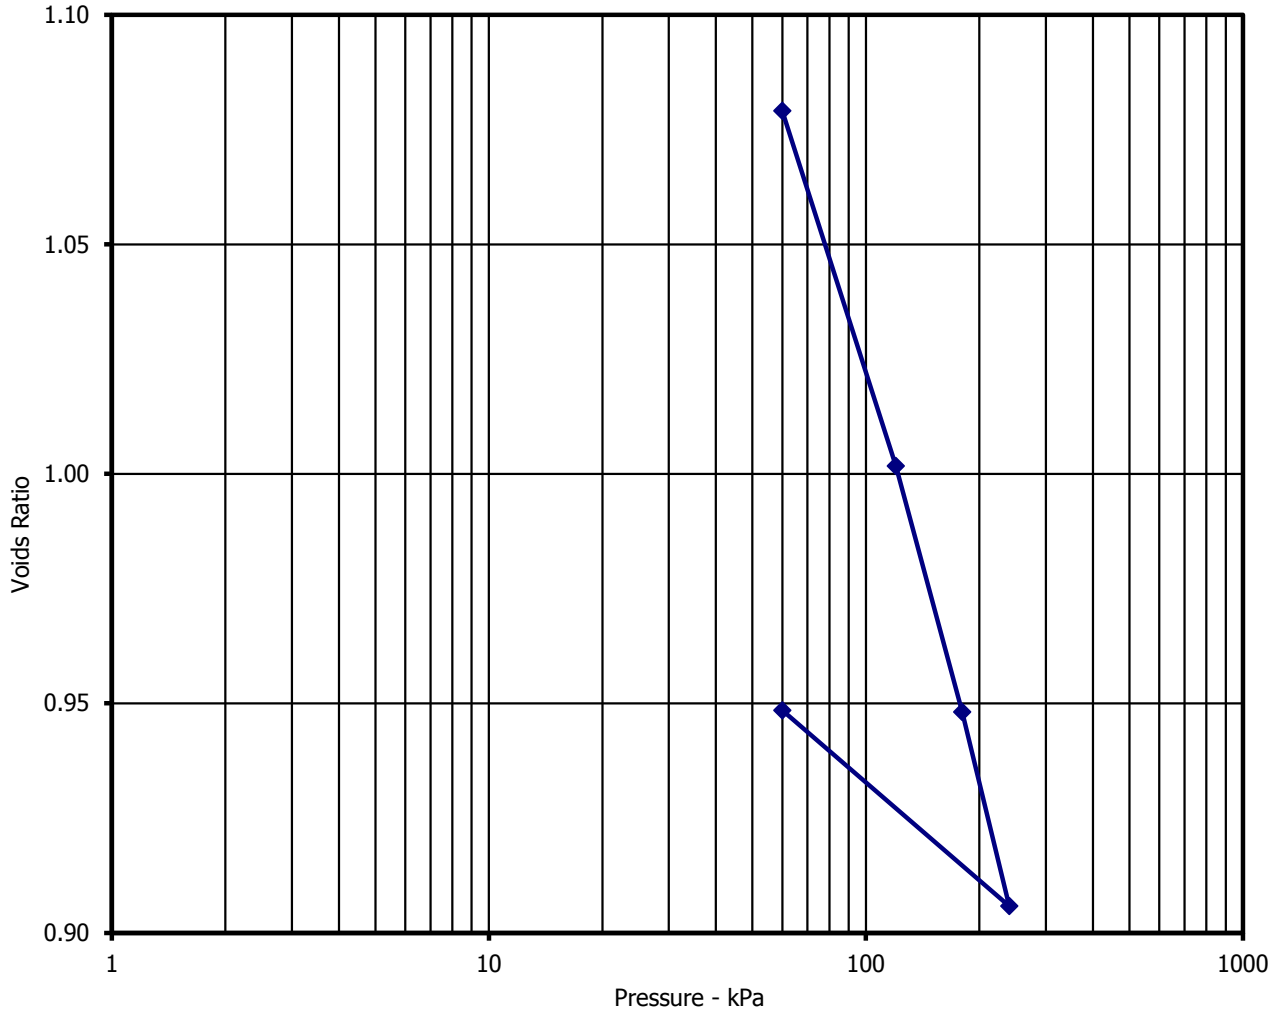
One Dimensional Consolidation testing has indicated that the upper 3.50m soils are of high compressibility with Volume Change Compressibility values (m_v) up to nearly 0.60m^2/MN. These values are more typical of a normally consolidated soils compared to an over-consolidated deposits such as the London Clay Formation. These results may be an effect of their high soil moisture content which may have resulted in high voids ratio at low soil stresses as shown. Although it appears the upper 3.50m soils are swollen, to particularly high values. Subsequently, in its current state, it is felt that soil suction values would be zero when any amount of overburden is removed such as in the construction of a basement, thus any swelling or heave forces would not be effective.
