01 SECOND FLOOR PLAN - PROPOSED REPAIRS TO STONE STAIR
1: 100 @ A3 / 1: 50 @ A1

02 SECTION AA - PROPOSED REPAIRS TO STONE STAIR
1: 100@ A3 / 1: 50 @ A1

C01	13.08.2014				Drawing Title: REPAIRS TO STONE STAIR - PROPOSED	Project: 153	Scale: 1:25 @ A1, 1:50 @ A3
									Drawing Number: CONSTRUCTION 153 422
									Revision: C01
							Client: SIMON BISHOP	Date: 13.08.2014	Drawn By: ML
							Project: 29 Percy Street, London, W1T 2DA

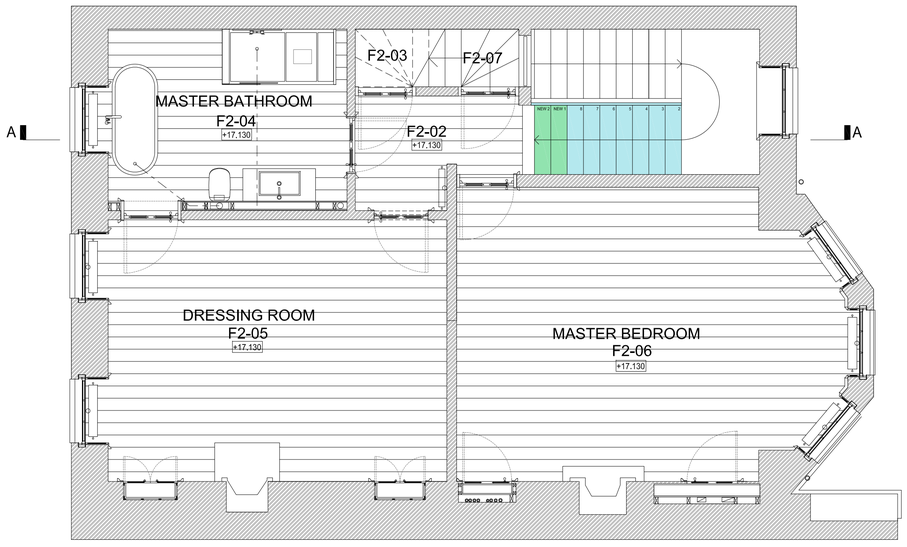
001) - - EXISTING STEEL BEAM
002) - - NEW ORNATE BOXING OF THE STEEL BEAM

REINSTALL THE EXISTING TREAD ELEMENTS, THE HANDRAIL AND THE TIMBER PANELLING. ALL WORK TO BE AS EXISTING.

INSTALL TWO NEW STONE TREADS TO LOOK LIKE EXISTING.
