Ground Investigation Report

11 Prince Albert Road
London
NW1 7SR

J14004A

November 2014

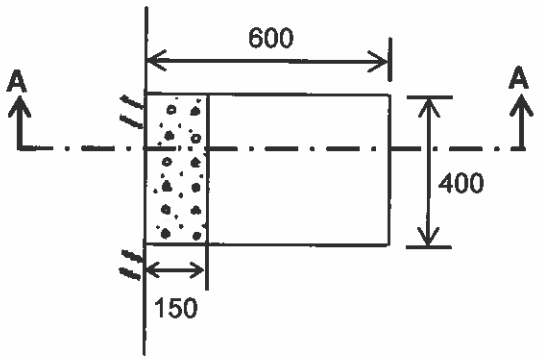
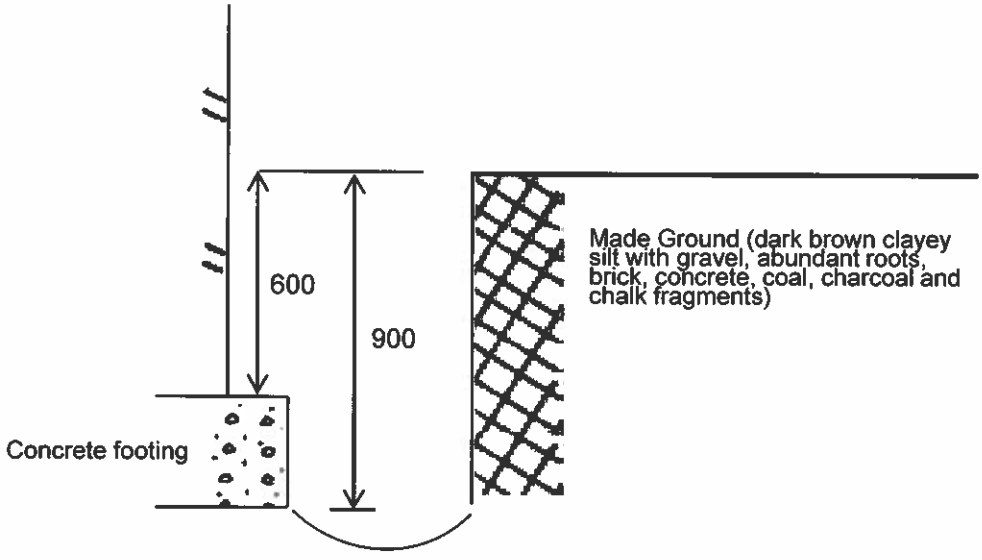
Trial Pit Nos 1 and 2 were excavated adjacent to the western boundary wall, although from slightly different levels. They encountered a concrete and brick footing bearing on made ground at depths of 0.9 m and 1.0 m below ground level respectively. Trial Pit No 2 was also excavated adjacent to a small brick retaining wall, which was founded on made ground at 0.4 m. The northern boundary wall was found to be supported by a brick footing bearing on made ground at 0.9 m below ground level.

Remarks:	Scale:
All dimensions in millimetres	1:20
Sides of trial pit remained stable during excavation	Logged by:
Groundwater: Not encountered	ML

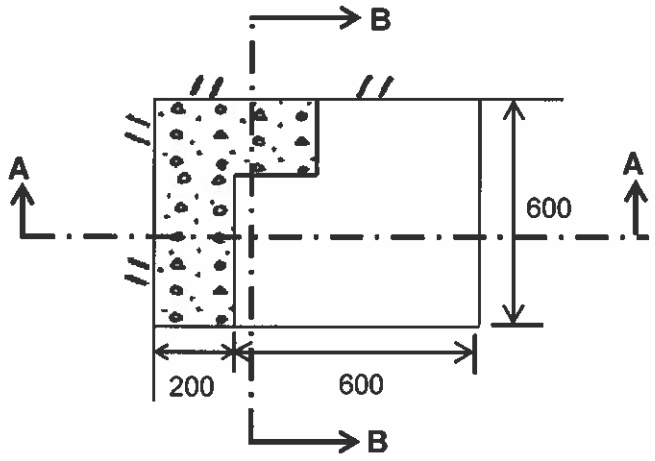
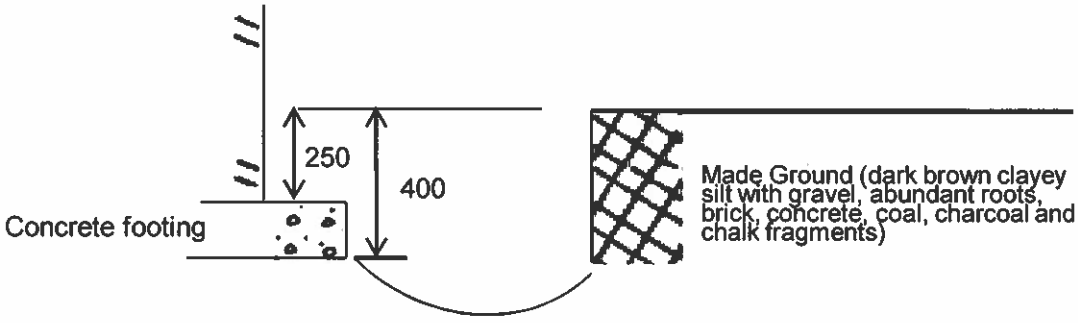
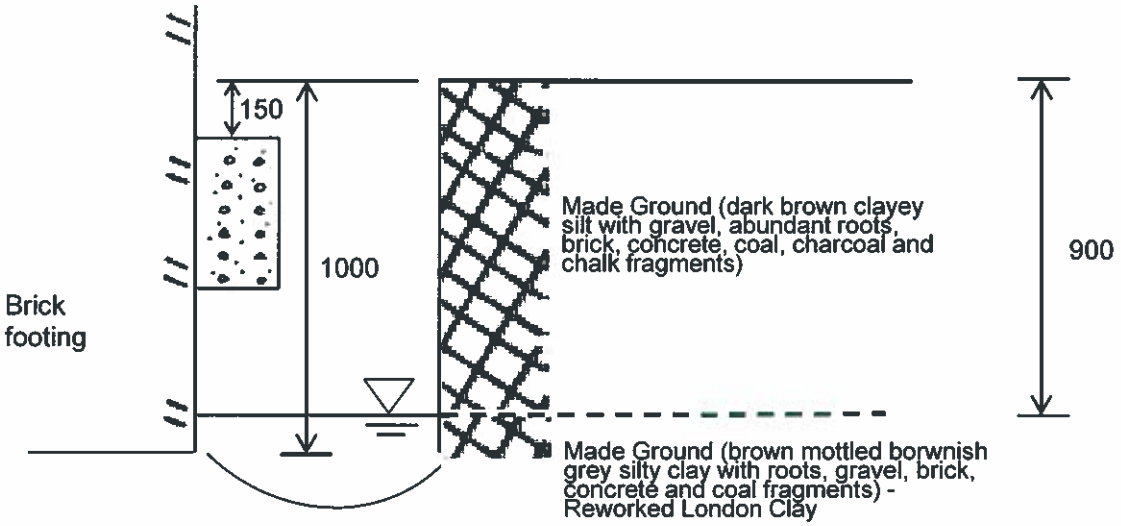
GEA Geotechnical & Environmental Associates	Tyttenhanger House Coursers Road St Albans Herts AL4 0PG	Site 11 Prince Albert Road, London NW1 7SR	Trial Pit Number 2

Remarks:		Scale:
All dimensions in millimetres	Sample: 0.4 m	1:20
Sides of trial pit remained stable during excavation		Logged by:
Groundwater: perched at 0.9 m		ML

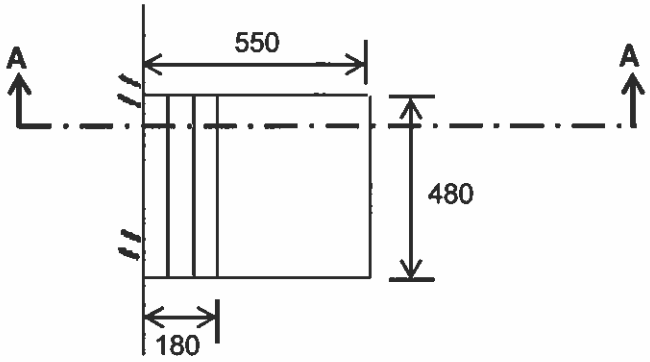
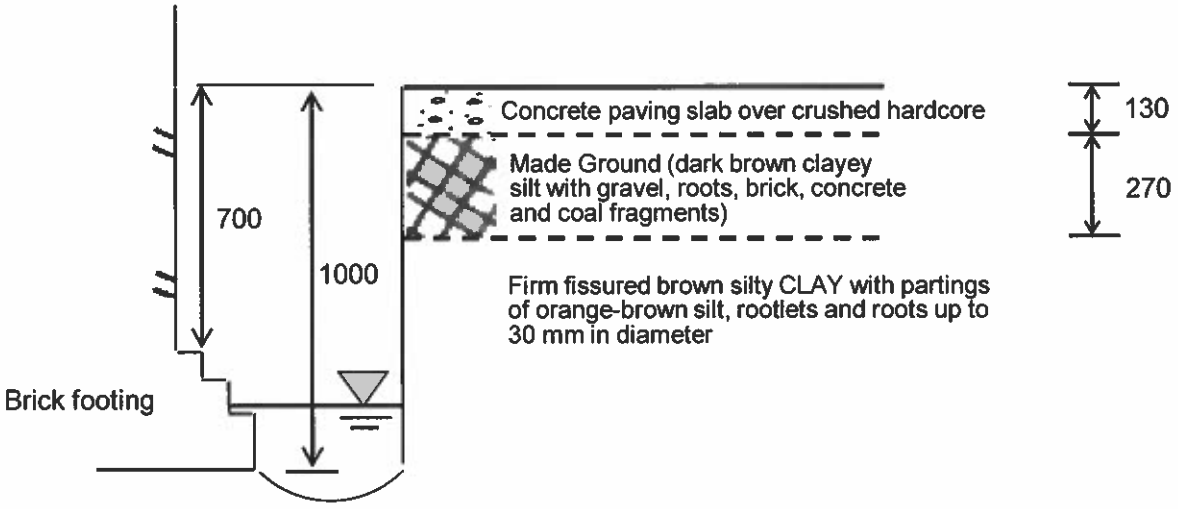
Geotechnical & Environmental Associates	Tyttenhanger House Coursers Road St Albans Herts AL4 0PG	Site 11 Prince Albert Road, London NW1 7SR	Trial Pit Number 3

Trial Pit No 3 was excavated adjacent to the rear elevation of the existing house, which was found to be supported by a brick footing that extended away from the wall by 180 mm and was bearing on London Clay at a depth of 1.0 m. An identical brick footing was also encountered in Trial Pit No 5, which was excavated adjacent to the western elevation of the house, within the existing lightwell.

Remarks:		Scale:
All dimensions in millimetres	Samples: 0.2 m 1.0 m	1:20
Sides of trial pit remained stable during excavation		Logged by:
Groundwater: Perched at 0.85 m		ML

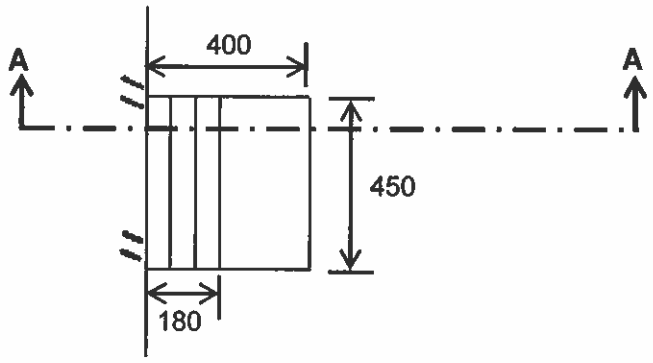
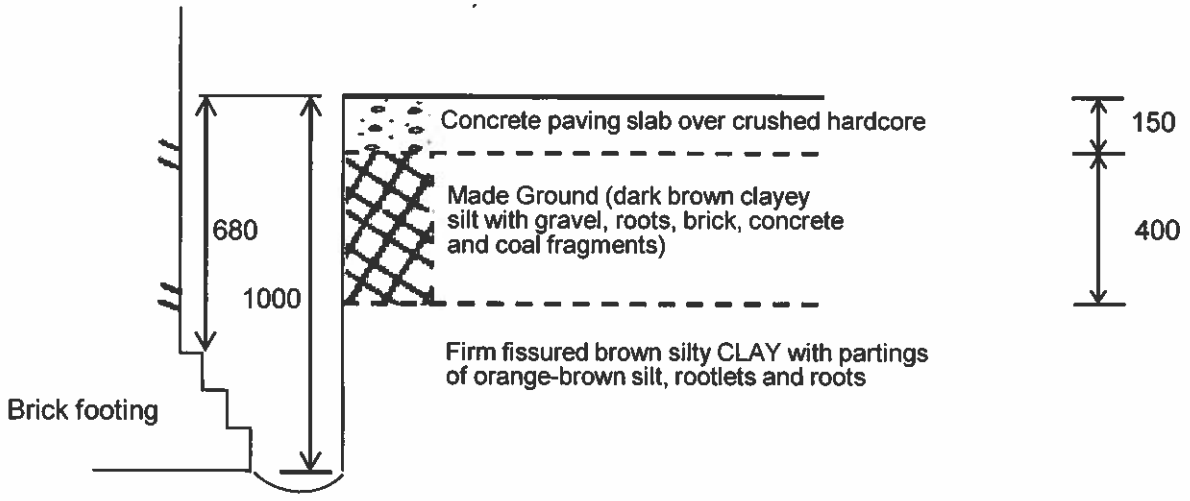
Geotechnical & Environmental Associates	Tyttenhanger House Coursers Road St Albans Herts AL4 0PG	Site 11 Prince Albert Road, London NW1 7SR	Trial Pit Number 5

Remarks:		Scale:
All dimensions in millimetres	Sample: 1.0 m	1:20
Sides of trial pit remained stable during excavation		Logged by:
Groundwater: Perched under foundation at 1.0 m		ML

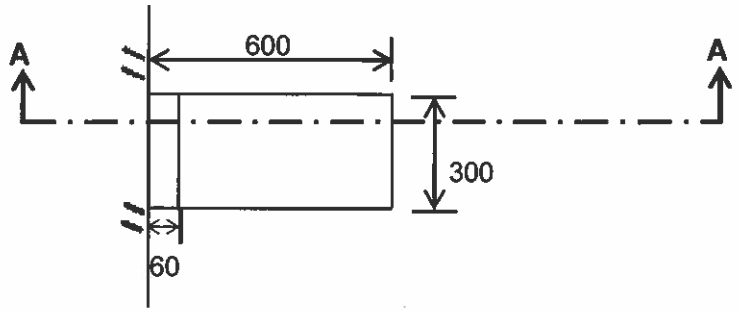
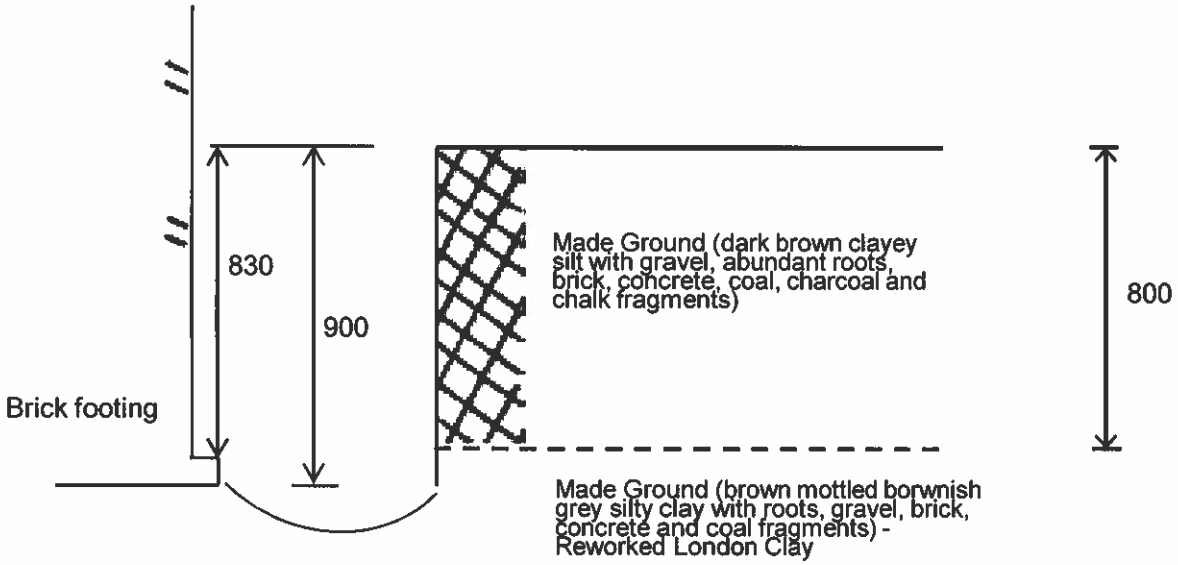
Geotechnical & Environmental Associates	Tyttenhanger House Coursers Road St Albans Herts AL4 0PG	Site 11 Prince Albert Road, London NW1 7SR	Trial Pit Number 6

Remarks:		Scale:
All dimensions in millimetres	Sample: 0.4 m	1:20
Sides of trial pit remained stable during excavation		Logged by:
Groundwater: Perched under foundation at 0.9 m		ML

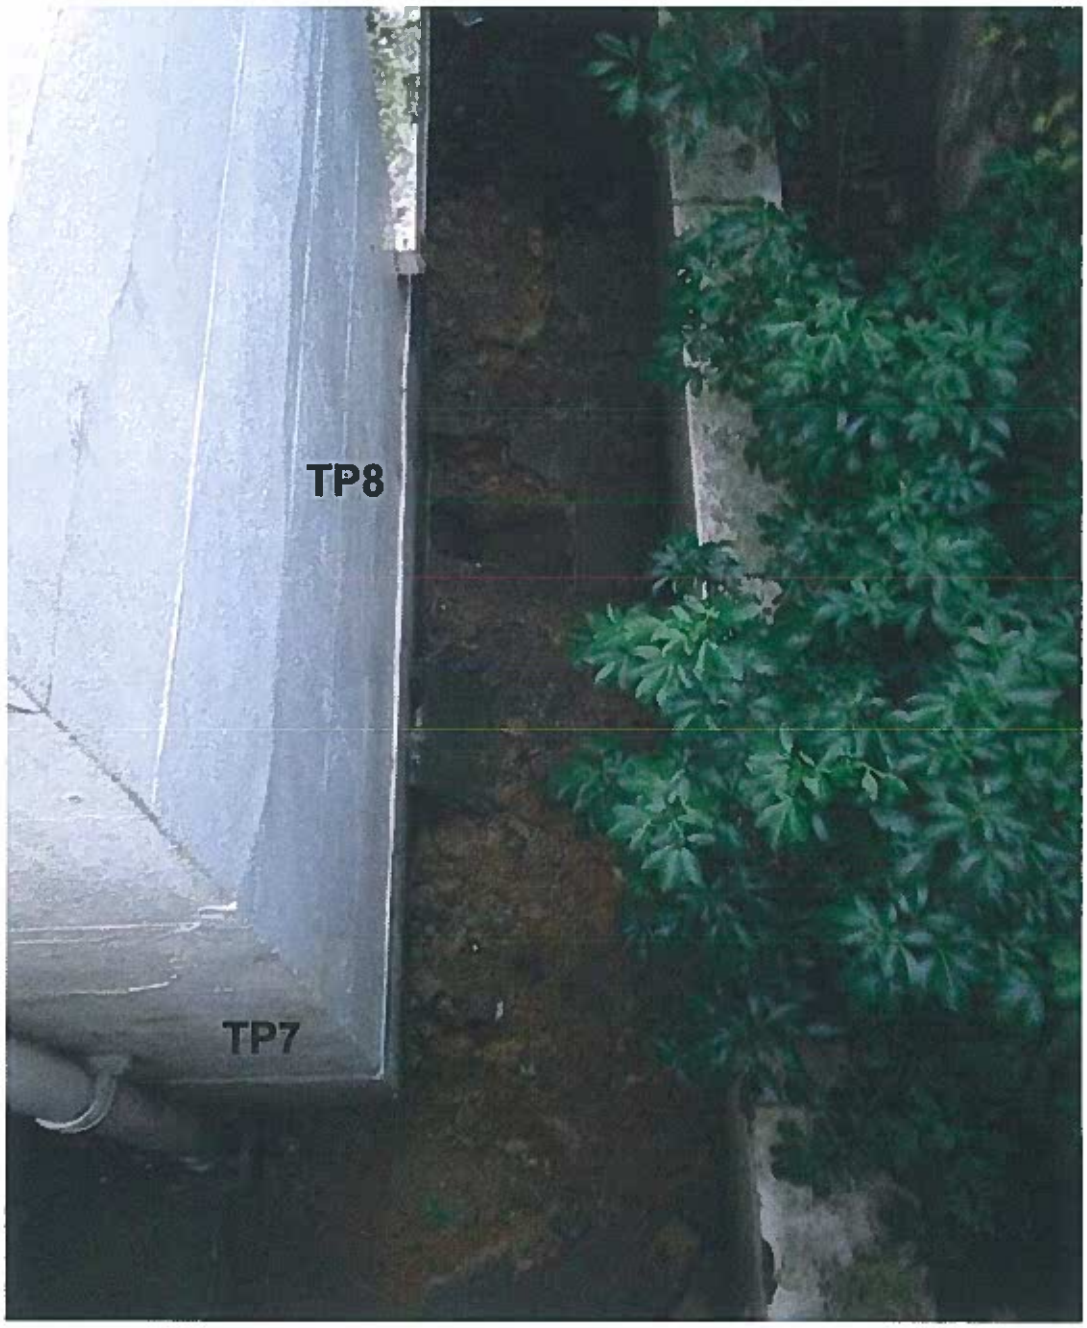
Photograph showing location of Trial Pit Nos 7 and 8

Trial Pit Nos 7 and 8 were positioned adjacent to the northern elevation within the lightwell and were excavated in order to assess the footings of both the house and the retaining walls around the extent of the existing lightwell. Trial Pit No 7 however was terminated on a concrete obstruction that spanned the width of the lightwell and was at least 250 mm thick. The concrete was not broken out in case it formed part of an existing footing. At the base of the retaining wall within this trial pit, what appeared to be new engineering bricks were identified. It is therefore possible that structural work, including possibly underpinning, has taken place to the either the retaining wall and / or the existing house. Trial Pit No 8 was also terminated at a shallow depth due to the presence of a relic brick structure, a concrete obstruction and a concrete surround to a surface drain.
