SITE INVESTIGATION
FACTUAL REPORT

Report No:	148703
Client:	CRAWFORD CLAIMS MGMT SUS
Site:	9 Rosslyn Hill, London
Client Ref:	SU1300377-Mr G Ramirez
Date of Visit:	24/07/2013

Investigation Layout Plan

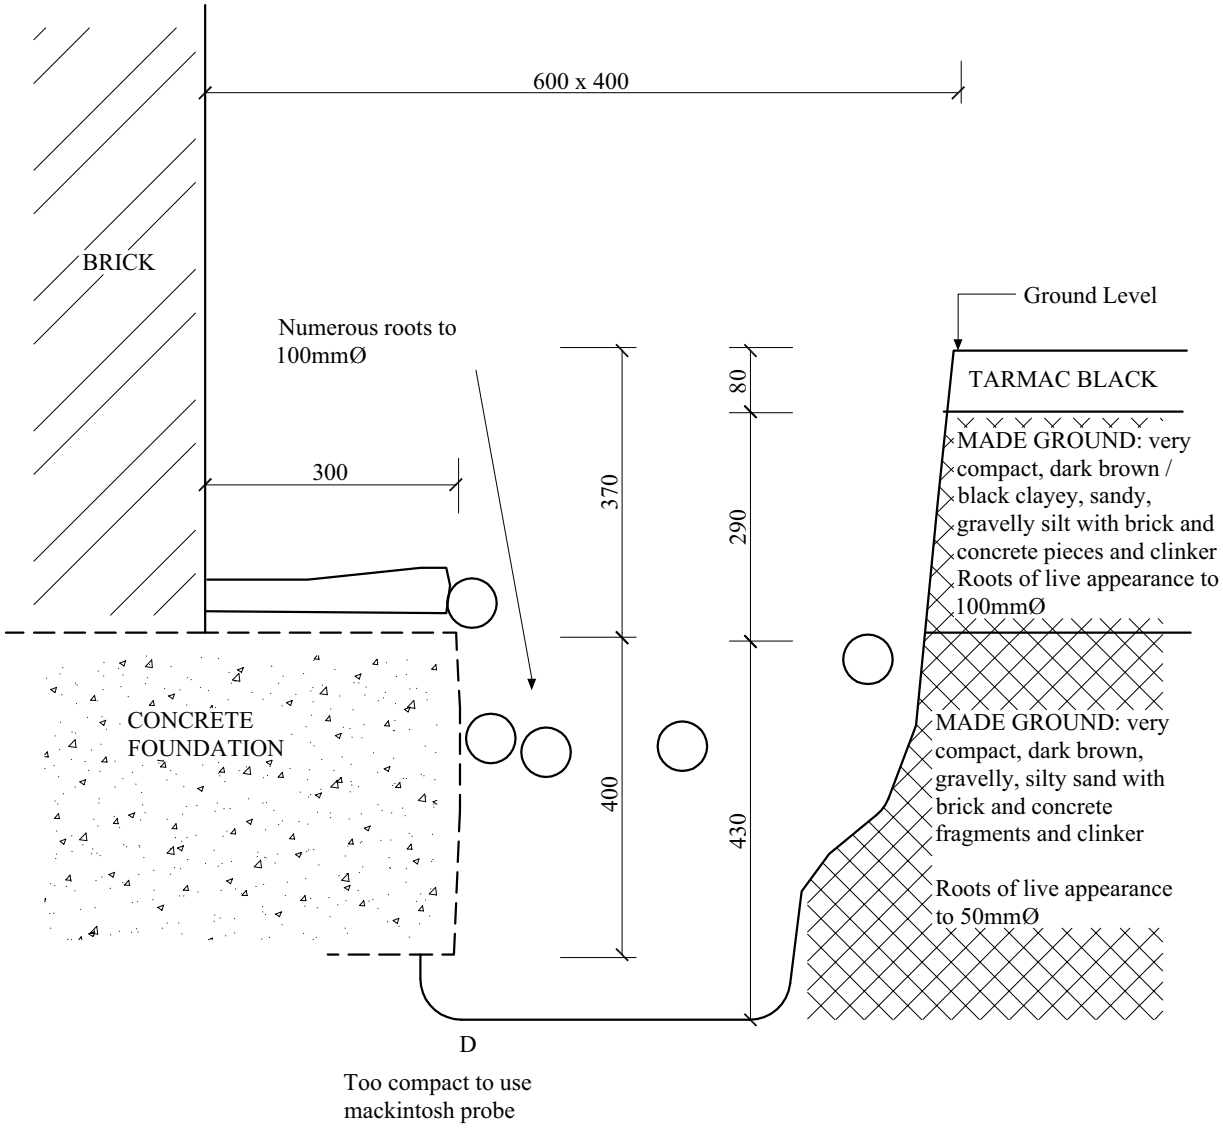
Trial Pit No: 1

U/S foundation assumed only. Found with the aid o f curved steel in. Unable to expose foundation due to roots

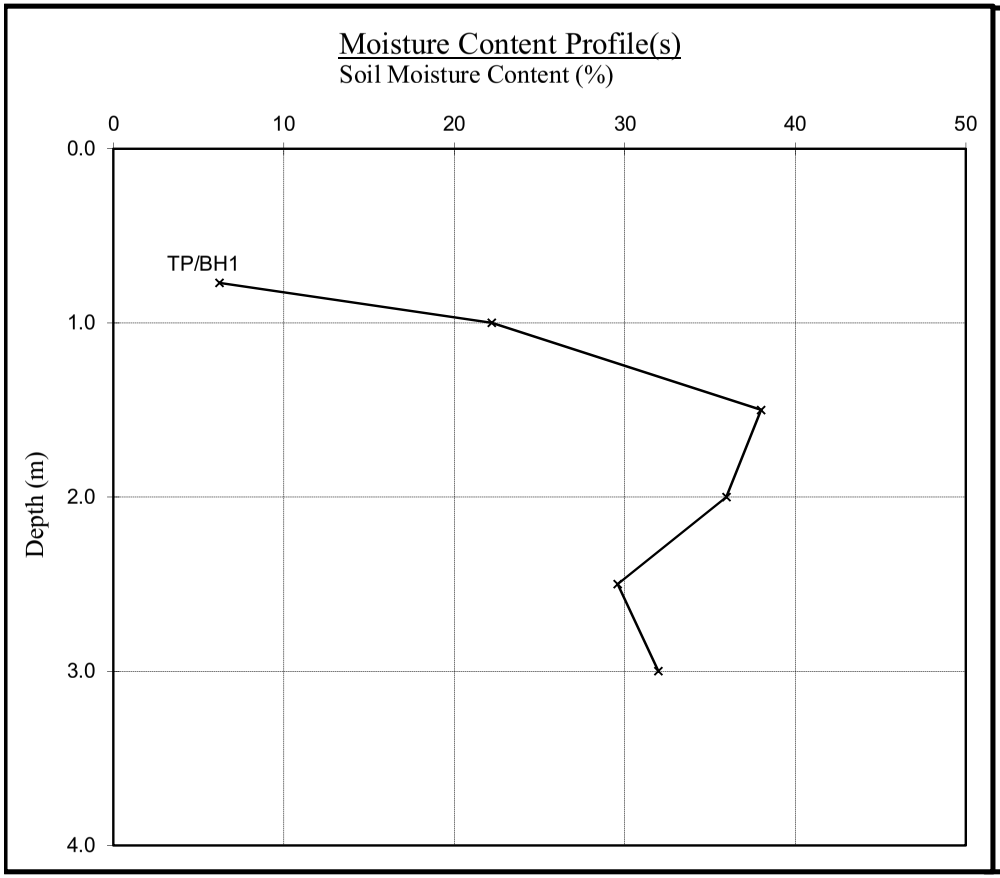
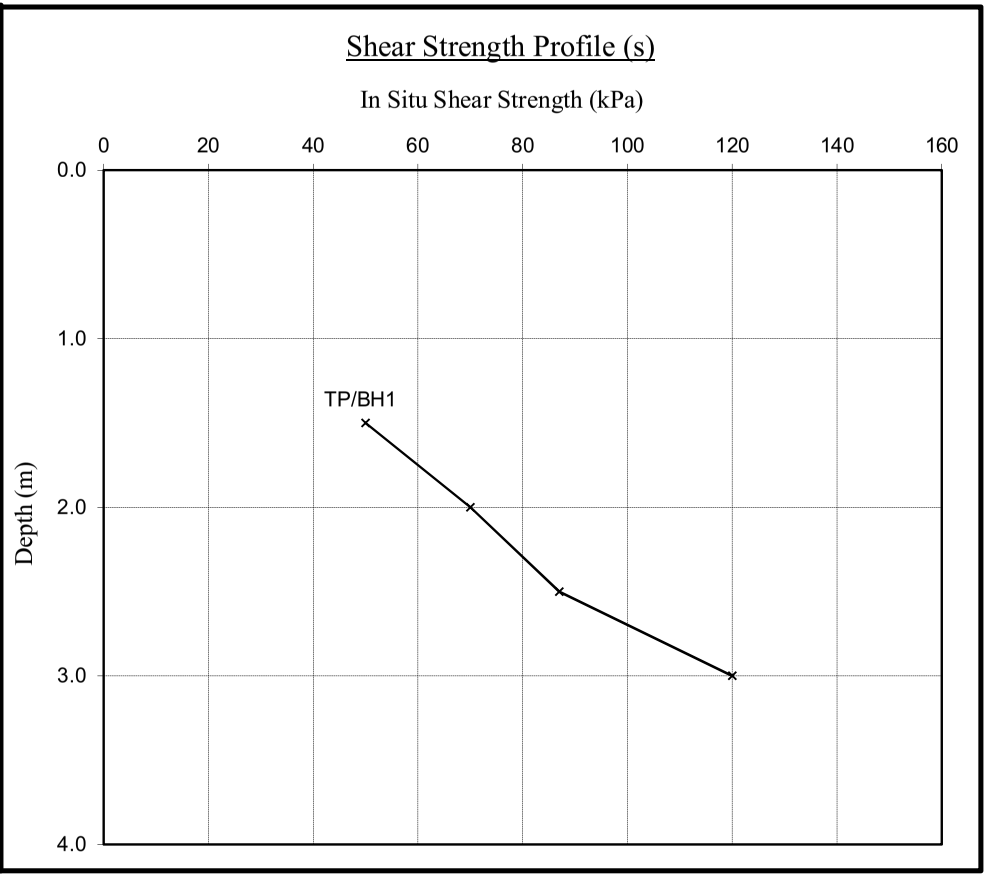
Moisture Content and Shear Strength Profiles

Unless otherwise stated, values of Shear Strength were determined in situ by CET using a Pilcon Hand Vane the calibration of which is limited to a maximum reading of 120 kPa.
