Basement Impact Assessment: Site Investigation Report
Revised from J11954 September 2014

Site: 85 Camden Mews, London NW1 9BU

Client: Whitehall Park Ltd

Project Reference: J12115

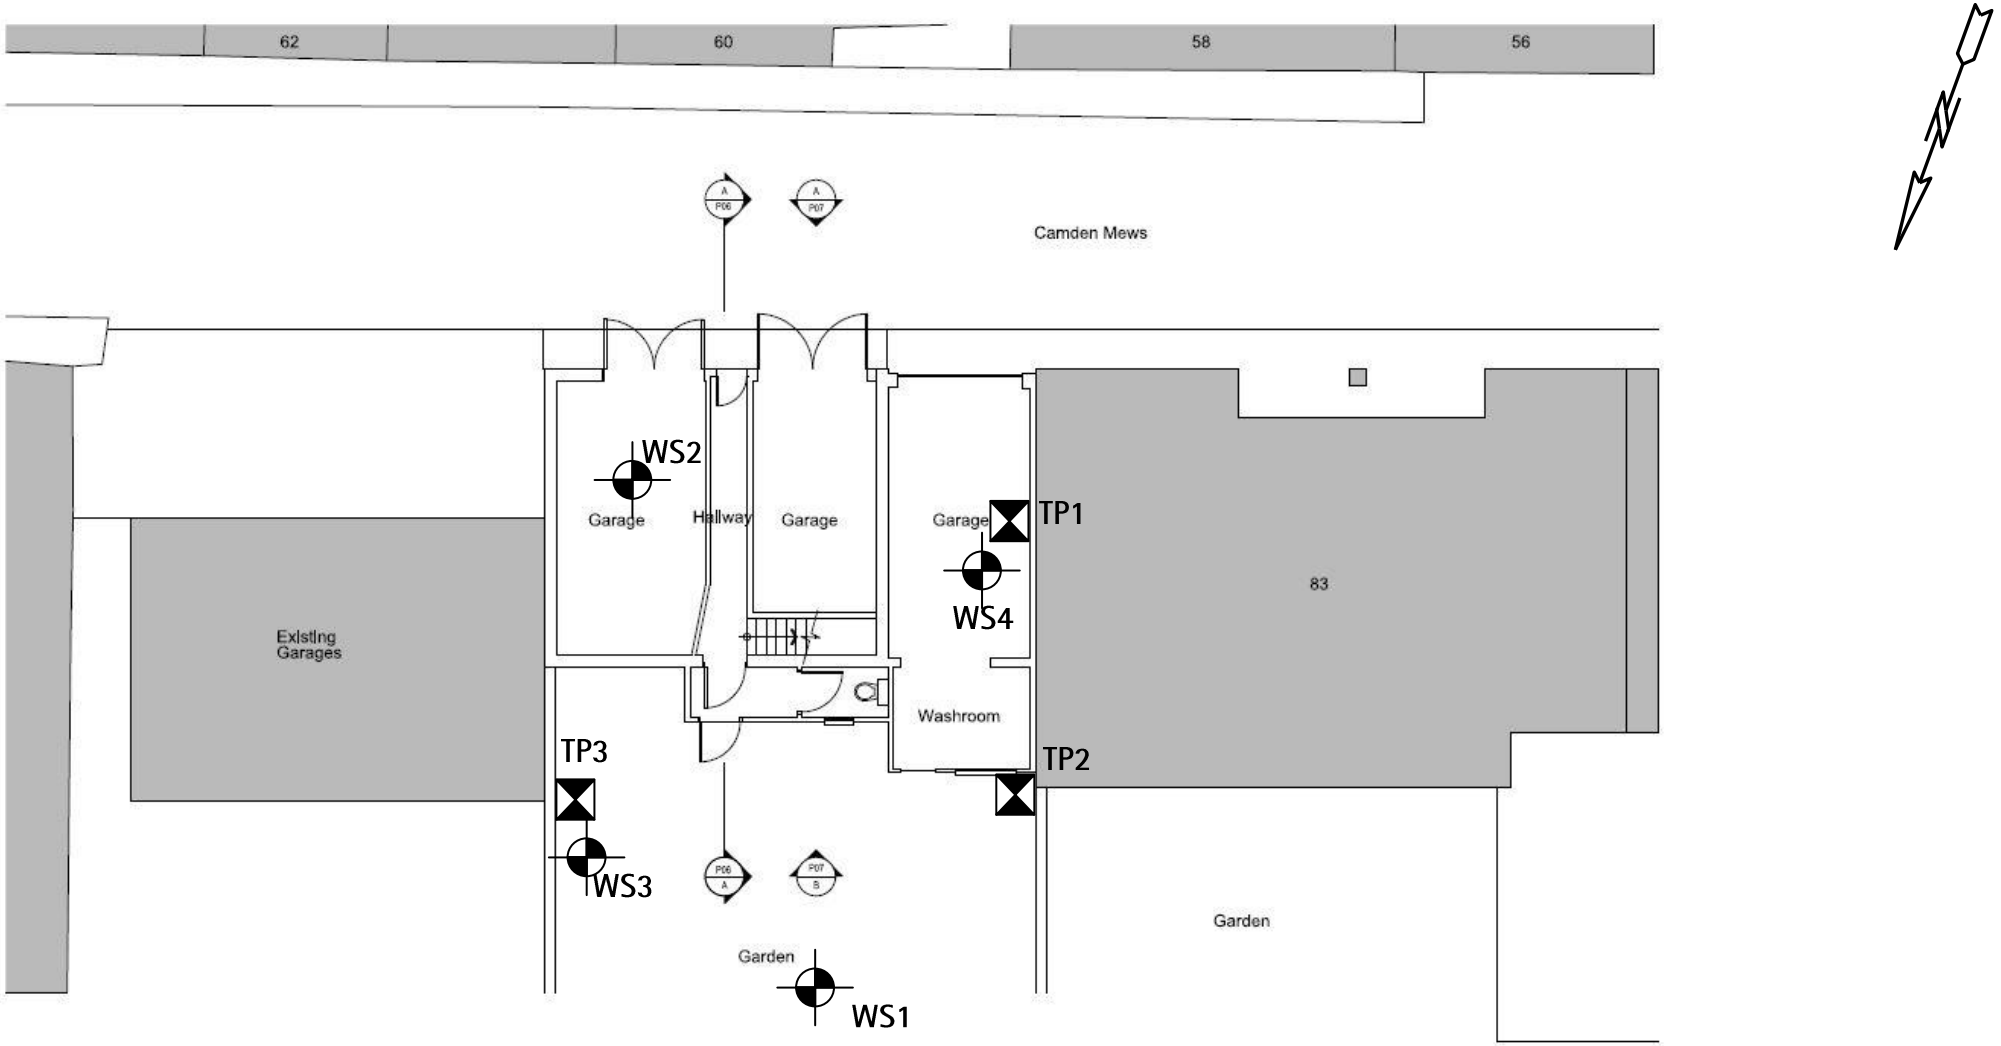
Site: 85 Camden Mews (London NW1)	STL: J12115	Fig No: 1
Date: 09 January 2015	Please note WS1, WS2, TP1, TP2, TP3 from previous investigation.

Exploratory hole locations are shown in Figure 1 in Appendix A.

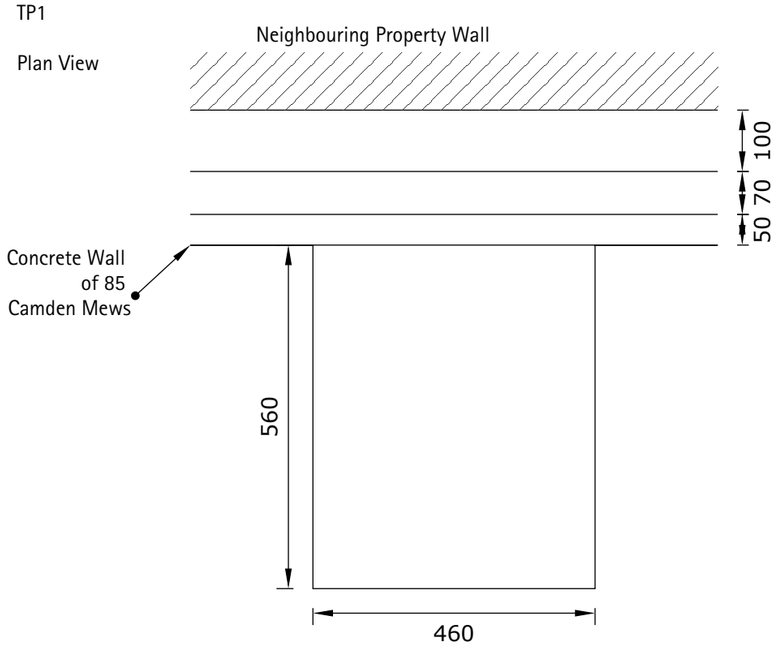
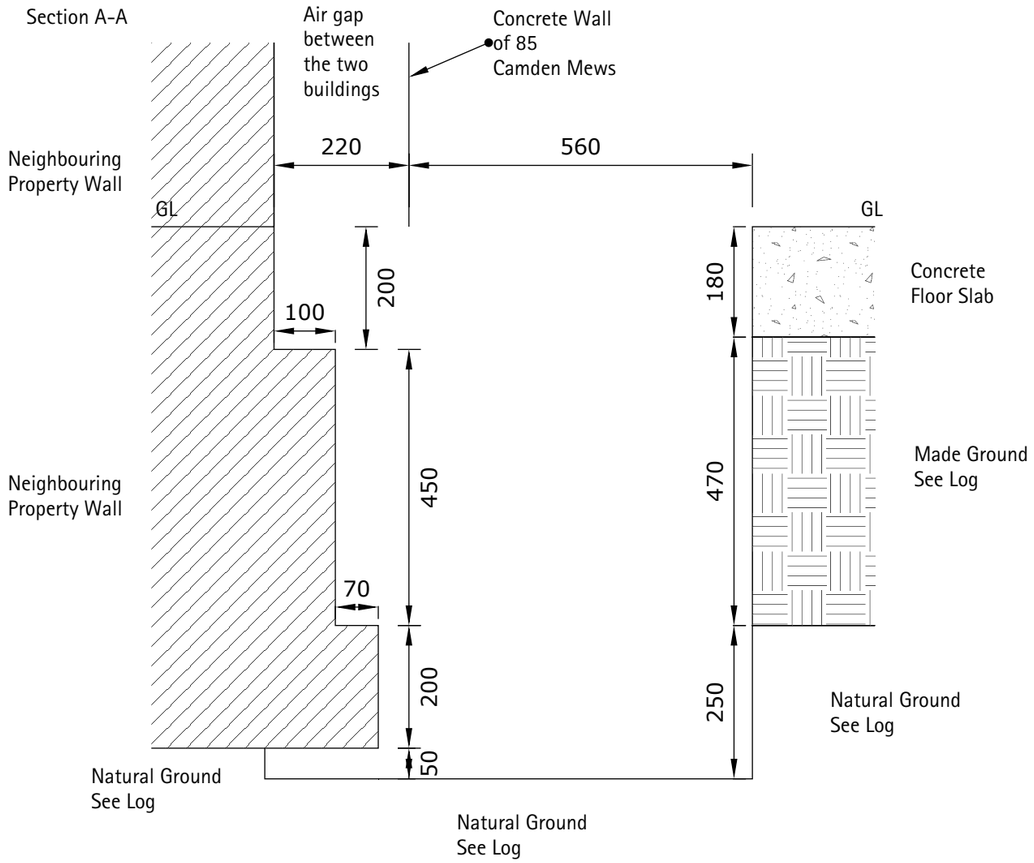
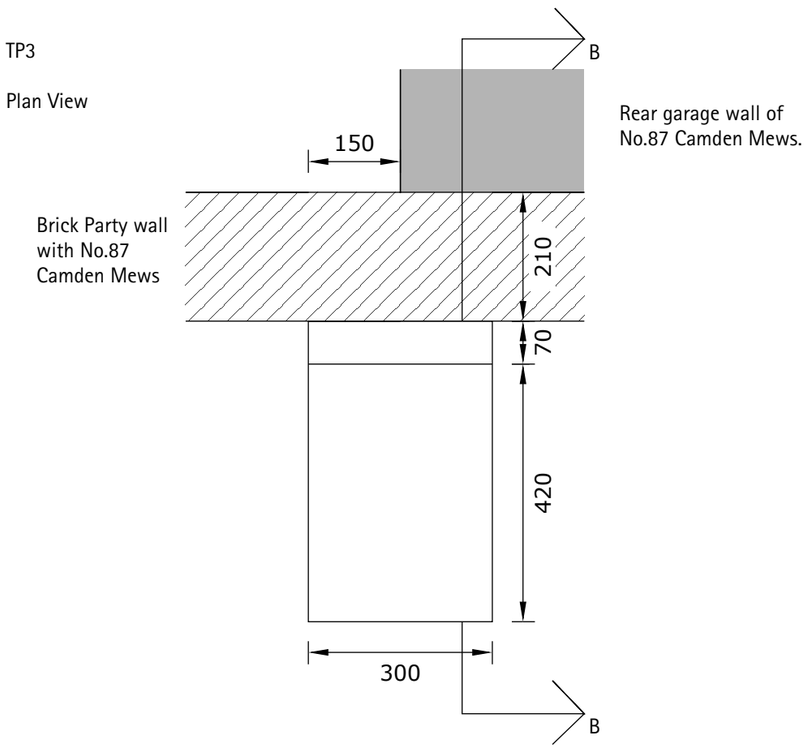
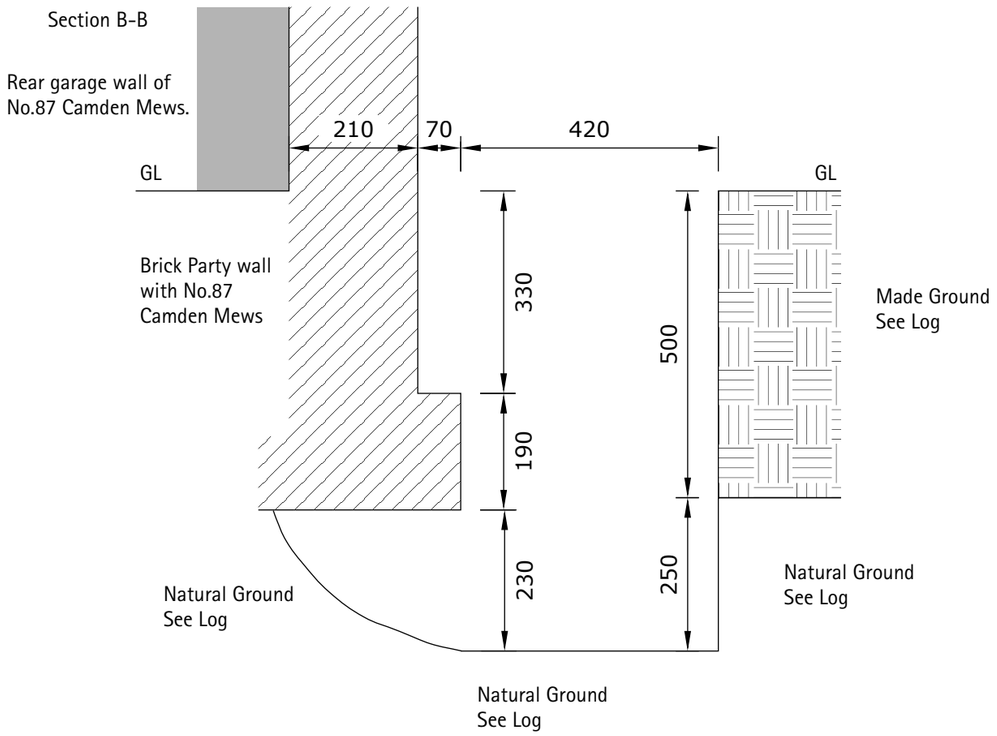
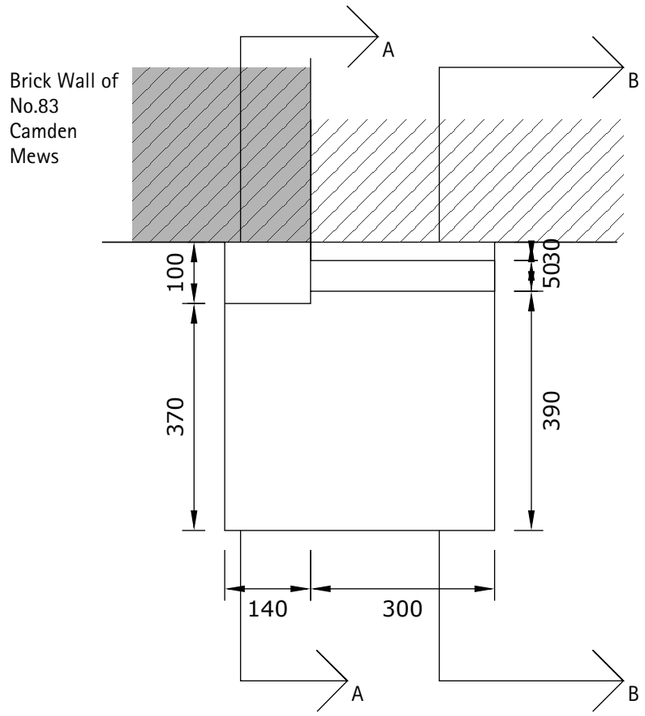
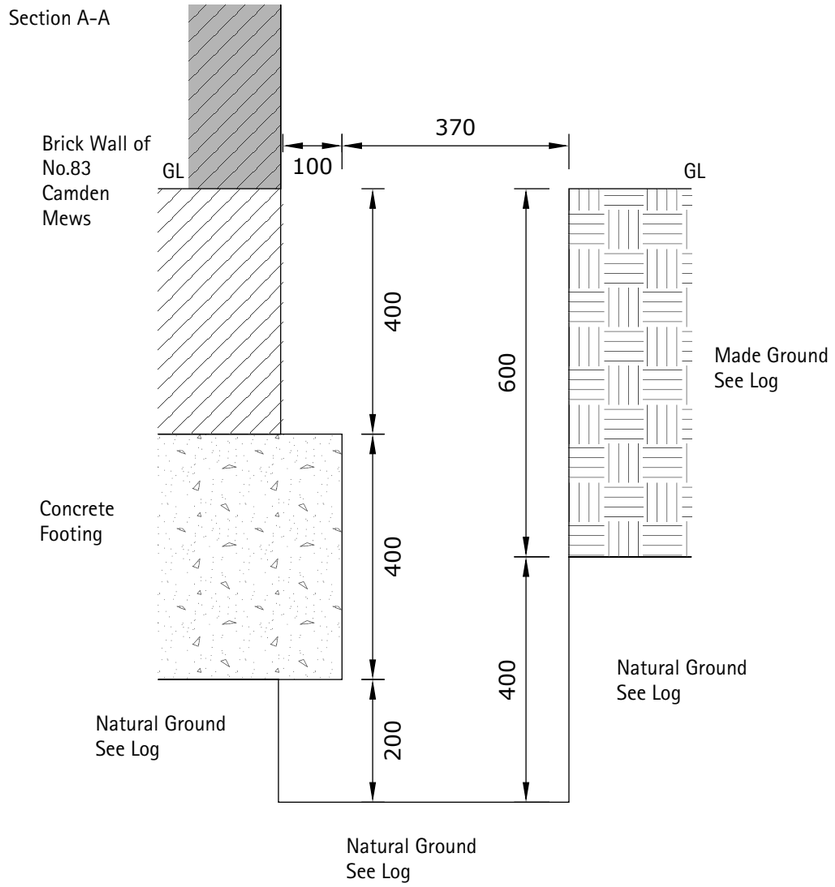
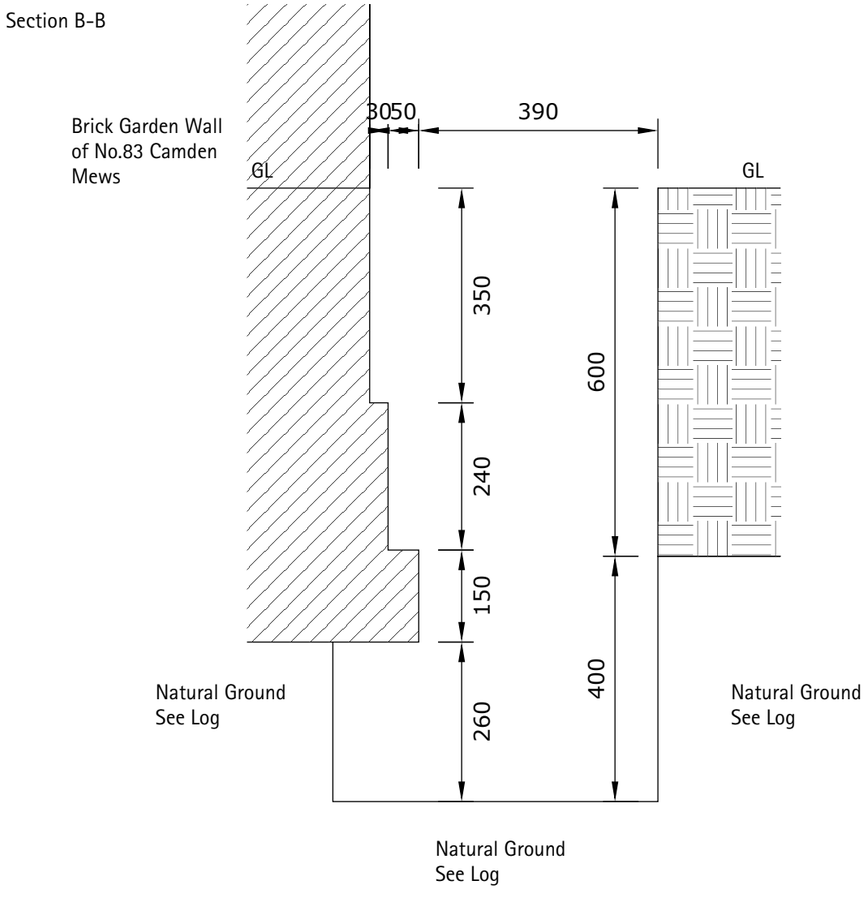
The existing foundations to boundary walls were exposed in hand dug trial pits. The arrangement of the foundations is shown in the sections in Appendix A; foundations are at 0.52m to 0.85m below ground level, formed in the natural clay soils.

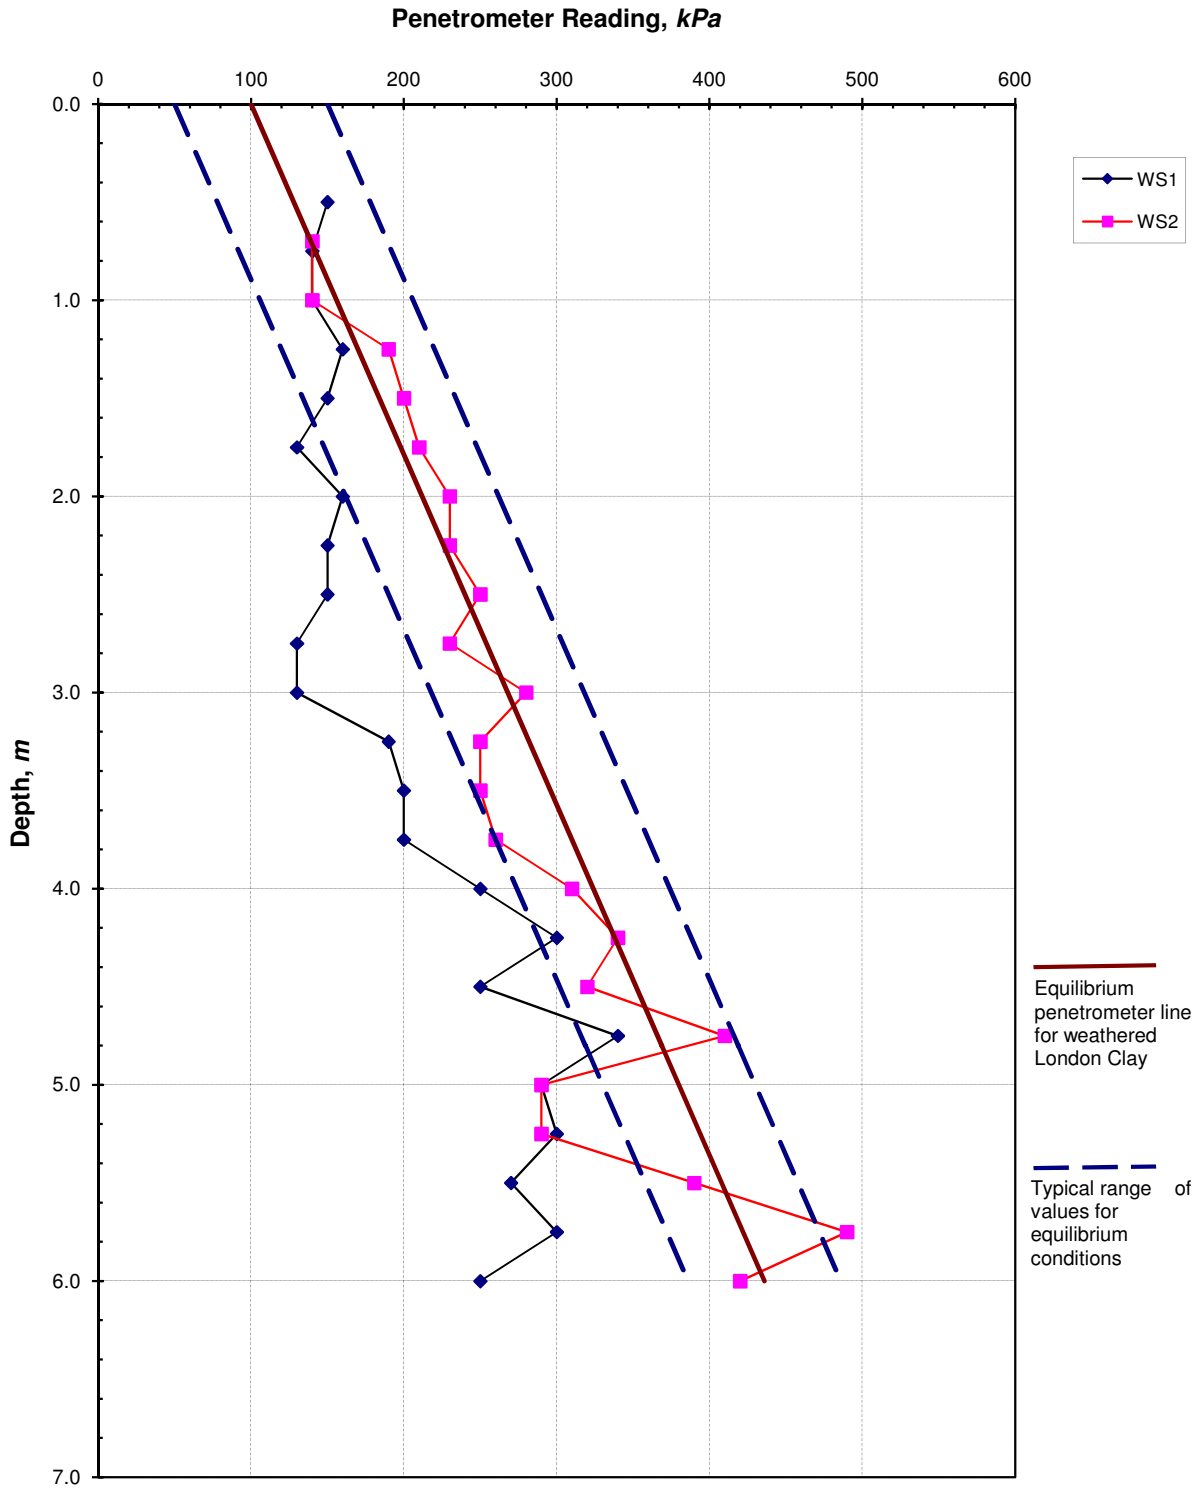
Client:	**Whitehall Park Ltd**	**Job No:** J11954	
Site:	**85 Camden Mews, London NW1**	**Date:** 10/09/2014	**Fig. HP1**

The measured moisture contents are above 30% and vary little over the test depth in either hole. The moisture content profiles are generally consistent with those expected for clays not affected by trees. In WS1, the moisture content results are below 0.5 of the Liquid Limit but do not fall below 0.4 of the Liquid Limit. In WS2, the moisture content results are also below 0.5 of the Liquid Limit, and straddle the 0.4 Liquid Limit profile below about 1m.

In considering all of the above observations, it is considered that the soils tested are not highly desiccated, and that the potential for the clays in WS2 to heave is marginal. This is consistent with the moderate water demand trees present in the vicinity of the site. However, the Engineer should check their influence using the guidance in NHBC Chapter 4.2 and make sure that the design caters for the potential effects of lateral pressure/heave from the trees in the future.
