Factual Ground Investigation Report

Denmark Street South
4 Flitcroft Street
London
WC2H 8DJ

J12236

December 2012

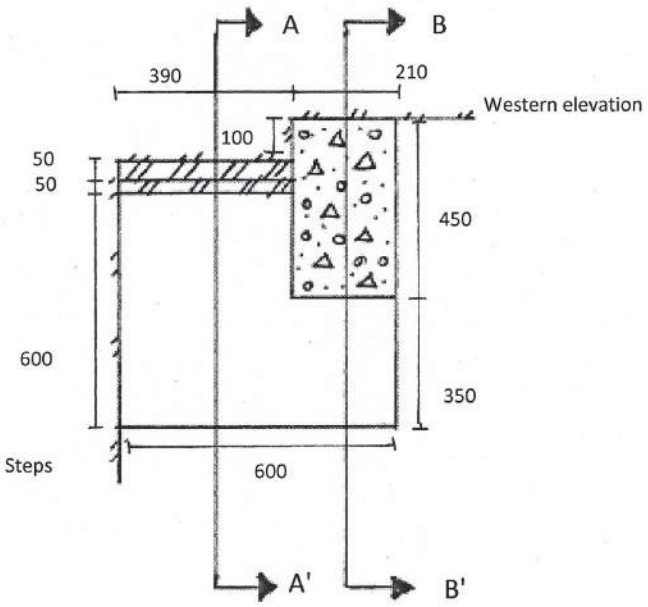
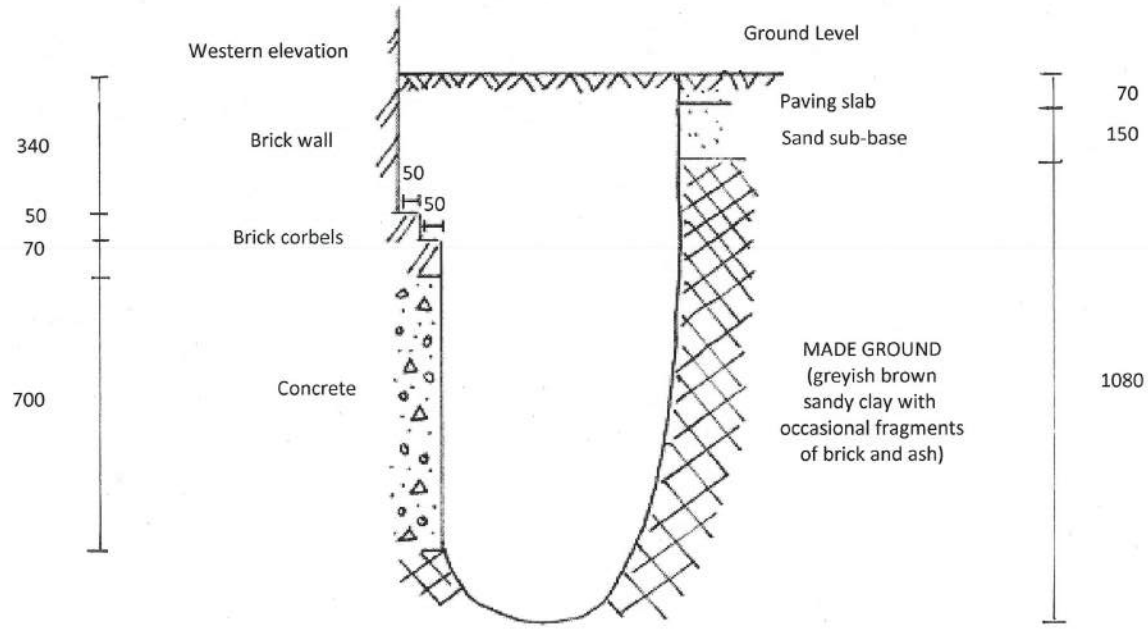
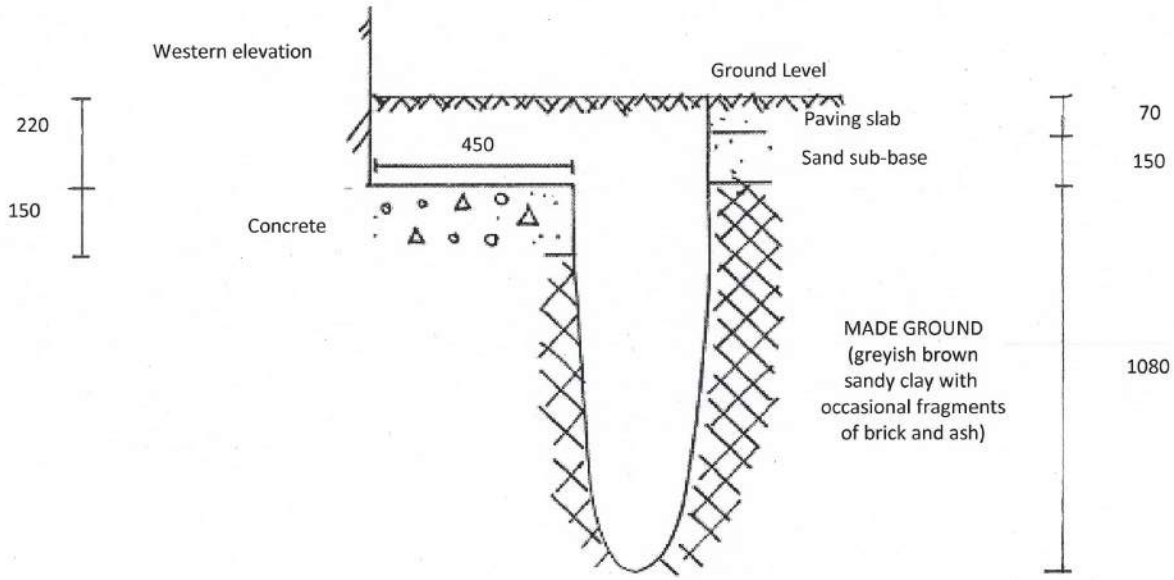
Trial Pit Nos 1, 2, 3 and 4 found that the existing buildings are founded at depths of between 1.16 m and 2.46 m on made ground or gravelly sand of the Lynch Hill Gravel.

View of footings encountered in Trial Pit No 1, looking east

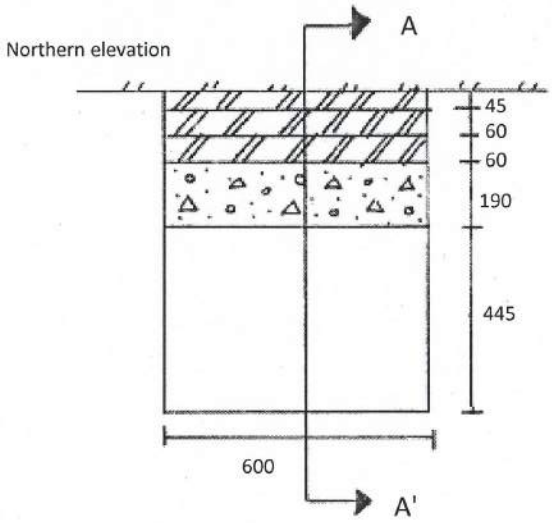
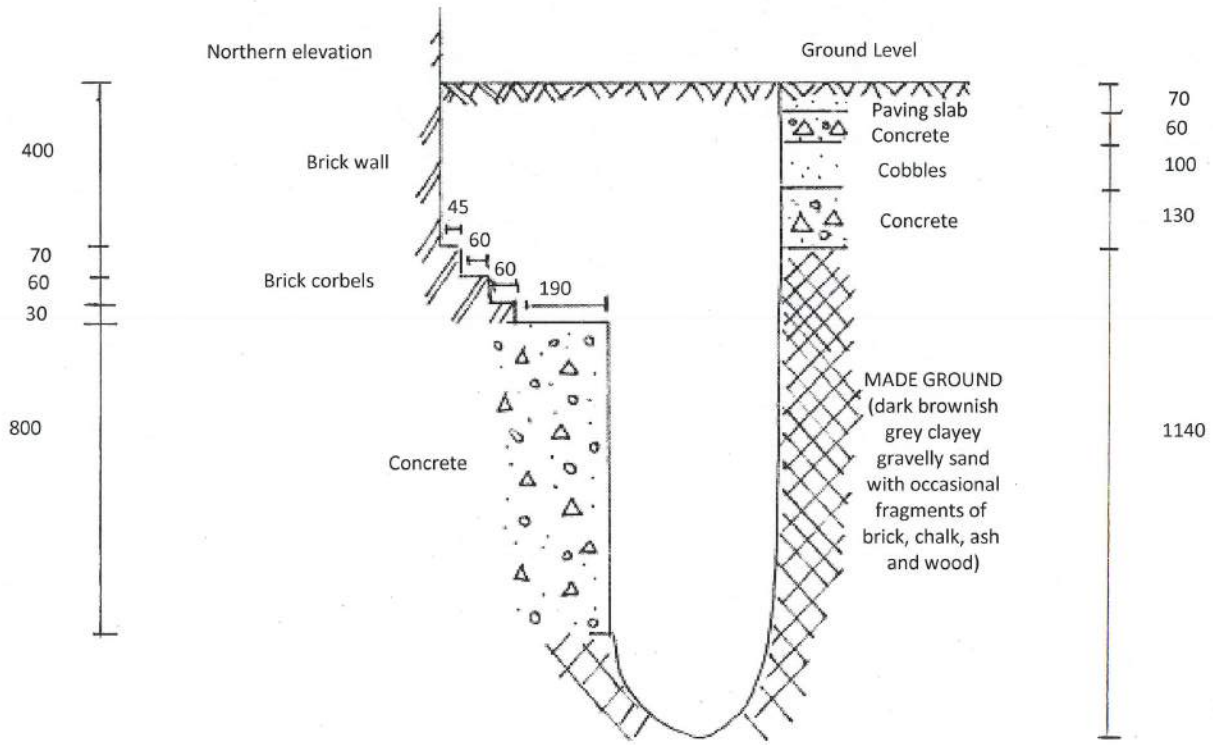
Remarks:	Scale:
All dimensions in millimetres	1:20
Sides of trial pit remained stable during excavation	Logged by:
Groundwater not encountered	HD

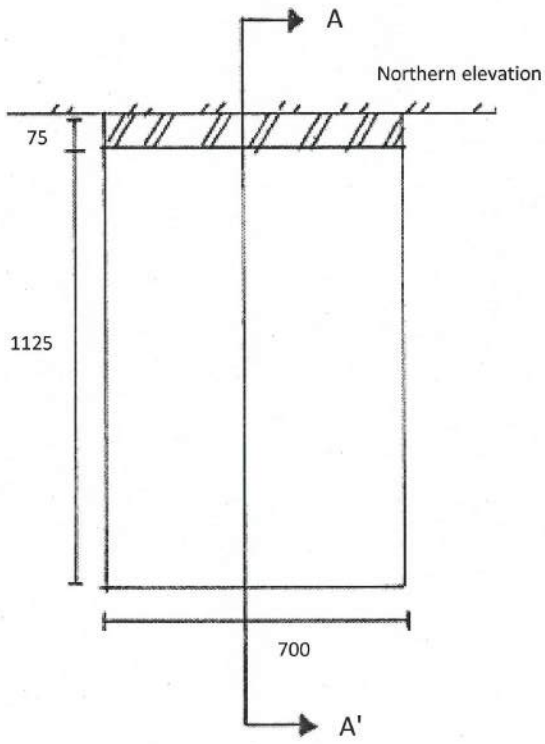
Remarks:	Scale:
All dimensions in millimetres	1:20
Sides of trial pit remained stable during excavation	Logged by:
Groundwater not encountered	HD

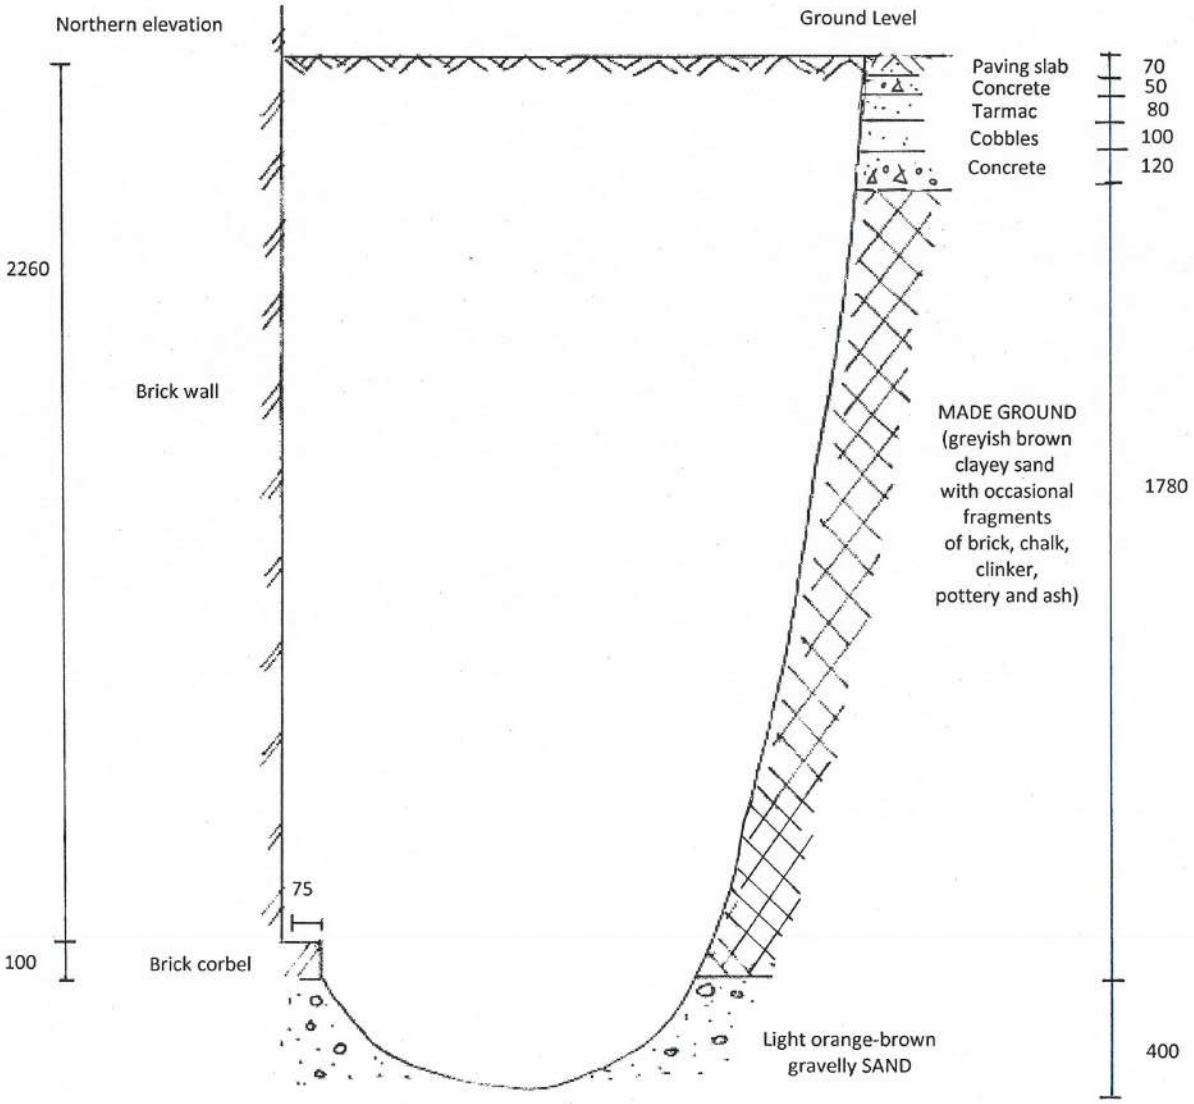
Remarks:	Scale:
All dimensions in millimetres	1:20
Sides of trial pit remained stable during excavation	Logged by:
Groundwater not encountered	HD

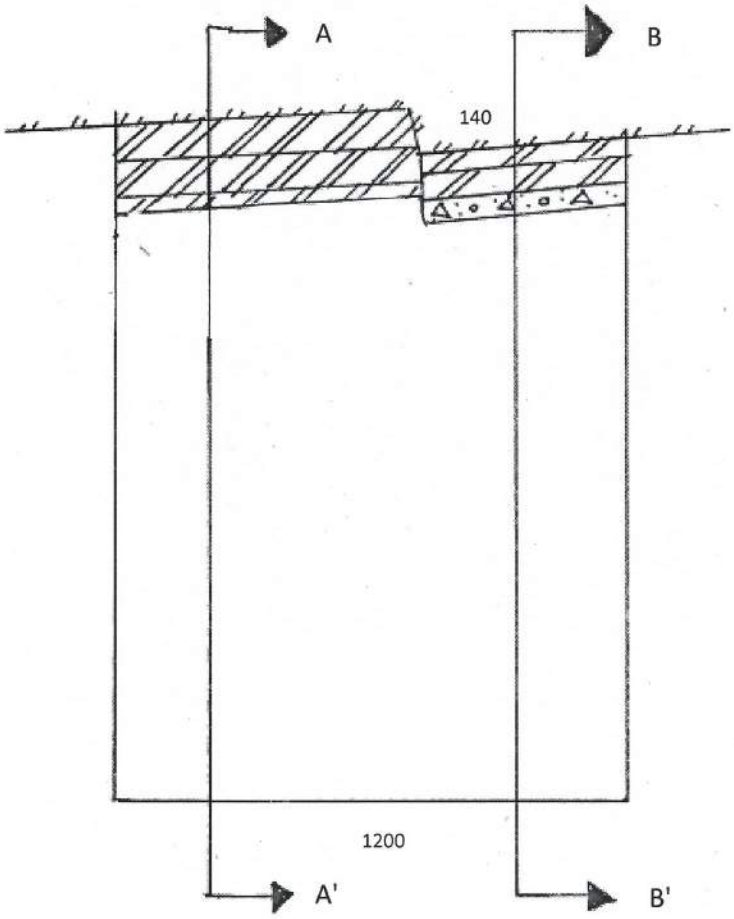
Southern elevation

Remarks:	Scale:
All dimensions in millimetres	1:20
Sides of trial pit remained stable during excavation	Logged by:
Groundwater not encountered	HD

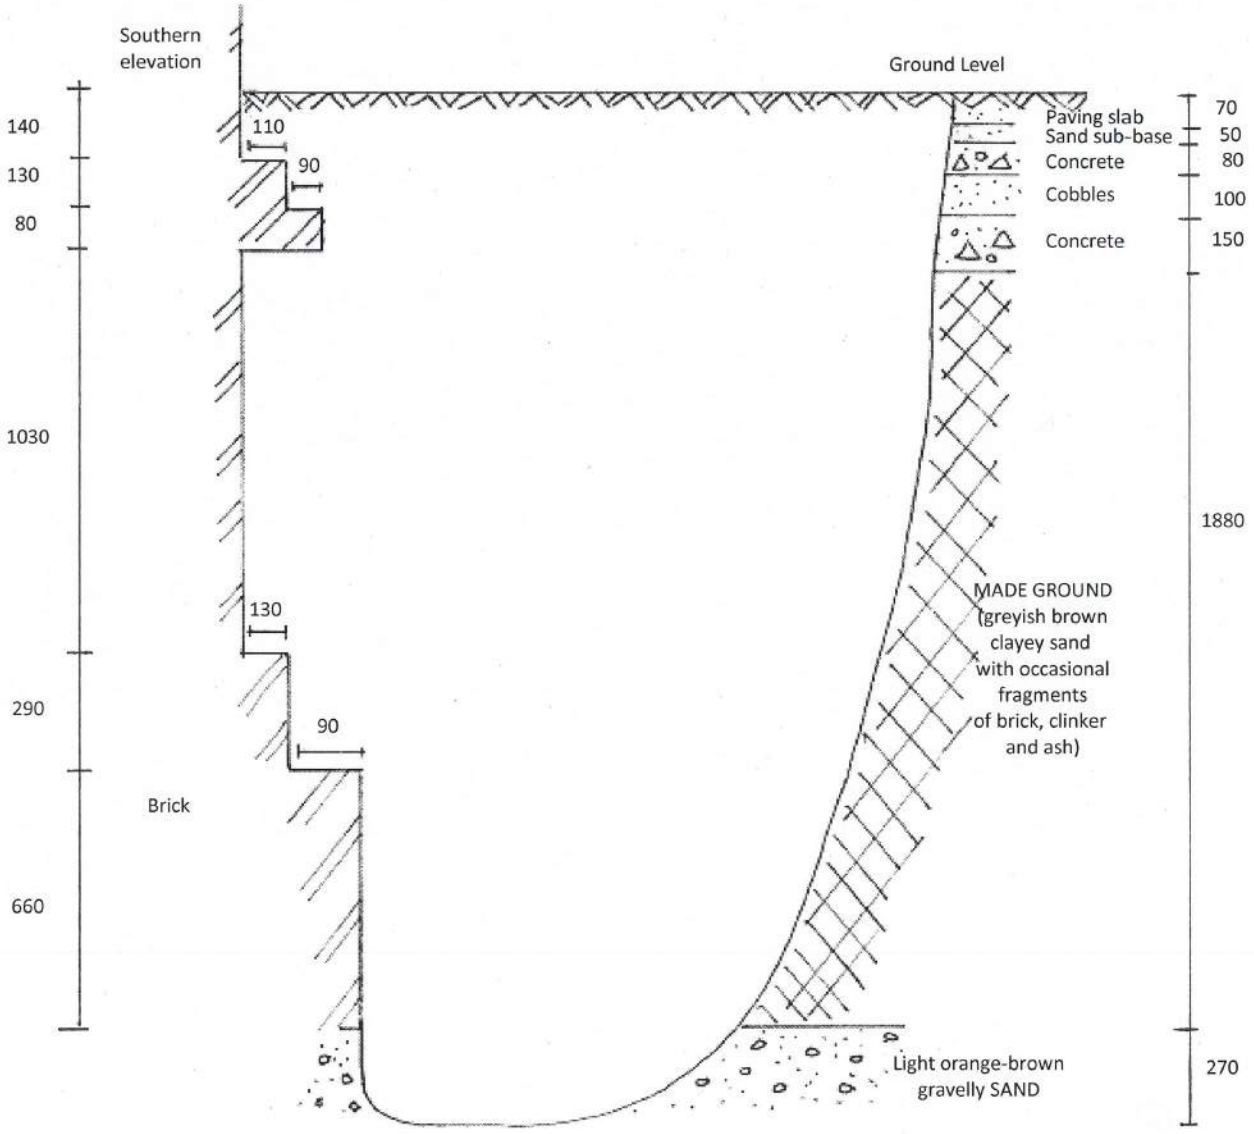
Remarks:	Scale:
All dimensions in millimetres	1:20
Sides of trial pit remained stable during excavation	Logged by:
Groundwater not encountered	HD

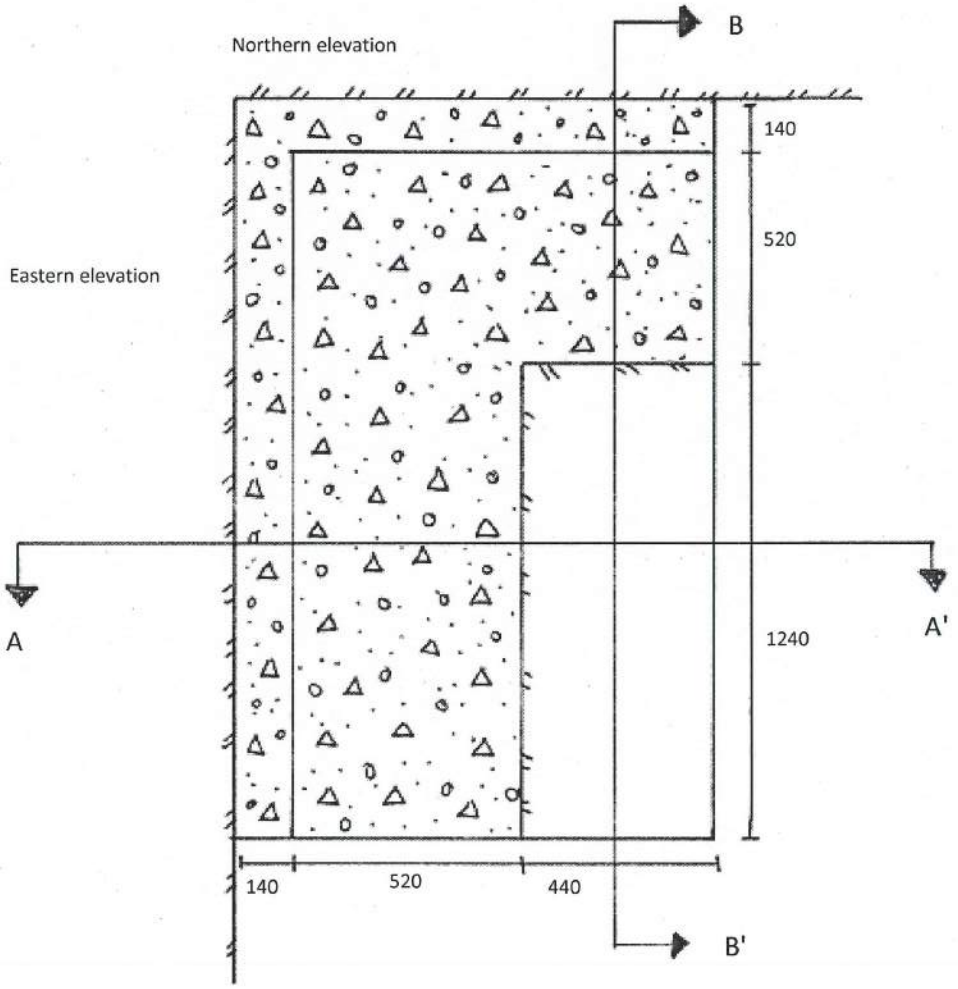
Remarks:	Scale:
All dimensions in millimetres	1:20
Sides of trial pit remained stable during excavation	Logged by:
Groundwater not encountered	HD

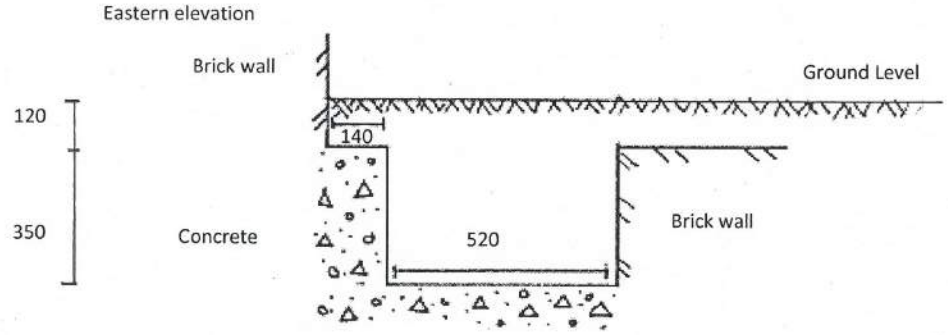
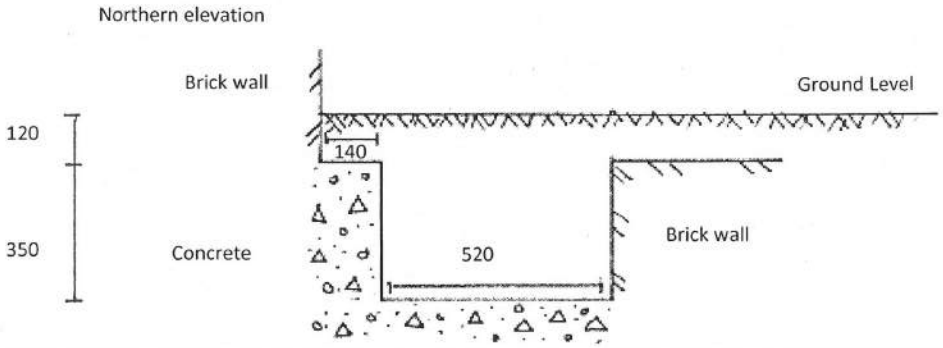
Trial Pit No 5 was terminated at a depth of 0.47 m due to a basement ceiling. It is now known that the existing basement at that location extends outside the footprint of the building structure.

View of the findings encountered in Trial Pit No 5, looking northwest

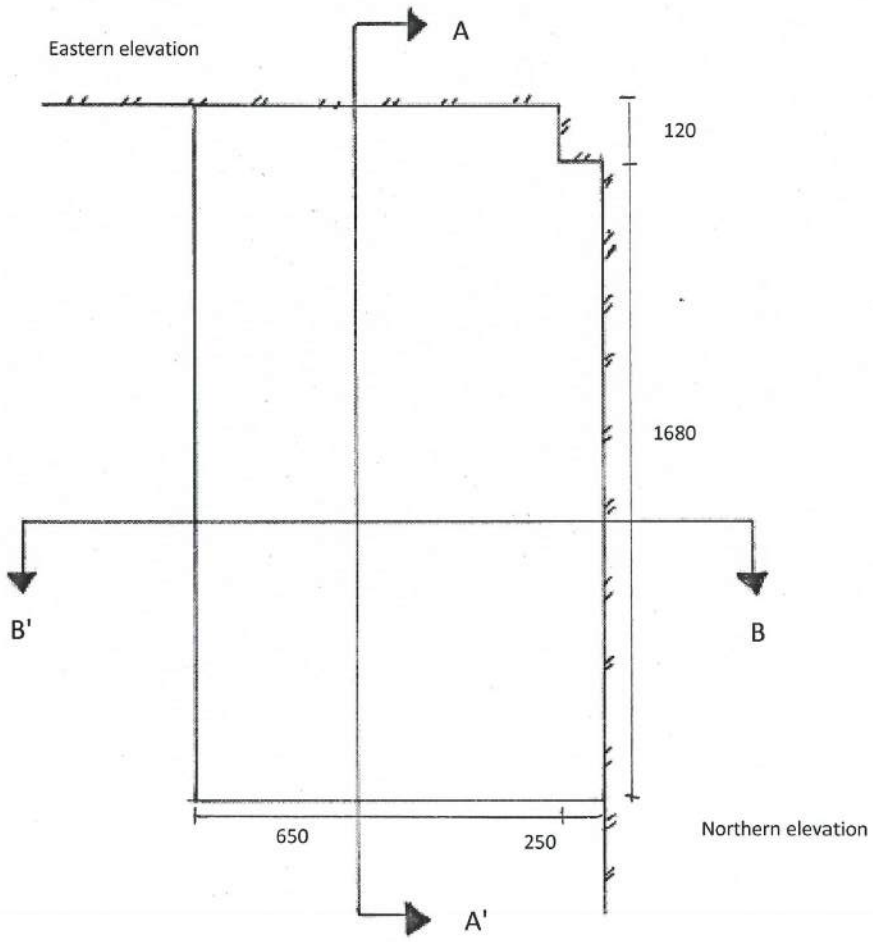
Trial Pit No 6 was excavated to a depth of 0.6 m but due to the loose nature of the fill material at this location it was not possible to continue the pit manually.

Remarks:	Scale:
All dimensions in millimetres	1:20
Sides of trial pit did not remain stable during excavation - not possible to install shoring to continue pit	Logged by:
Groundwater not encountered	HD

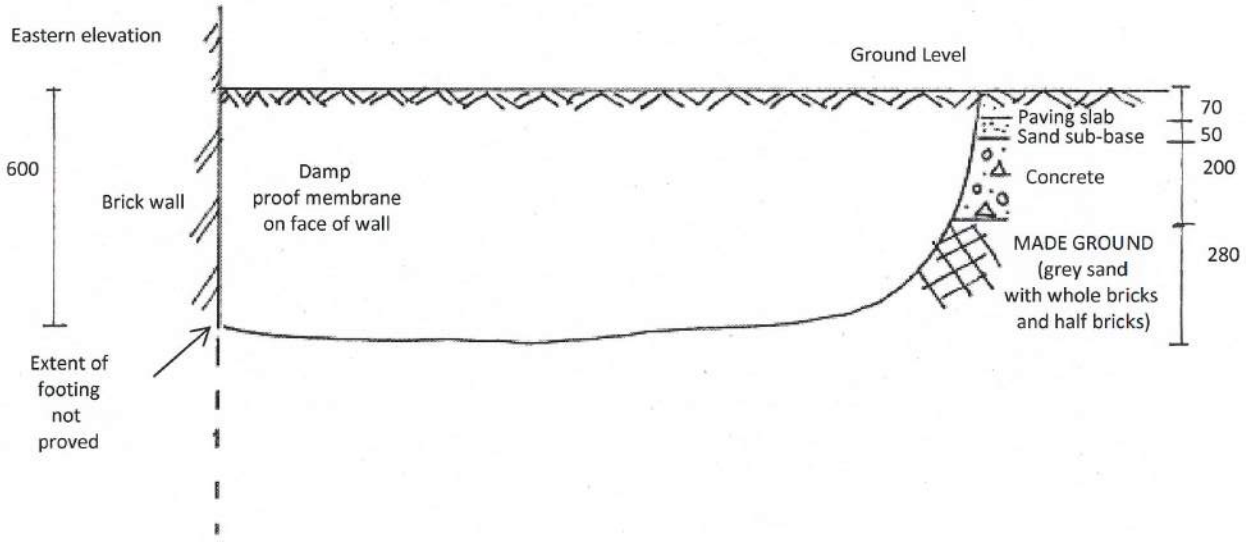
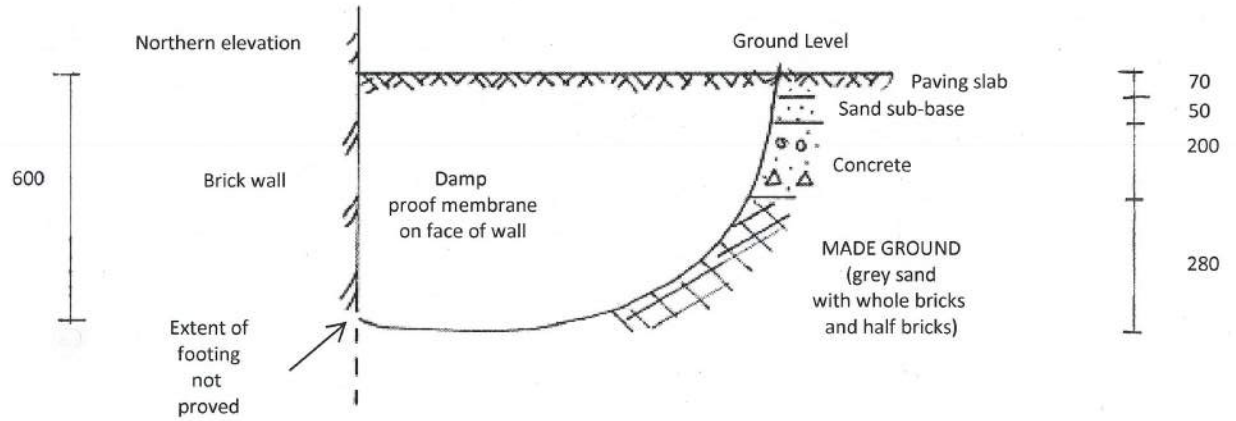
View of the findings encountered in Trial Pit No 6, looking north

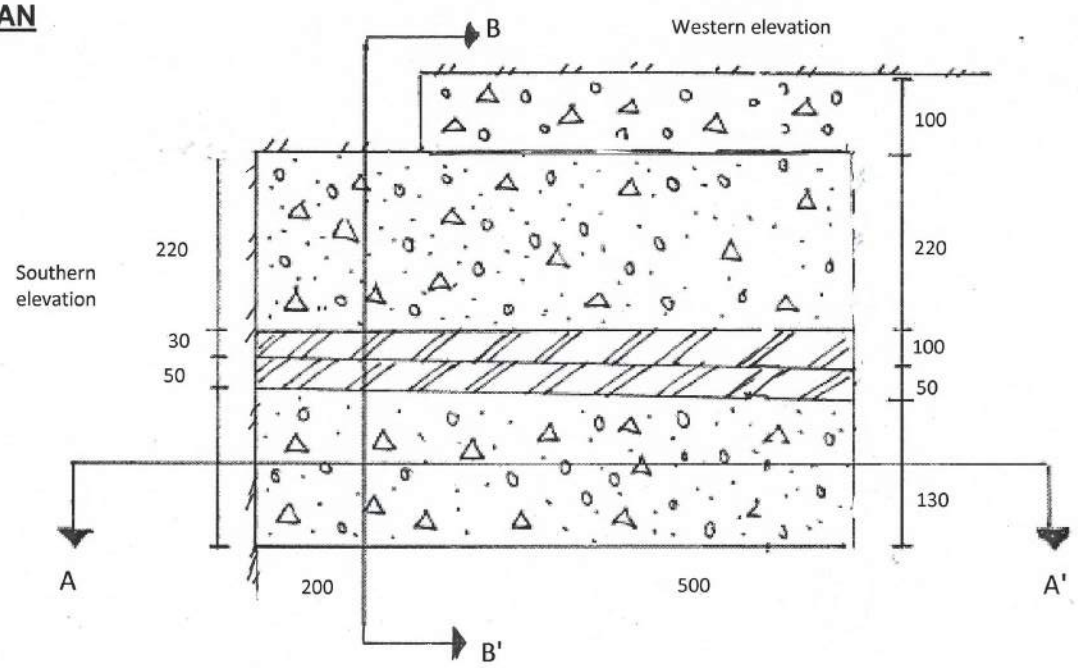
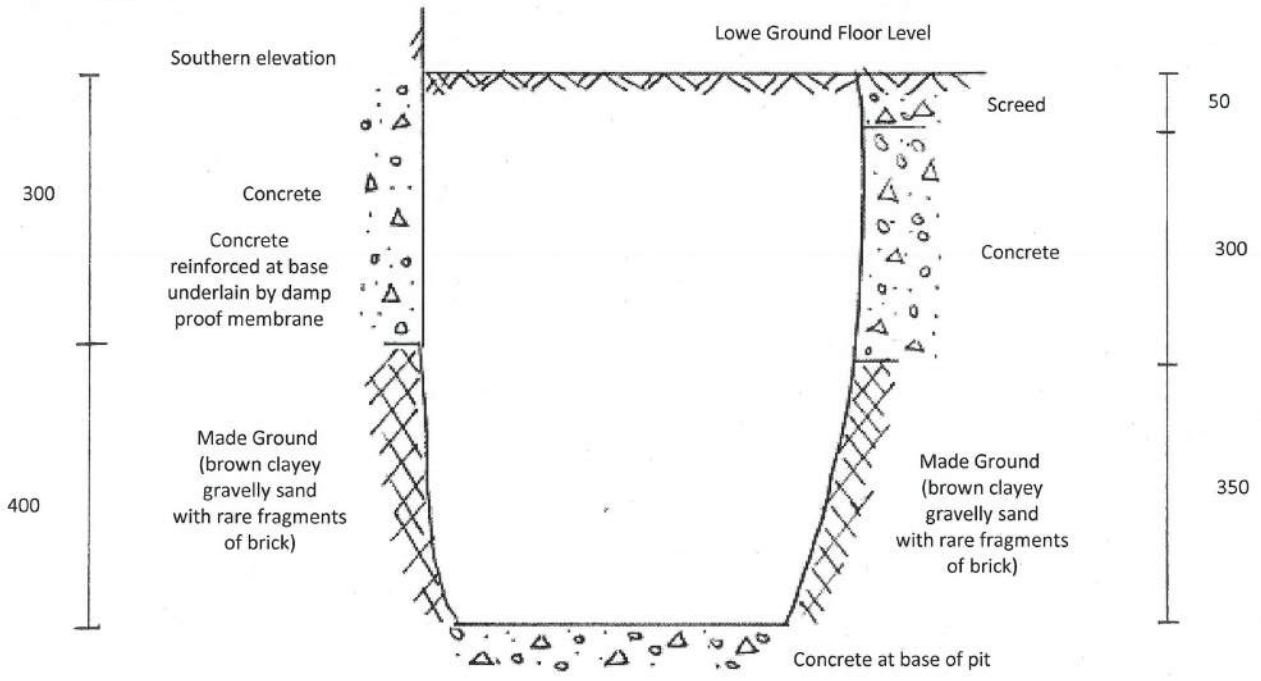
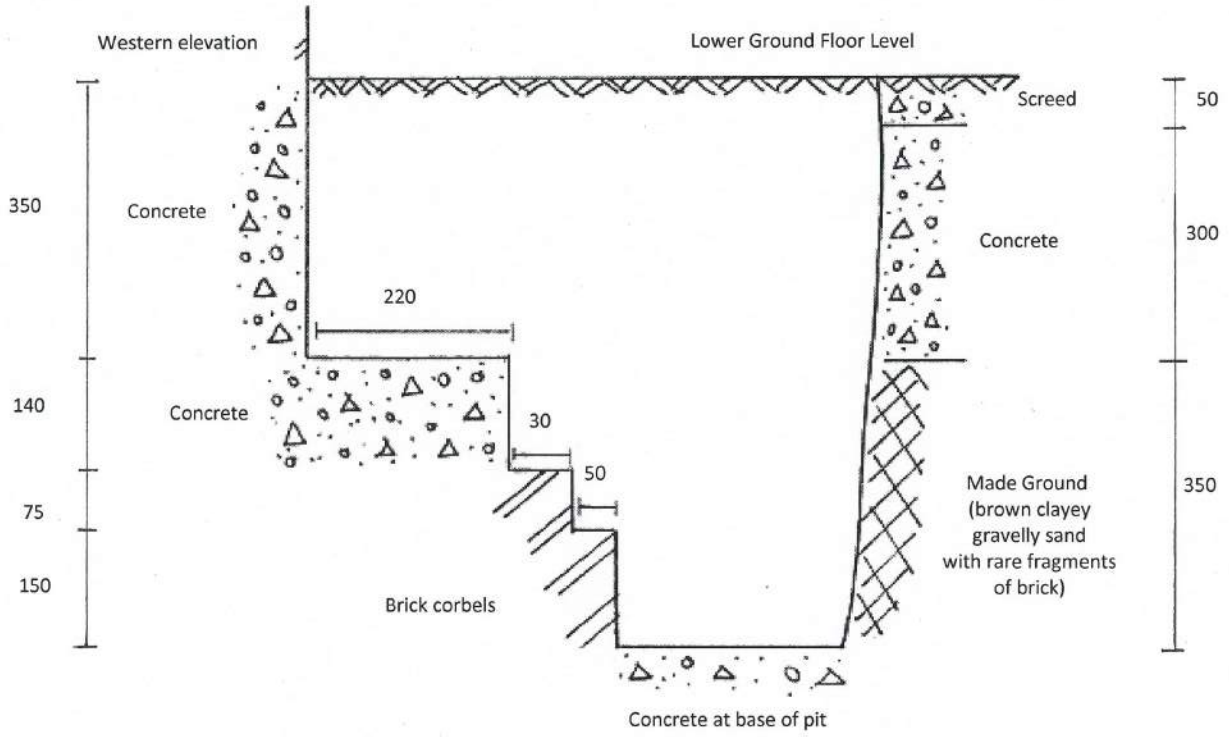
The extent of the footing encountered in Trial Pit No 7 has not been proved due to a layer of concrete at a depth of 0.7 m. Probing with a 'Hilti' drill at two locations within the trial pit indicate the concrete to extend to a depth of a least 1.2 m at which depth there appears to be a metal obstruction. Further investigations in the form of a single core, drilled using a concrete corer was carried out approximately 1.5 m from the southern elevation of No 4 Flitcroft Street. The core was terminated at a depth of 0.75 m due to snagging and it was not possible to continue the core.

Note: Two probes through base of concrete were carried out using a hilti drill and the concrete is at least 500 mm thick, underlain by an obstruction, possibly metal
