Fitzjohn's Avenue, NW3

Ground Investigation Survey and Contaminated Land Assessment

REPORT ON PHASE 2 GROUND INVESTIGATION

Contract: 52247A

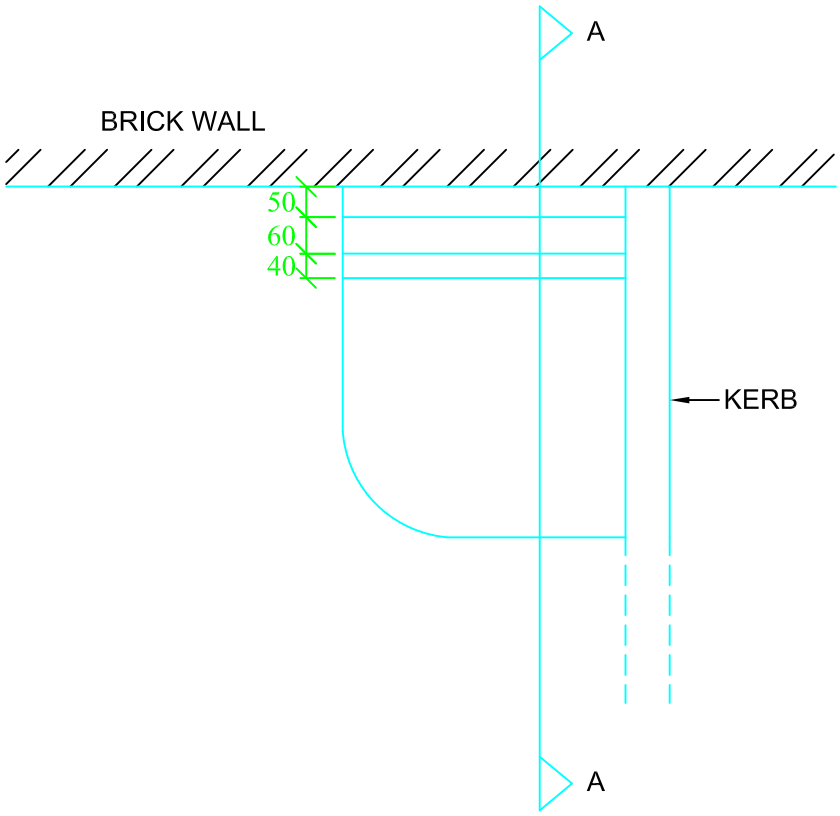
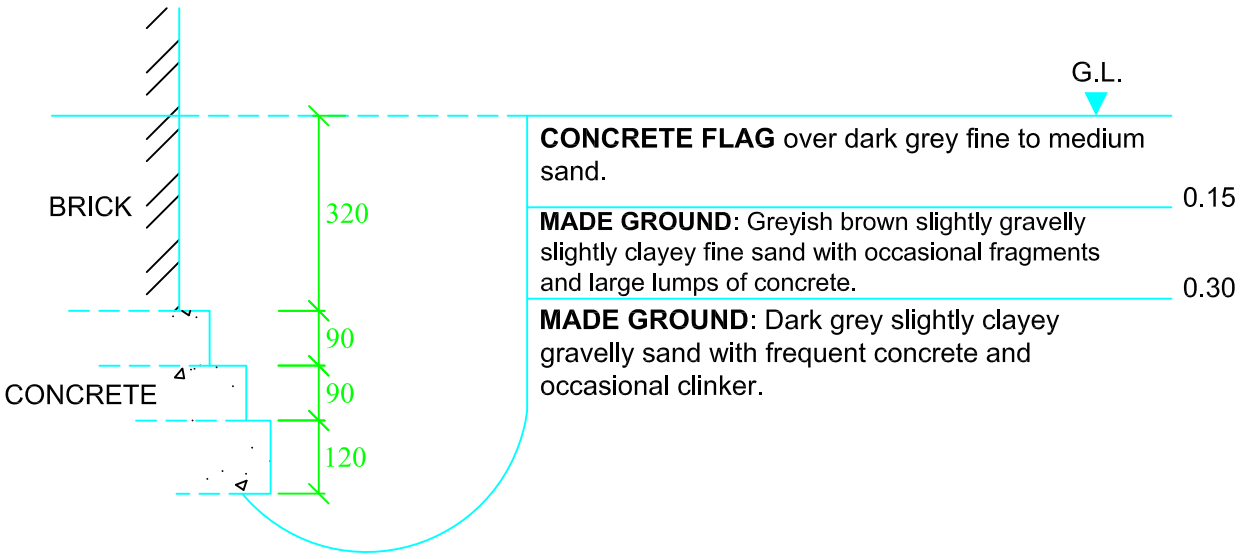
Figure No. A2.5

END OF TRIAL PIT 0.70m

All dimensions in millimetres.
Depths of strata changes in metres.
Groundwater not encountered during excavation.
Date of Sitework 22/08/14.

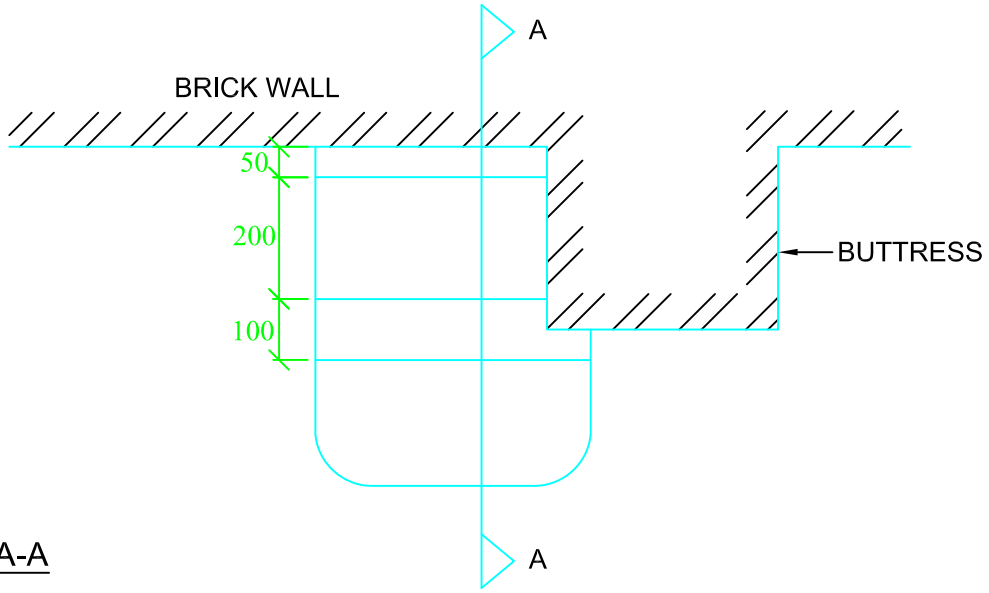
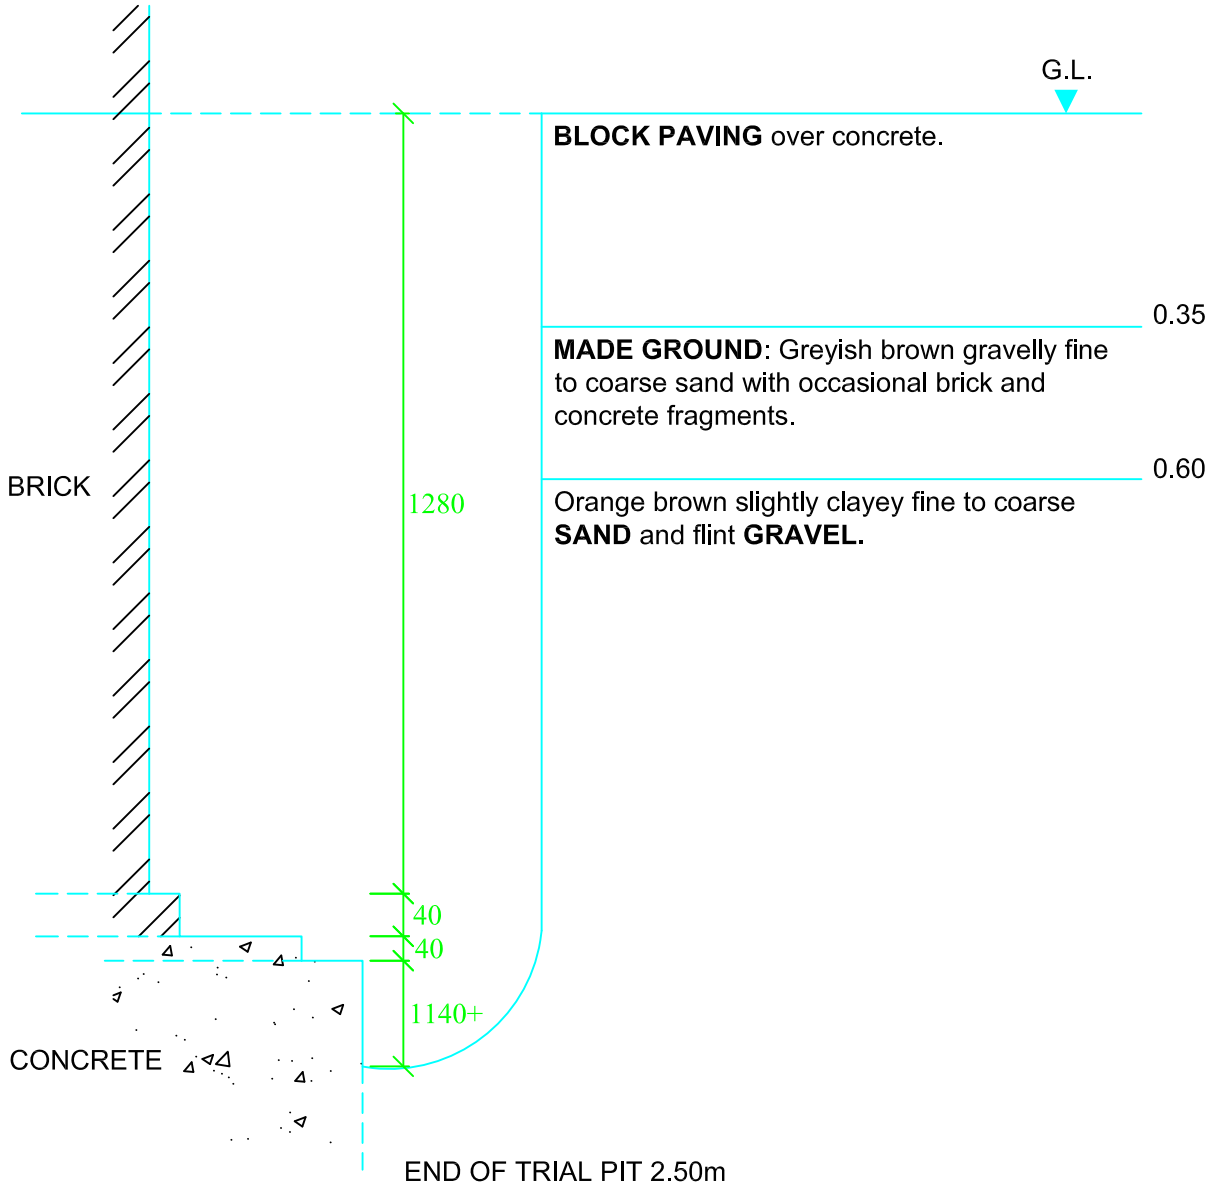
Fig: A2.6

7.1.3 Details of the foundations to the adjacent boundary wall to the site are provided in the trial pit logs given in Appendix 2, Figures A2.6 to A2.8 and trial pit photographs Figures A2.9 to A2.11.

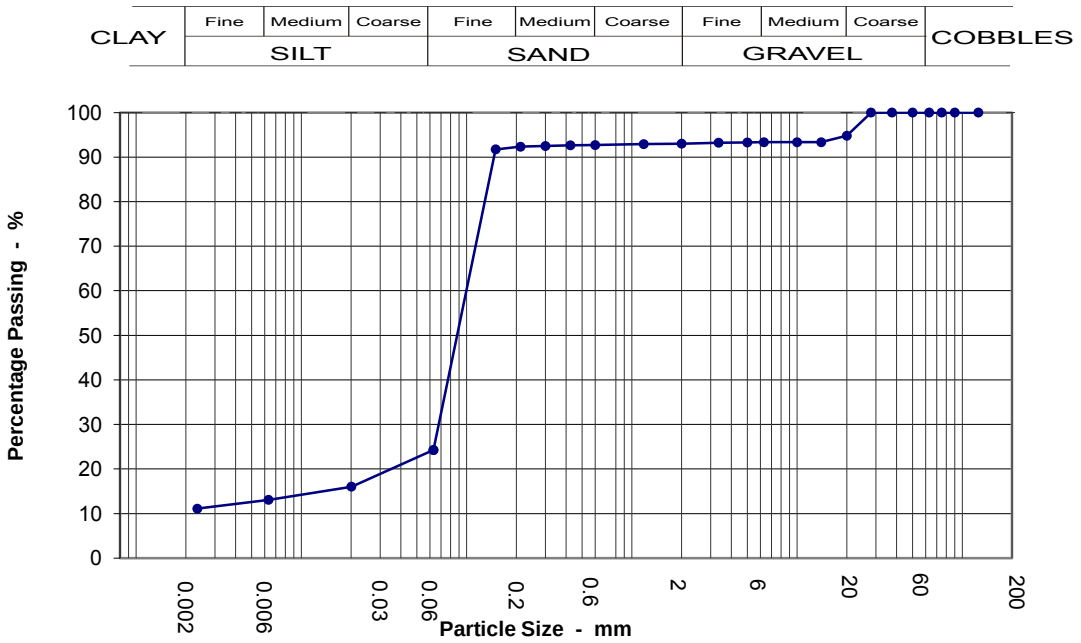
Figure A3.1

K4 SOILS	PARTICLE SIZE DISTRIBUTION BS 1377 : Part 2 : 1990 : Clause 9	Our Report No:	17352
		Project No:	522474A
Location	Fitzjohn's Avenue, Hampstead NW3 6PA	Borehole / Trial Pit No:	BH1
		Depth	2.50 m
Visual Soil Description	Brown gravelly clayey silty fine SAND (gravel is fmc and sub-rounded to rounded)	Sample Type/No	D - 5

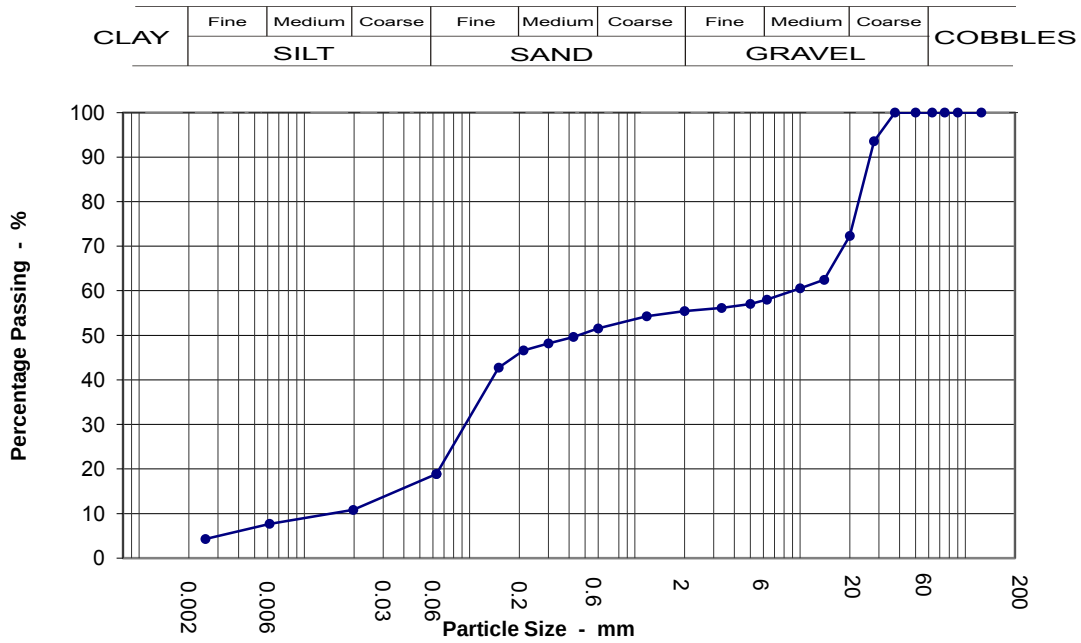
Figure A3.1

K4 SOILS	PARTICLE SIZE DISTRIBUTION BS 1377 : Part 2 : 1990 : Clause 9	Our Report No:	17352
		Project No:	522474A
Location	Fitzjohn's Avenue, Hampstead NW3 6PA	Borehole / Trial Pit No:	BH1
		Depth	4.90 m
Visual Soil Description	Dark greyish brown silty clayey very sandy GRAVEL (gravel is fmc and sub-rounded to rounded)	Sample Type/No	D - 10

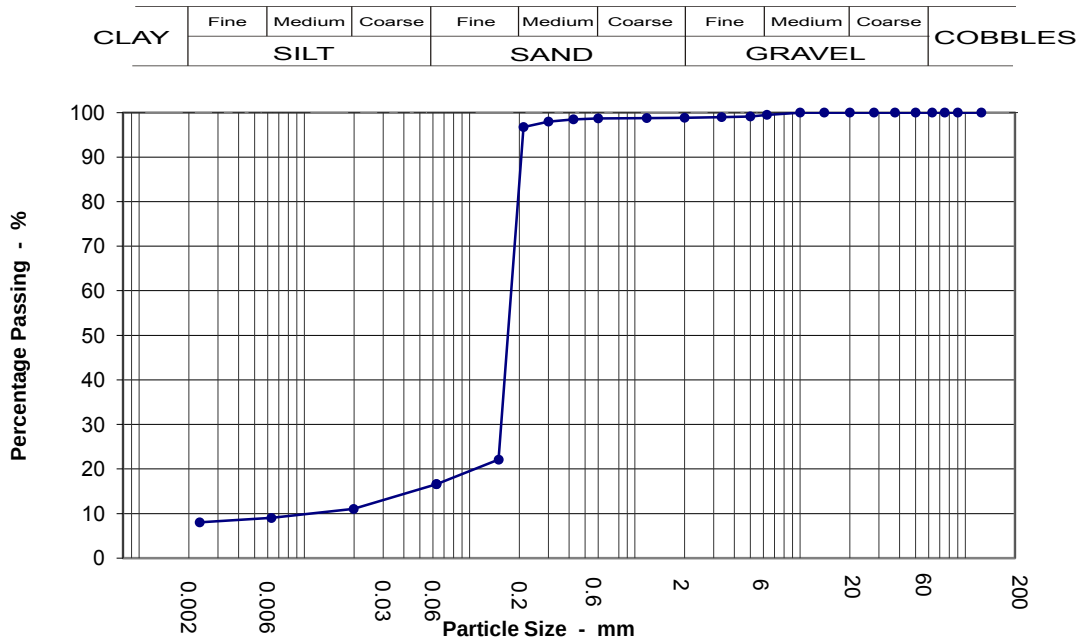
Figure A3.1

K4 SOILS	PARTICLE SIZE DISTRIBUTION BS 1377 : Part 2 : 1990 : Clause 9	Our Report No:	17375
		Project No:	52247a
Location	Arthur West House, 79 Fitzjohn's Avenue, Hampstead NW3 6PA	Borehole / Trial Pit No:	BH2
		Depth	2.00 m
Visual Soil Description	Brown clayey silty SAND with rare fine gravel	Sample Type/No	D - 3

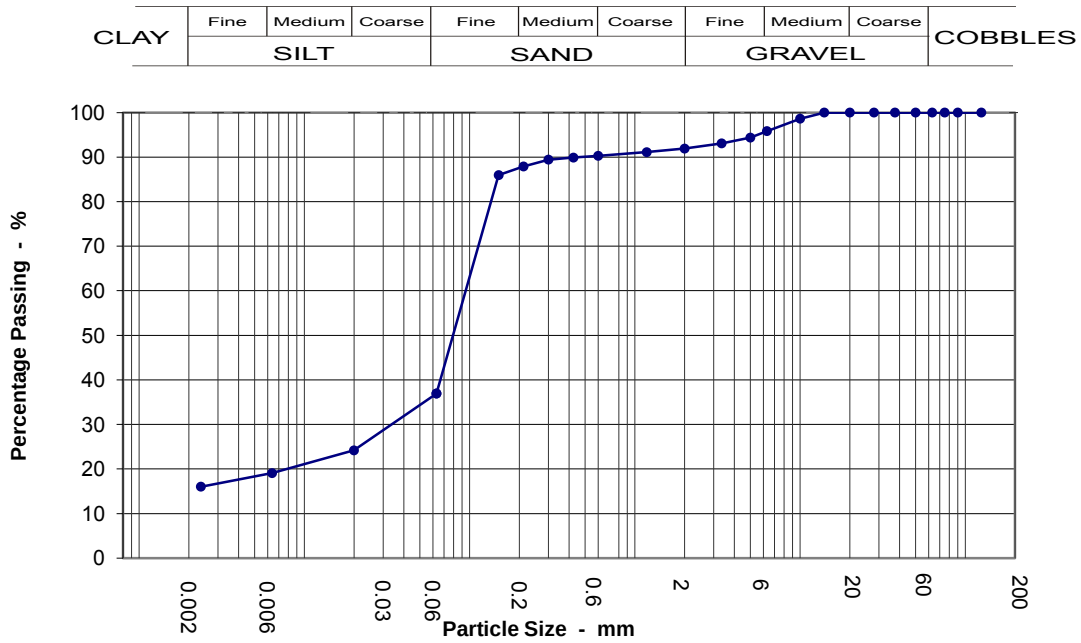
Figure A3.1

K4 SOILS	PARTICLE SIZE DISTRIBUTION BS 1377 : Part 2 : 1990 : Clause 9	Our Report No:	17375
		Project No:	52247a
Location	Arthur West House, 79 Fitzjohn's Avenue, Hampstead NW3 6PA	Borehole / Trial Pit No:	BH2
		Depth	5.00 m
Visual Soil Description	Brown and occasional grey and reddish brown sandy silty CLAY with occasional fm mudstone fragments	Sample Type/No	D - 6

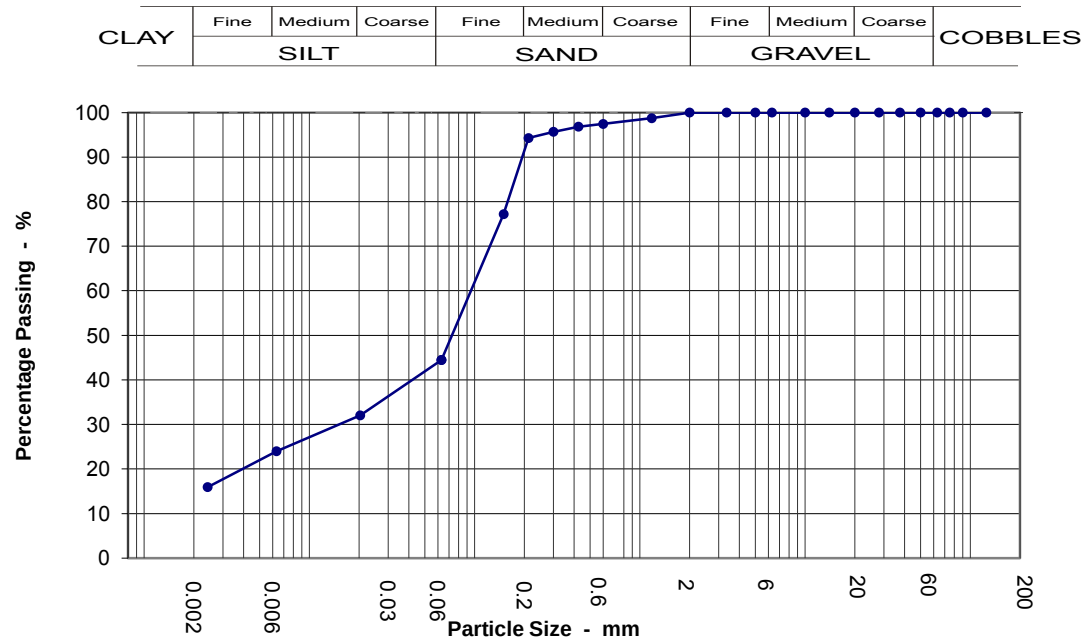
Figure A3.1

K4 SOILS	PARTICLE SIZE DISTRIBUTION BS 1377 : Part 2 : 1990 : Clause 9	Our Report No:	17375
		Project No:	52247a
Location	Arthur West House, 79 Fitzjohn's Avenue, Hampstead NW3 6PA	Borehole / Trial Pit No:	BH2
		Depth	15.50 m
Visual Soil Description	Grey sandy silty CLAY	Sample Type/No	D - 20

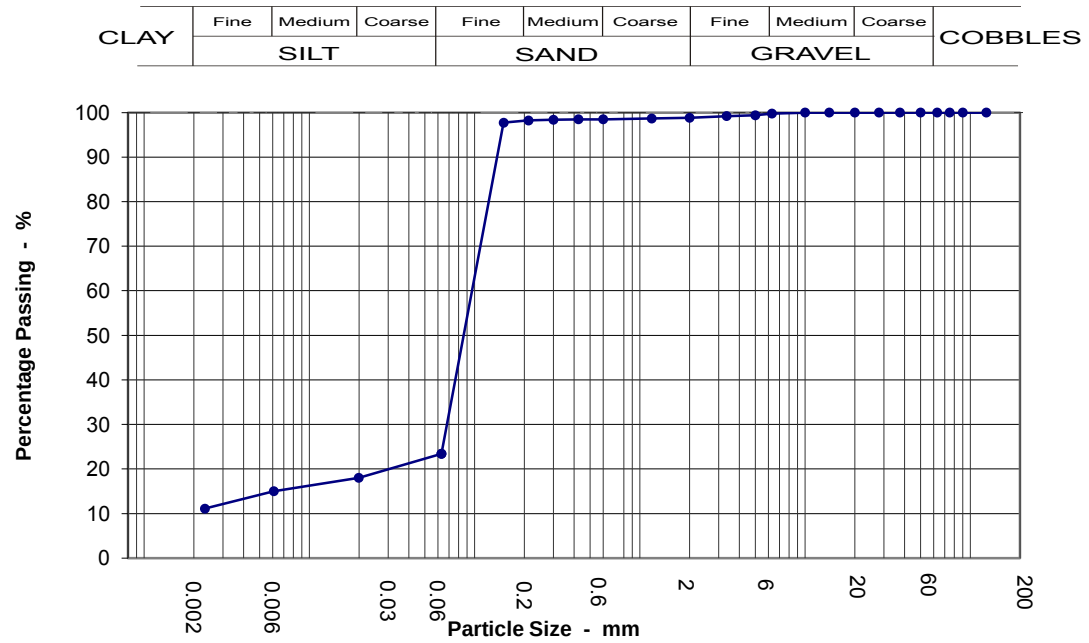
Figure A3.1

K4 SOILS	PARTICLE SIZE DISTRIBUTION BS 1377 : Part 2 : 1990 : Clause 9	Our Report No:	17352
		Project No:	522474A
Location	Fitzjohn's Avenue, Hampstead NW3 6PA	Borehole / Trial Pit No:	BH3
		Depth	6.50 m
Visual Soil Description	Orange brown and occasional grey slightly gravelly silty clayey SAND (gravel is fine and angular)	Sample Type/No	D - 10

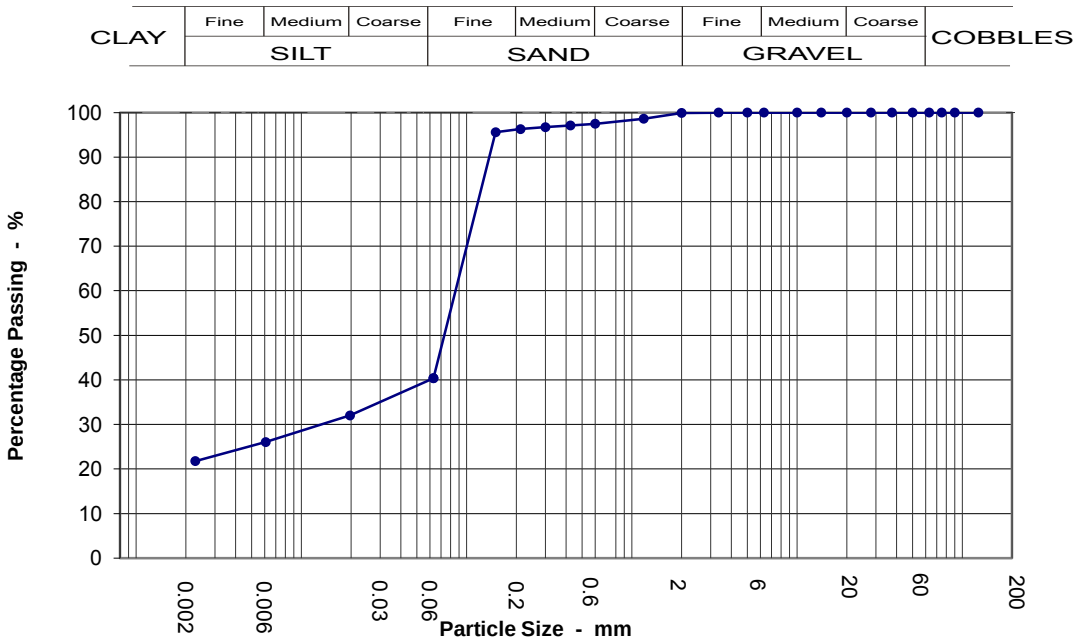
Figure A3.1

K4 SOILS	PARTICLE SIZE DISTRIBUTION BS 1377 : Part 2 : 1990 : Clause 9	Our Report No:	17352
		Project No:	522474A
Location	Fitzjohn's Avenue, Hampstead NW3 6PA	Borehole / Trial Pit No:	BH4
		Depth	6.20 m
Visual Soil Description	Greyish brown and occasional orange brown sandy silty CLAY	Sample Type/No	D - 14

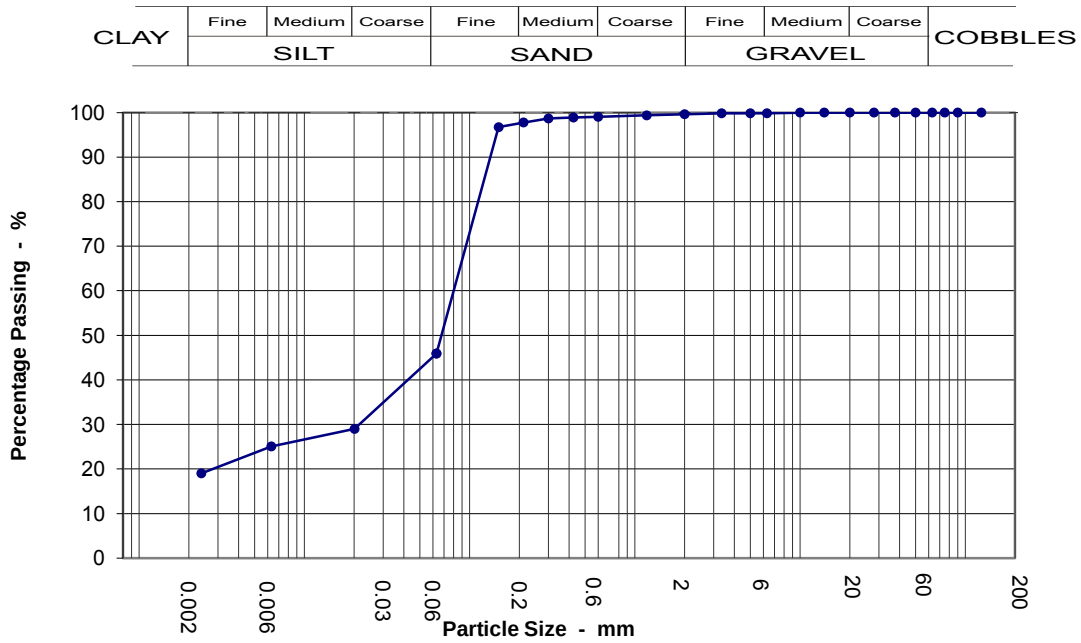
Figure A3.1

K4 SOILS	PARTICLE SIZE DISTRIBUTION BS 1377 : Part 2 : 1990 : Clause 9	Our Report No:	17352
		Project No:	522474A
Location	Fitzjohn's Avenue, Hampstead NW3 6PA	Borehole / Trial Pit No:	BH4
		Depth	7.50 m
Visual Soil Description	Pale grey, pale brown and occasional orange brown fine sandy silty CLAY	Sample Type/No	D - 16

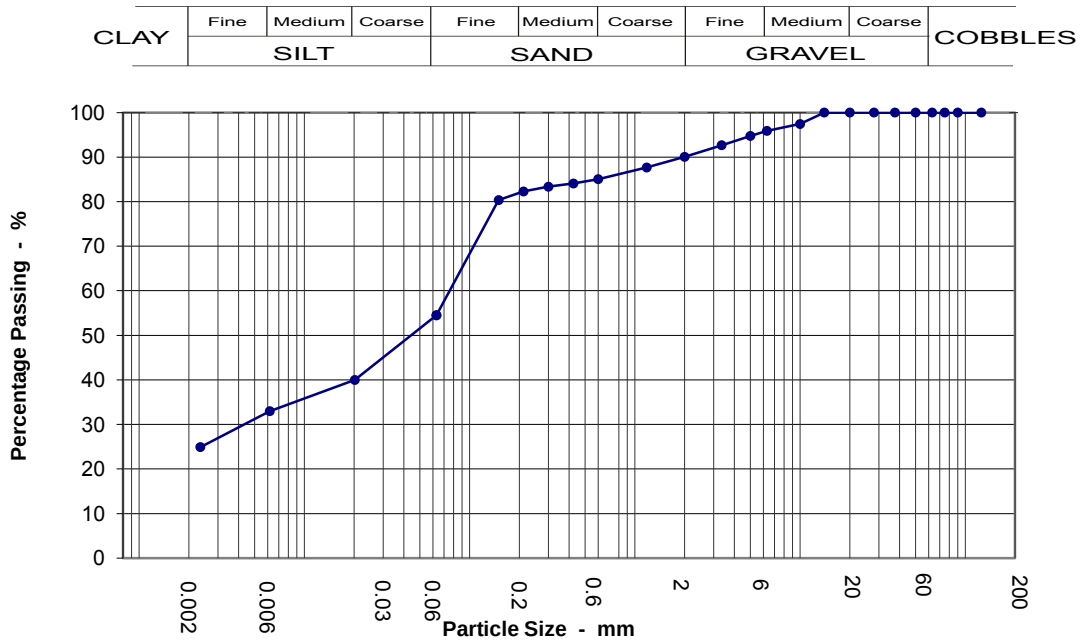
Figure A3.1

K4 SOILS	PARTICLE SIZE DISTRIBUTION BS 1377 : Part 2 : 1990 : Clause 9	Our Report No:	17352
		Project No:	522474A
Location	Fitzjohn's Avenue, Hampstead NW3 6PA	Borehole / Trial Pit No:	BH4
		Depth	10.00 m
Visual Soil Description	Orange brown and grey sandy silty CLAY with occasional fm mudstone fragments	Sample Type/No	D - 20

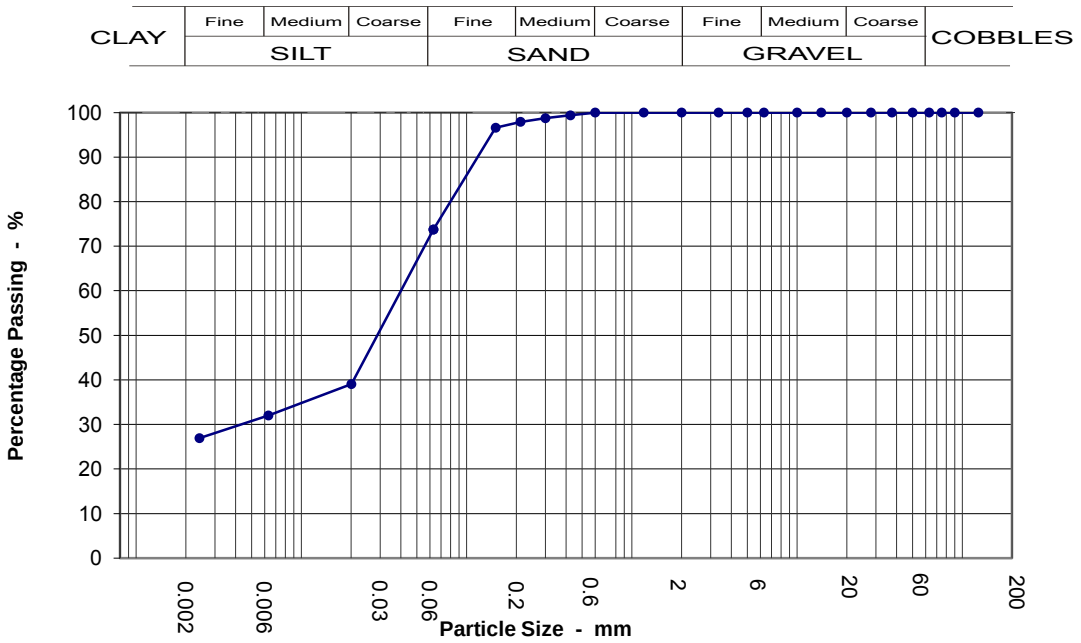
Figure A3.1

K4 SOILS	PARTICLE SIZE DISTRIBUTION BS 1377 : Part 2 : 1990 : Clause 9	Our Report No:	17352
		Project No:	522474A
Location	Fitzjohn's Avenue, Hampstead NW3 6PA	Borehole / Trial Pit No:	BH5
		Depth	3.00 m
Visual Soil Description	Pale brown and pale grey slightly sandy silty CLAY	Sample Type/No	D - 6

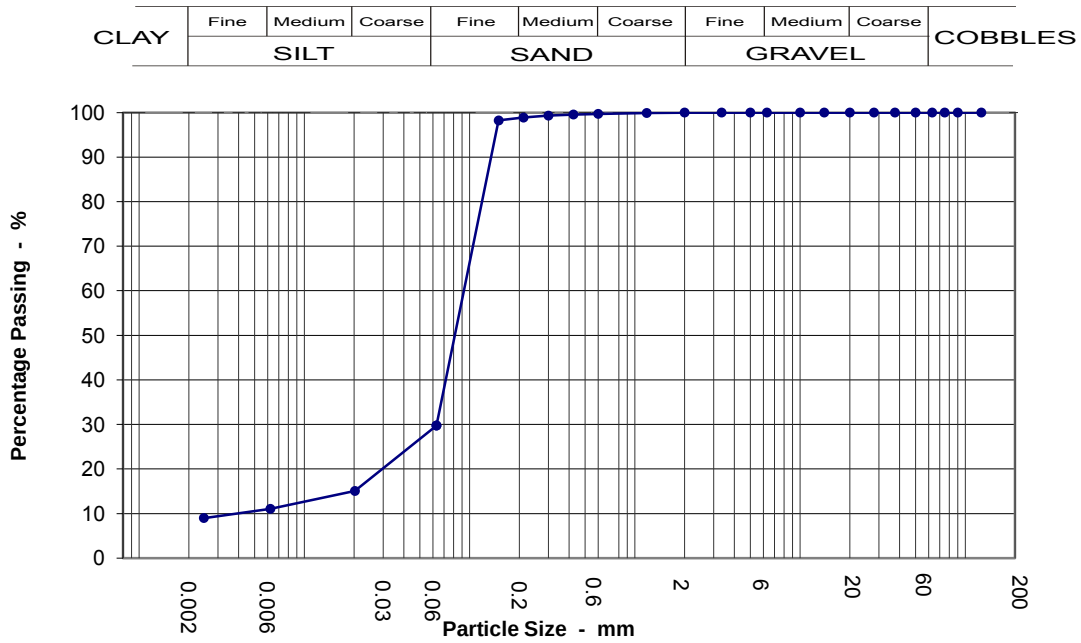
Figure A3.1

K4 SOILS	PARTICLE SIZE DISTRIBUTION BS 1377 : Part 2 : 1990 : Clause 9	Our Report No:	17352
		Project No:	522474A
Location	Fitzjohn's Avenue, Hampstead NW3 6PA	Borehole / Trial Pit No:	BH5
		Depth	8.00 m
Visual Soil Description	Greyish brown clayey silty SAND	Sample Type/No	D - 14

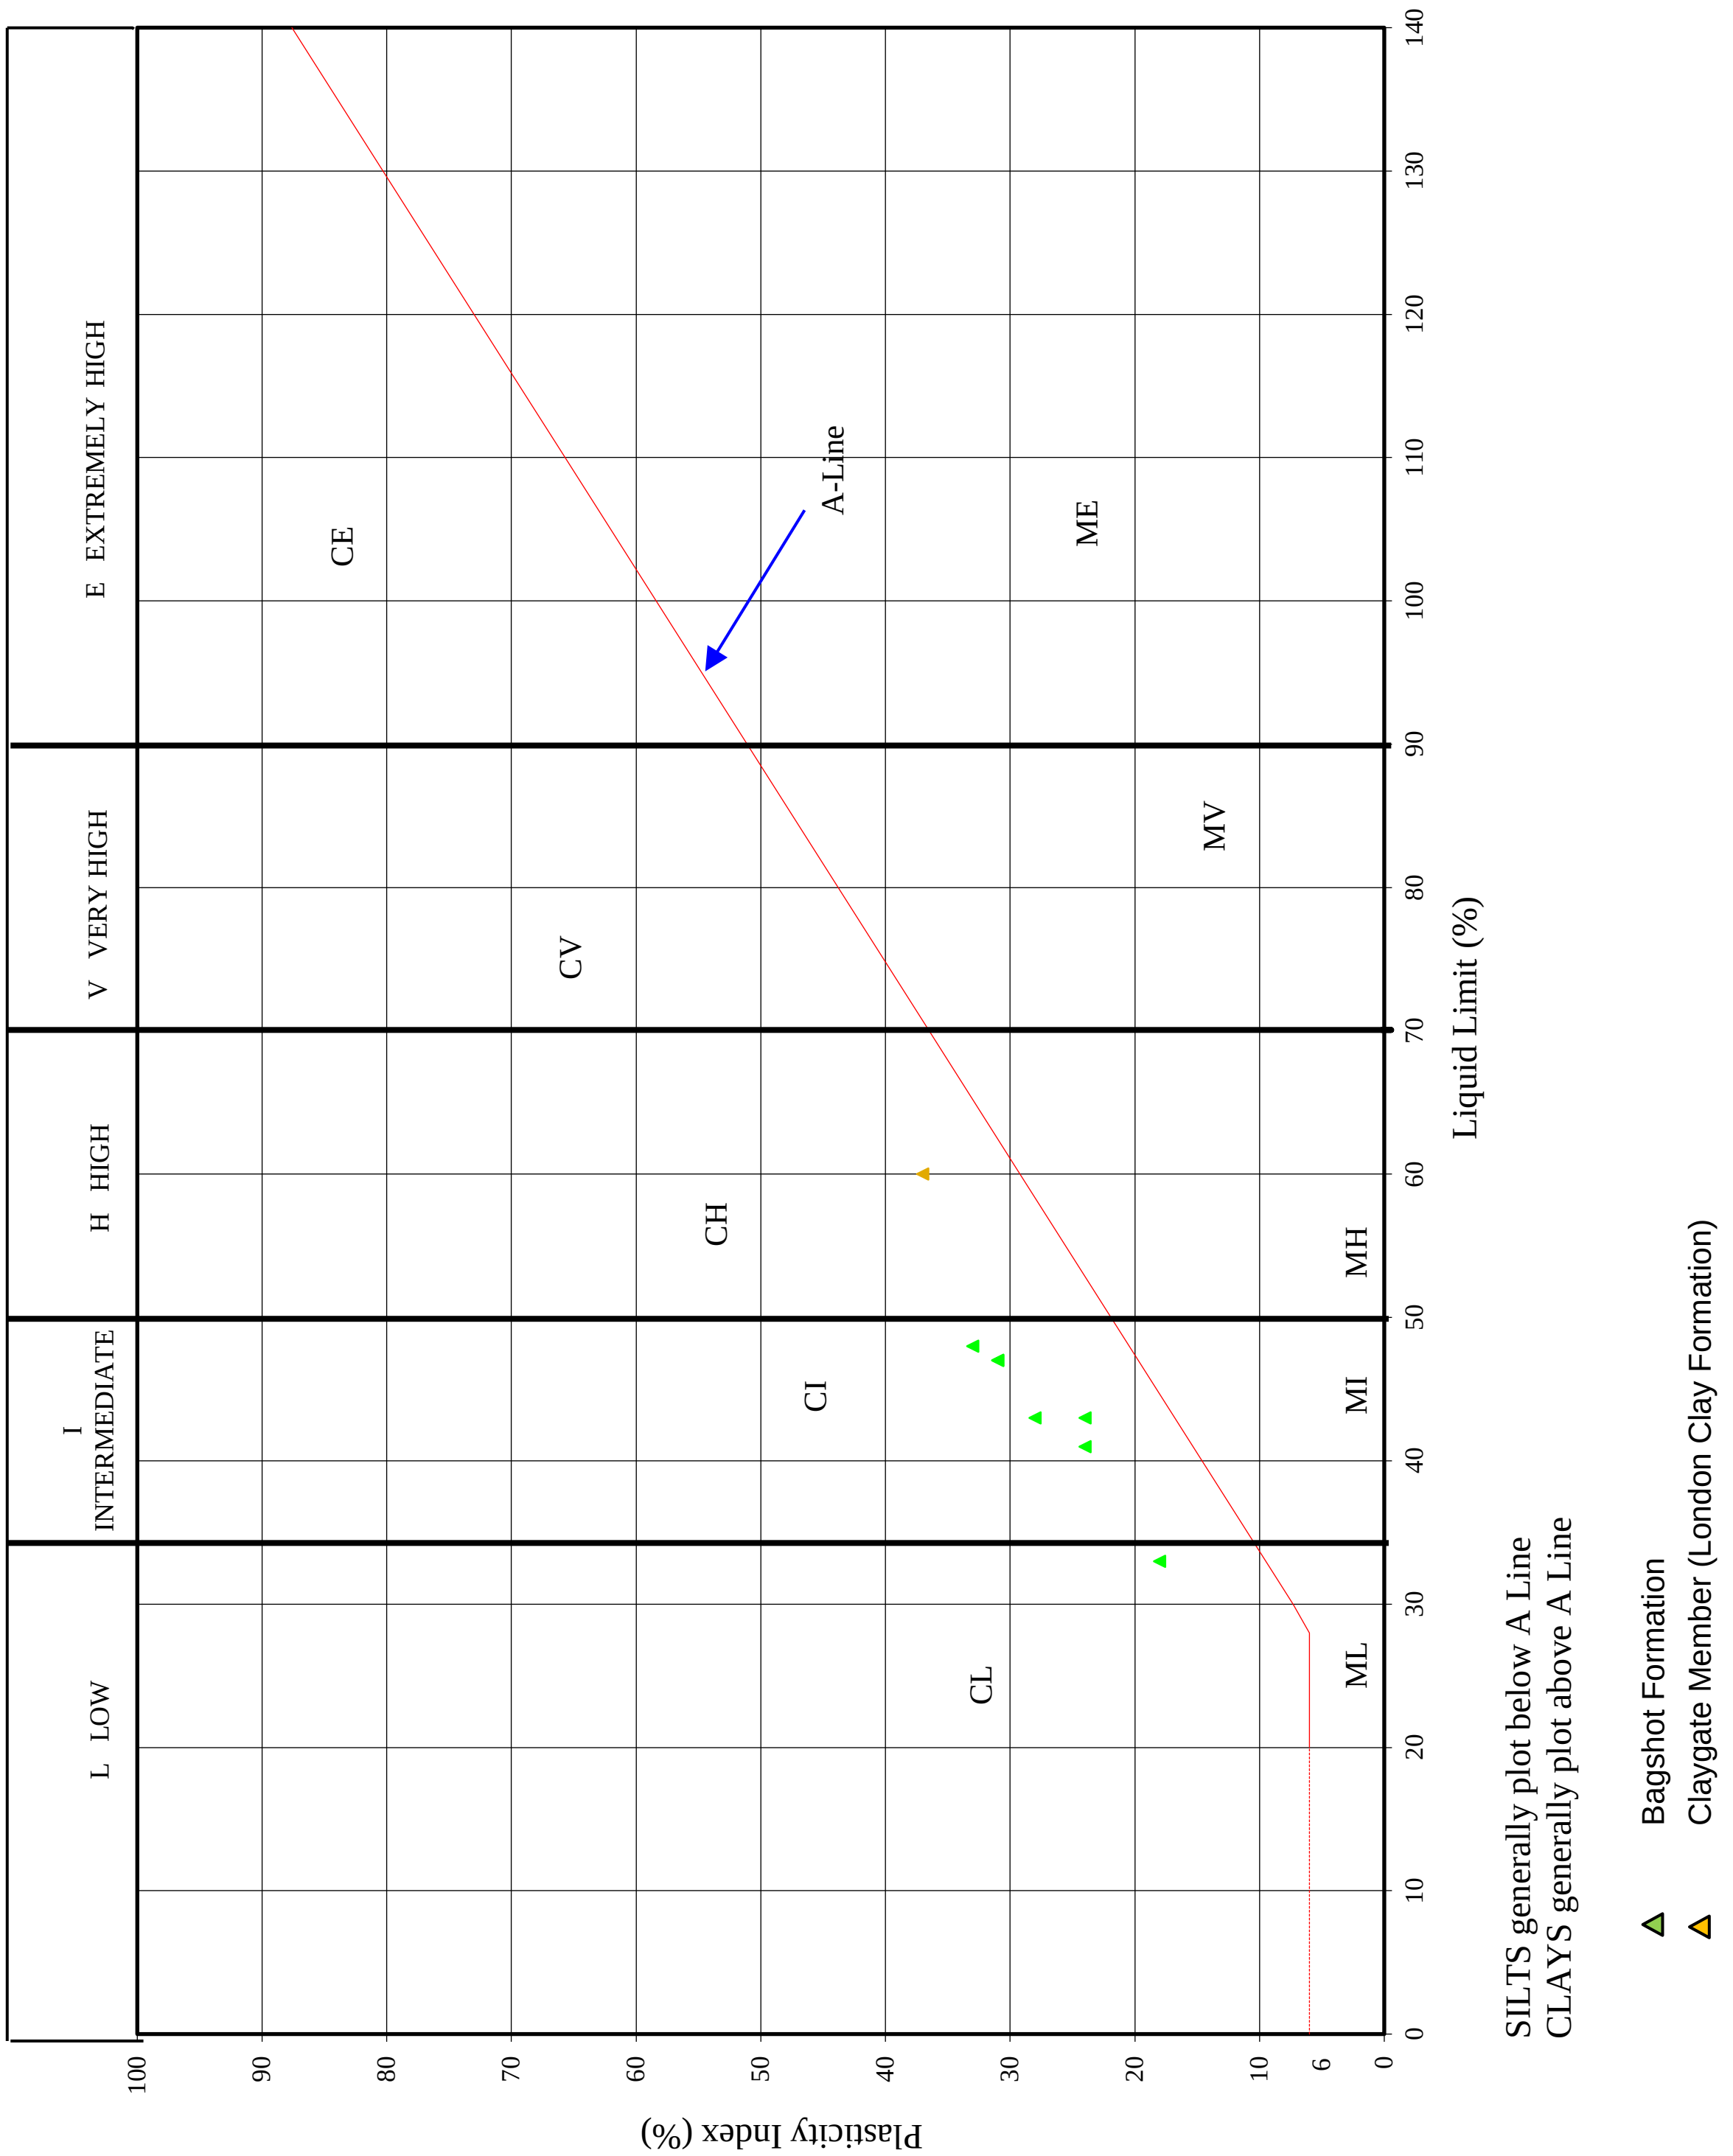
IAN FARMER ASSOCIATES Geotechnical & Environmental Specialists	**PLASTICITY CLASSIFICATION CHART**	Job no. 52247A
	Fitzjohn's Avenue, Hampstead, NW3 6PA	Fig no. A3.3

7.5.2 Laboratory testing for the clay beds recorded natural moisture contents of between 11% and 25%, with an average of 19% and plasticity indices of between 18% and 33%, with an average of 27%. The plastic index test results are presented on the plasticity classification chart, Appendix 3, Figure A3.3.

7.7.2 Laboratory testing undertaken on one sample of the clay recorded a natural moisture content of 25% with a plasticity index of 37%. The plastic index test result is presented on the plasticity classification chart, Appendix 3, Figure A3.3.
