SOUTH ELEVATION

REPORT

ST. STEPHEN'S CHURCH
ROSSLYN HILL, NW3
CHURCH EXTERNAL
SOUTH ELEVATION

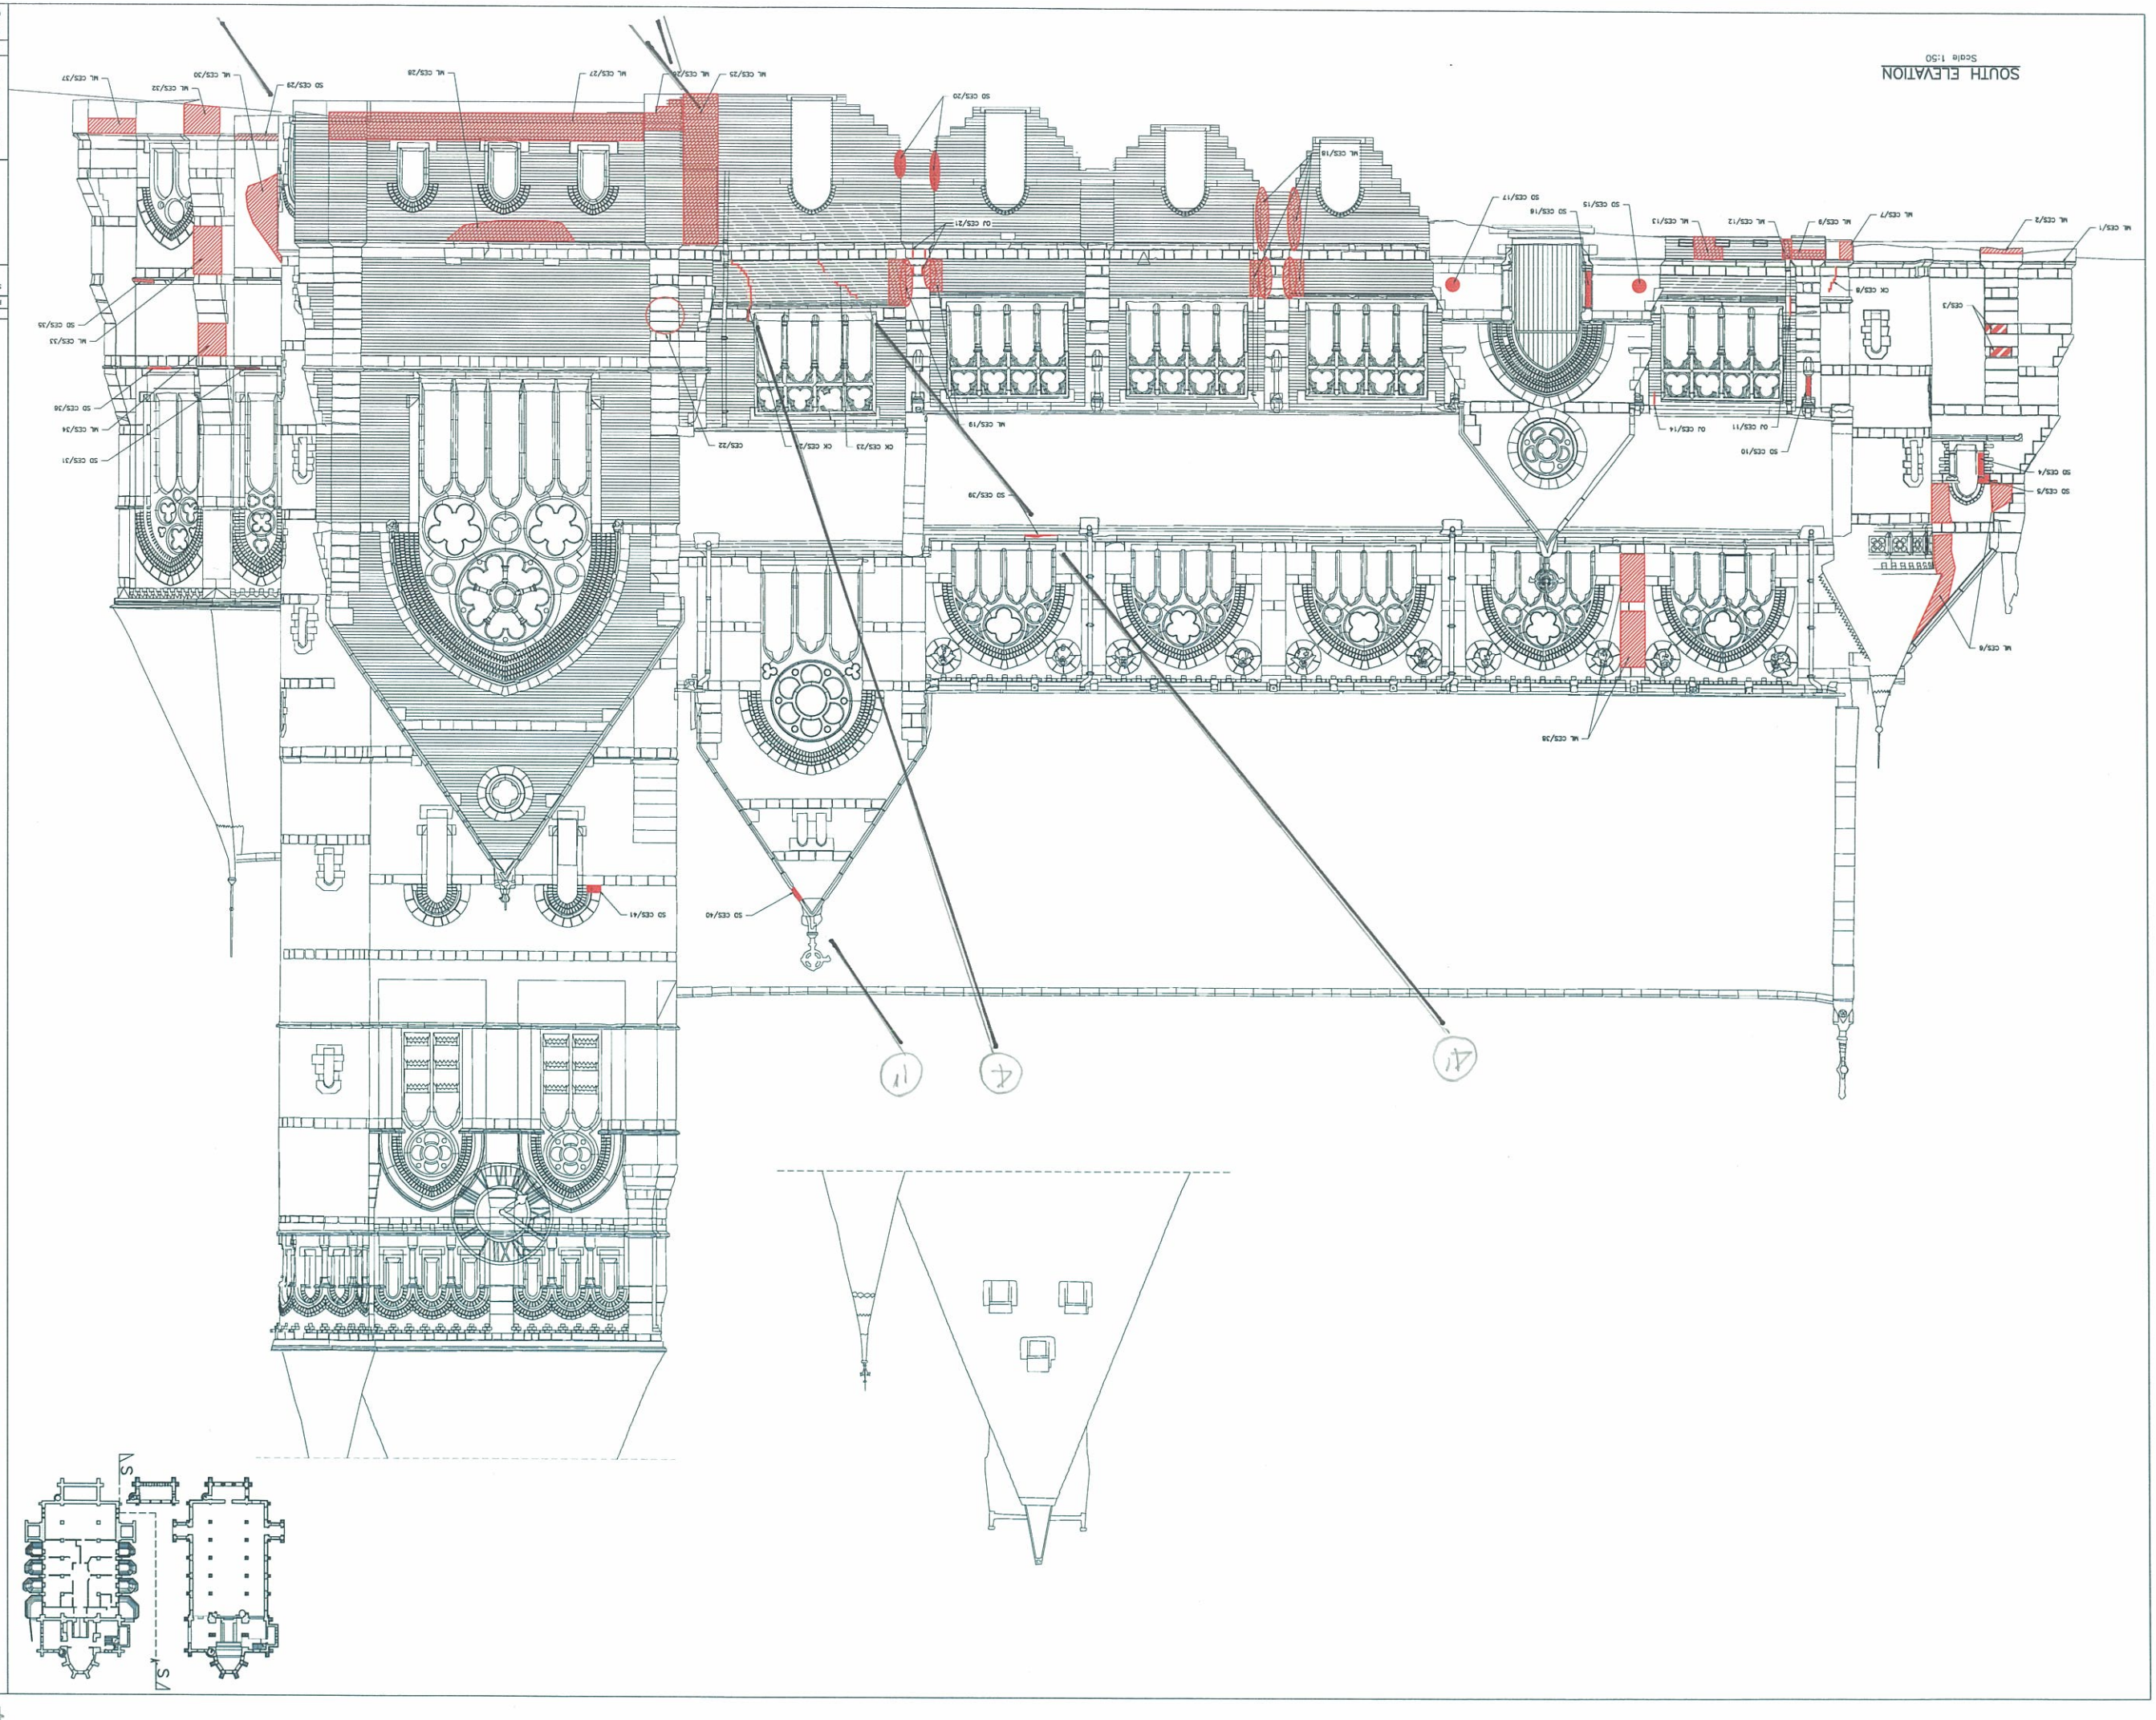
1. All structural engineering drawings are to be read in conjunction with the photographic report and related descriptive document.
2. This drawing and related documents reports structural defects found. Refer to Hyde Johns & Company's drawings/documents for additional information on surface/fixing decay.
3. Do not scale from this drawing in either paper or digital form. Use written dimensions only. To check drawing has been printed to intended scale this bar should be 50mm long:
