SITE INVESTIGATION
FACTUAL REPORT

Report No:	410301
Client:	Crawford Claims Management
Site:	38 Steele's Road, , Hampstead,
Client Ref:	SU1605138-Society of Inner Light
Date of Visit:	10/04/17

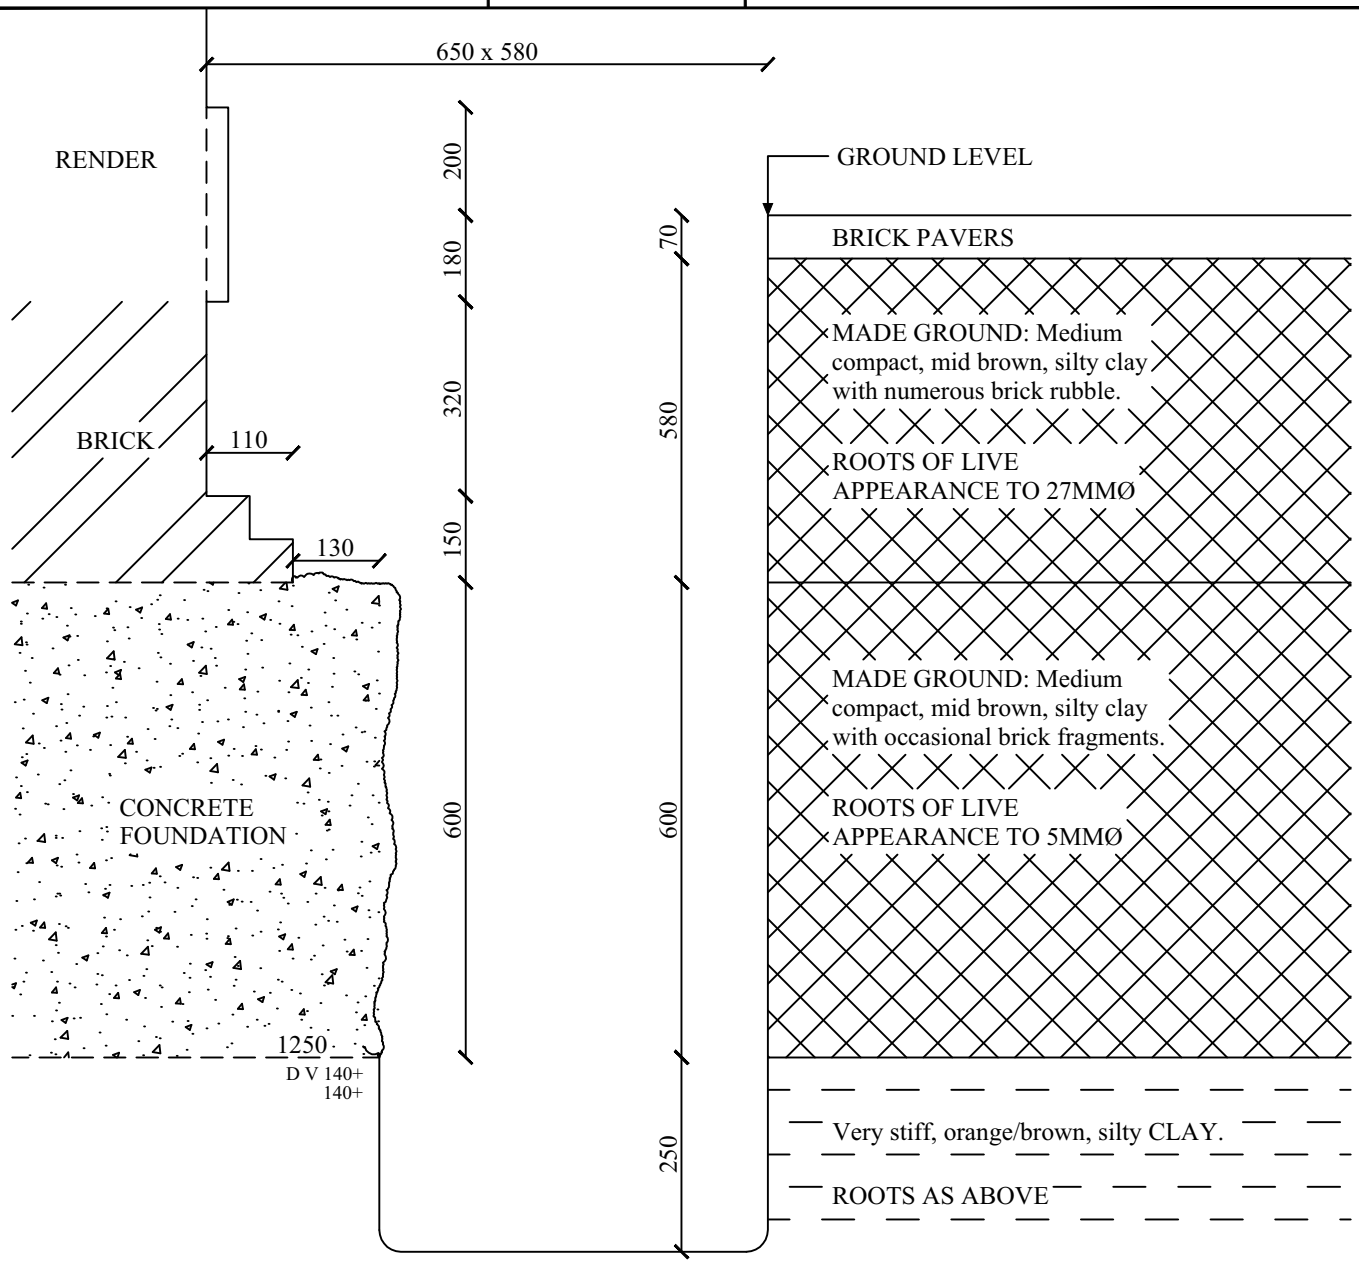
Trial Pit No: 1

FOR STRATA BELOW 1500mm SEE BH LOG 1

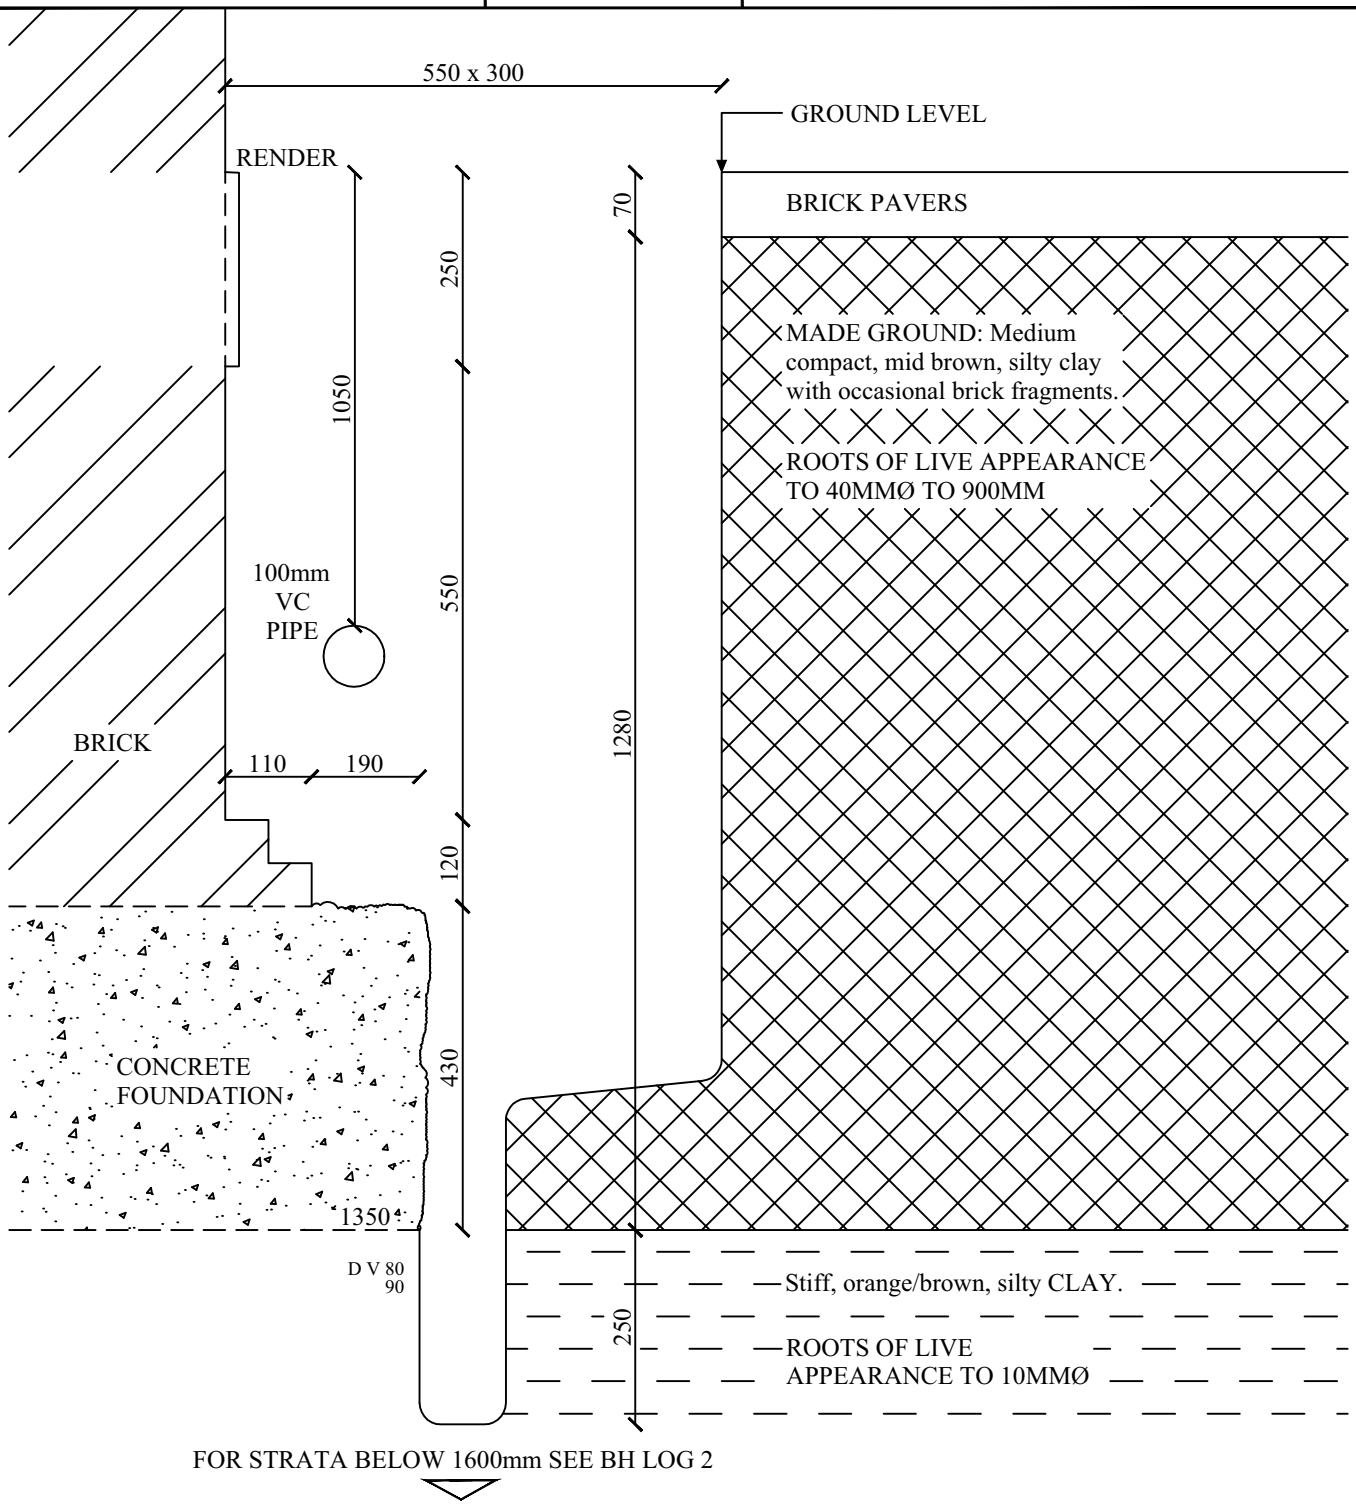
Trial Pit No: 2

FOR STRATA BELOW 1600mm SEE BH LOG 2
