Project
55 Gower Street
London

Title
Timber Notch Repairs

Drawing No
BB137 - 2017 - DT02

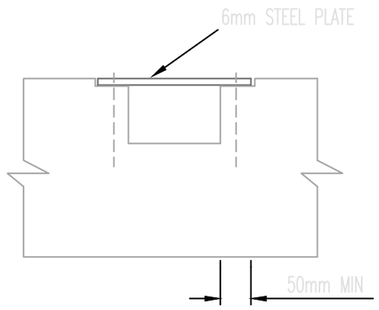
NOTCH REPAIR DETAIL 1

FOR NOTCHES UPTO 25mm DEEP AND OVER SERVICES

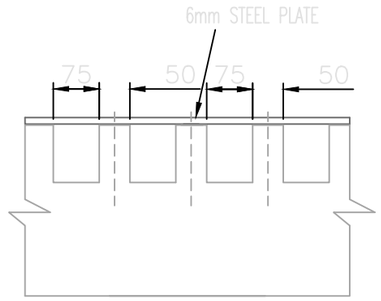
MULTI-NOTCH DETAIL 2

FOR NOTCHES UPTO 25mm DEEP AND OVER SERVICES
