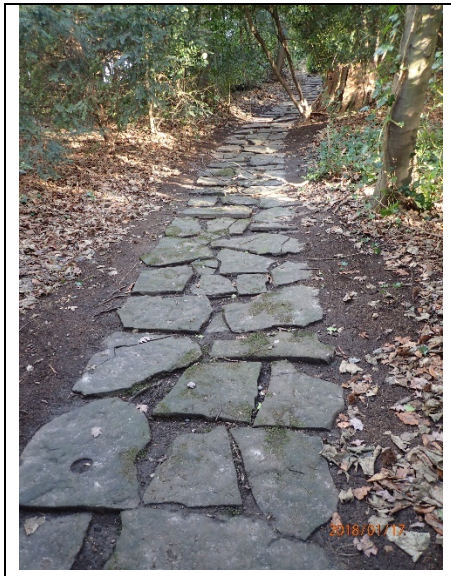
11.	**Woodland paths**	Condition and restoration works
	The woodland paths are located in the wood to the north of the garden and form a pathway through the woods (generally downhill) towards the pond. The paths are formed in sandstone flags of irregular shape and are carefully laid in the soil. In places the soil has been washed away by water running down the path, leading to the stones becoming dislodged. In other places steps have become unsafe, and saplings have sprouted up in the middle of the path. The paths have a good appearance and interesting qualities such as the very pleasing division of the path where one leads to the sunken garden. There is also a short retaining wall here constructed in brick burr and tufa which will be retained and consolidated if necessary. There is clear evidence that some of the stone flags have been re-used and performed other functions prior to their use here; this is most clearly evidenced by the circular stone toward the west end of the path towards the pond. The erosion of the earth forming the joints between the flags may be due partially to the lack of vegetation growing in the joints. It may be possible to establish a suitable low growing plant to colonise such areas to help stabilise the path fabric. Water will be discouraged from flowing directly down the path if possible, by “side shooting” it in appropriate places and allowing it to drain by other routes. Some areas will need to be rebuilt or re-instated in matching materials and style. Cleaning will be relatively pointless because algal	Localised repairs and the rebuilding of lost areas will be trialled initially, so that a method can be established. • Trial bedding of the stones onto a ‘soft’ mortar bed (a possible mortar bed may be made of 1NHL 3.5 lime to 5-6 parts of aggregate of which at least 50% may be limestone dust, or alternatively blends of hot mixed cl90 lime mortar and hydraulic lime mortars may also be appropriate and may provide more bonding adhesion). Such mortar beds will probably be 100-150 mm deep and may include some broken brick rubble in the base. • Where re-bedding flag stones is trialled, it is important to keep the dominant visual jointing material as earth. • Trial growing low level plants in-between the paving slabs to help stabilise the earth joints and reduce erosion of the earth around the slabs. • Find means to encourage the flow away of rain water from the path.

growth will quickly re-establish. However, no form of pressure washing will be used, as this is likely to further destabilise the earth around the flags.
