1 Existing Hall Plan (FF)

job no. 598	job title William Ellis School Highgate
date 27/11/18	dwg. title Existing Hall Plan
	Client: William Ellis School
CB/TC drawn/checked	Scale: 1:100 @ A1 / 1:200 @ A3
	dwg. no. 598_E-117 / rev. no. -

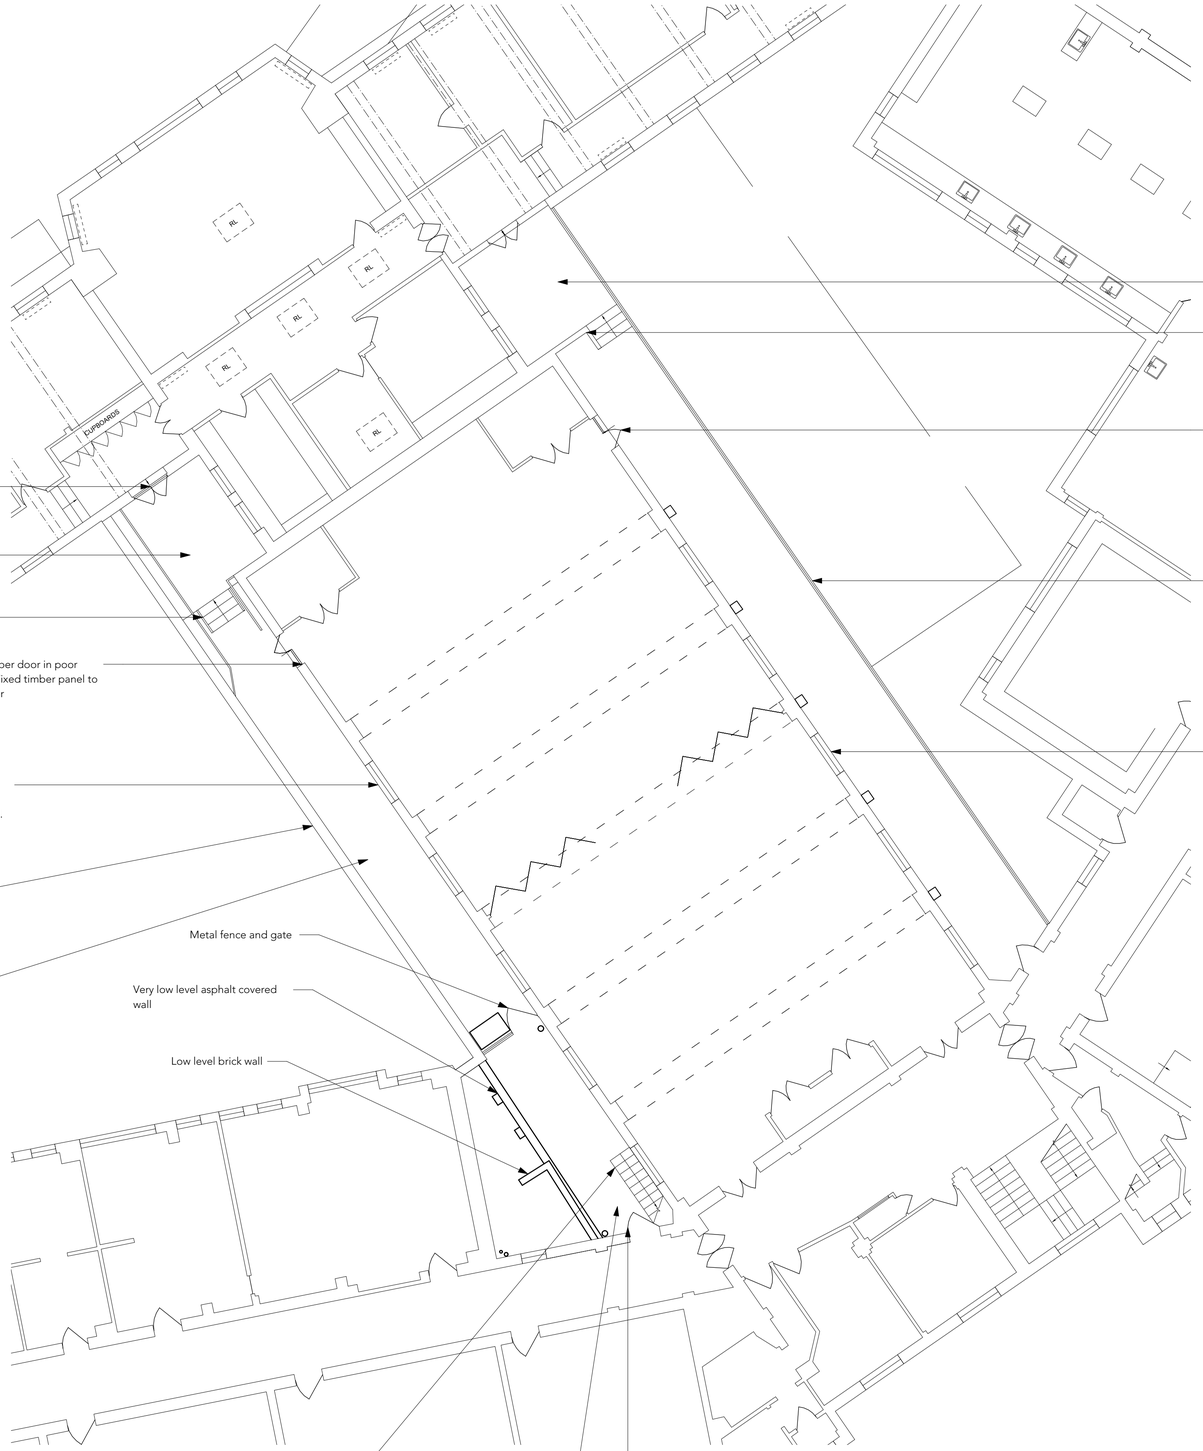
Reinforced concrete rib and hollow clay pot balcony slab with asphalt covering. poor condition where asphalt has melted

Painted timber door in poor condition. Fixed timber panel to right of door

Existing painted timber door with single glazed panels. Poor condition

Reinforced concrete rib and hollow clay pot balcony slab with roofing felt covering

White, uPVC glazed internal canopy. Poor condition

Existing, single-glazed crittal windows painted dark green, with white painted timber surround. Poor condition. 3x Pivot opening, however top window is fixed shut and other 2 openings are never used due to internal walkway

Existing, single-glazed crittal windows painted white, with white painted timber surround. Poor condition. 3x Pivot opening

Existing, external fire escape stair from second floor art rooms. Non-compliant (too narrow)
