**Level and Crack Monitoring**

Date of Issue: 22/09/2022

Occupier:	<b>Removed for data protection purposes</b>
Address:	<b>57 Aberdare Gardens</b>
Address:	
Town:	<b>London</b>
County:	
Post Code:	<b>NW6 3AL</b>
Contact Name	<b>Removed for data protection purposes</b>

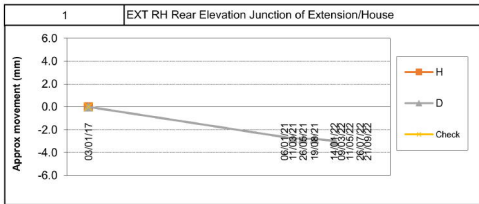
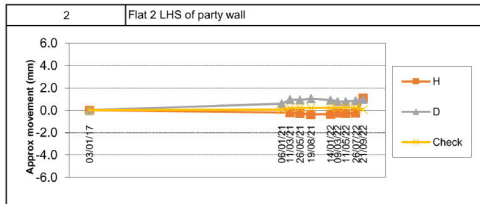
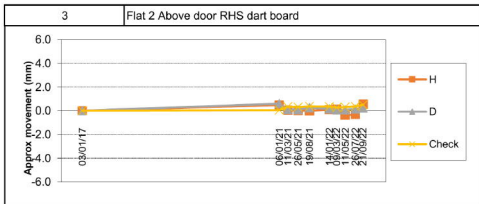
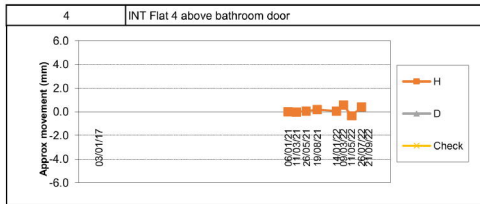
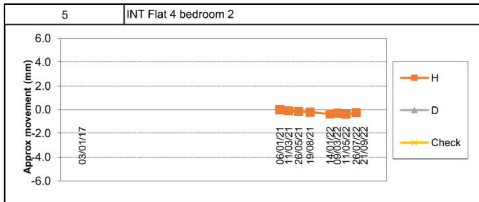
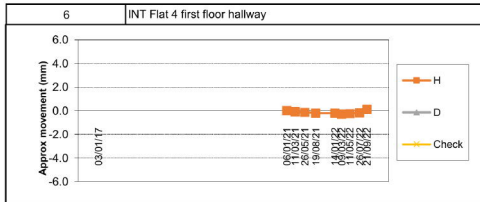
**Crack Monitoring - Movement Against Time**

1	EXT RH Rear Elevation Junction of Extension/House
2	Flat 2 LHS of party wall
3	Flat 2 Above door RHS dart board
4	INT Flat 4 above bathroom door
5	INT Flat 4 bedroom 2
6	INT Flat 4 first floor hallway
