# STATE OF CONDITION REPORT

#### **STEEL WINDOWS**

#### **179 TOTTENHAM COURT ROAD**

Date of Report: 26/01/2023

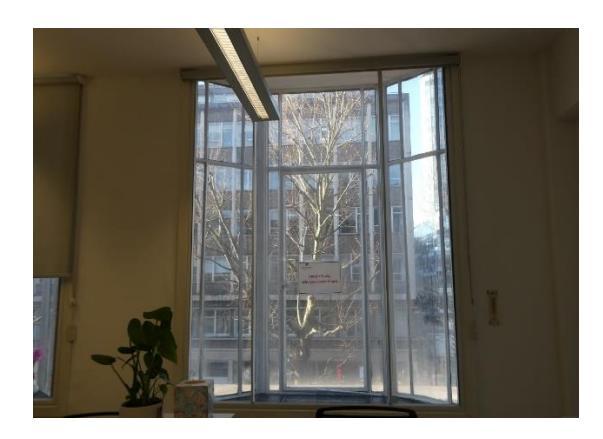
Please refer to photograph 1 at the end of this report that illustrates the typical facetted construction.

Photograph 1: Typical Facetted window.

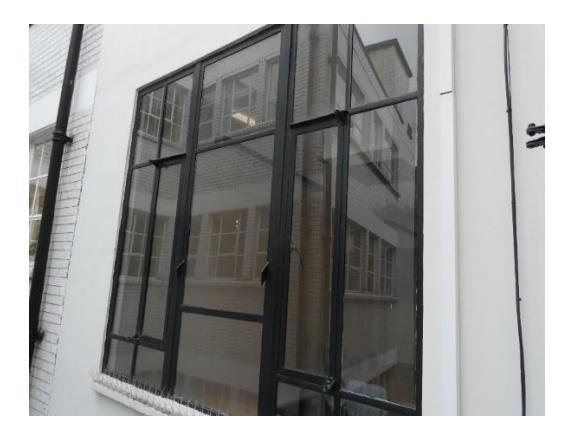
The windows to the rear elevations and to the front 1<sup>st</sup> floor elevation are conventional windows of varying configurations. Please refer to the photograph 2 and 3 in the photographs section at the end of this report.

Photograph 3: First floor ribbon windows.

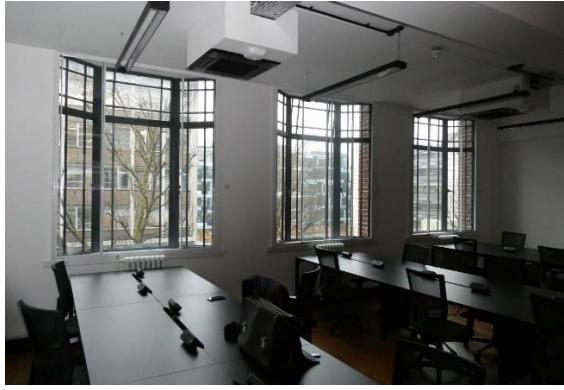
This floor has apparently been recently refurbished with part of these works having the original window frames repainted in a site applied black colour paint. Please refer to photograph 17.

Photograph 17: Window bays to the front (west) elevation.

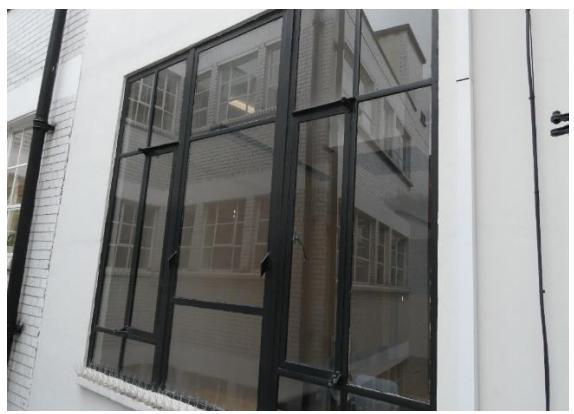
All the windows to the rear elevations have also been recently painted black internally and externally. Photograph 21 refers.

Photograph 21: Rear (east elevation) window has been replaced.
