Site Investigation Report

Job Information	
Client	Crawford & Co
Client ref	
Visit date	18/03/2022
Report date	21/03/2022

Job Summary	
✓	CCTV survey undertaken. Read more.
!	Drainage repairs required. Read more.
✓	2 trial holes undertaken. Read more.

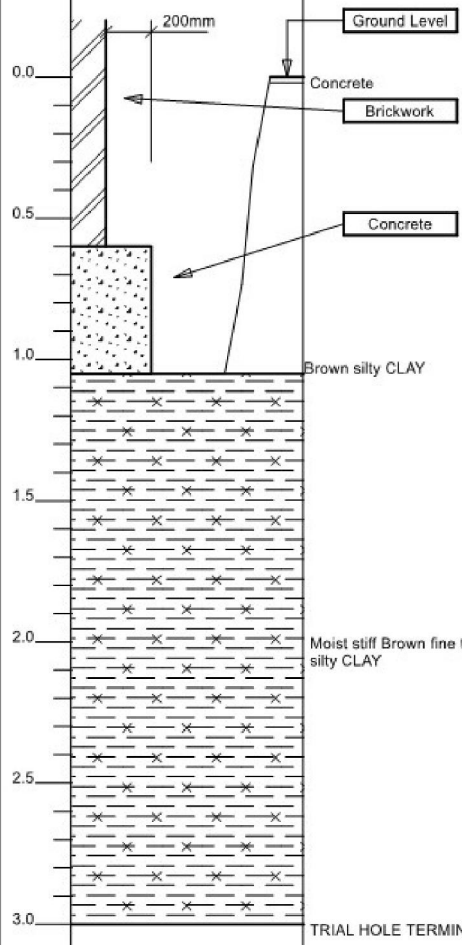
Trial Hole Log No.2

Location: Rear right corner of rear extension

Ground Level				
		Concrete				
		Brickwork				
0.5		Concrete				
1.0		Brown silty CLAY	70kpa		Soil @ 1.05m	
1.5			86kpa		Soil @ 1.55m	
2.0		Moist stiff Brown fine to medium gravelly silty CLAY	104kpa		Soil @ 2.05m	
2.5			116kpa		Soil @ 2.55m	
3.0		TRIAL HOLE TERMINATED	120kpa
