Ref 2277 – R1a

March 2023

Structural Report for the redevelopment of 26 Netherhall Gardens, NW3 Front Steps

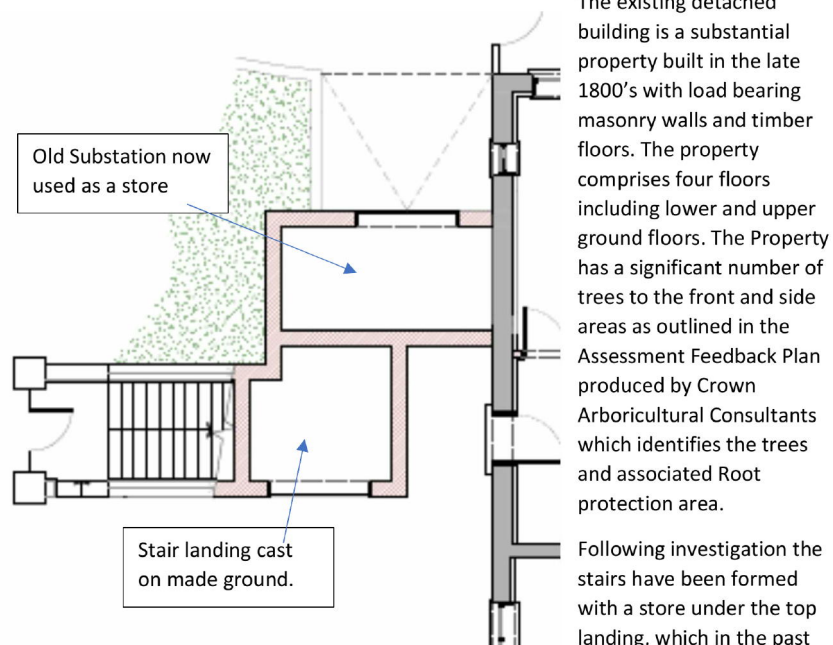
was used as a substation. The stair visible within the store are supported by steel beam placed below the stair section on the line of the riser. The remainder of the stair was built up with masonry walls on nominal foundations and back filled with clay and soil, probably obtained from the preparation of the house development. The Quarter landing was cast on the ground which has now dropped away leaving the slab suspended. The stairs are within this space also supported on steel beams and these beams have corroded excessively, to the point that there is minimal thickness of section left in place leaving the stairs unsupported. See photos below.
