Document type  
**Structural Review**

Date  
**August 2021**

# CHESTER TERRACE RETAINING WALL REMEDIATION STRUCTURAL REVIEW

Project name **Chester Terrace Wall Remediation – Structural Review**  
Project no. **1620012XXXX**  
Recipient **Nick Packard <Nick.Packard@cepc.org.uk>**  
Document type **Structural Report**  
Version **Rev01**  
Date **13/08/2021**  
Prepared by **Scott Brookes**  
Checked by **Jackie Heath**  
Approved by **Jackie Heath**  
Description **Structural assessment and review of current remedial strategy**

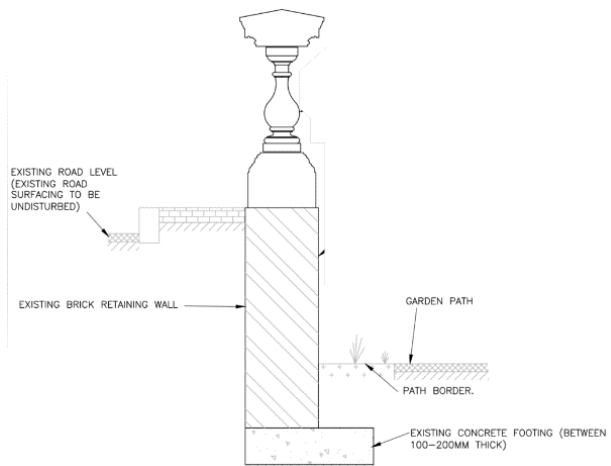
The retaining wall is predominantly rendered brickwork, with only a section at the north end replaced, possibly post-bombing, with a reinforced concrete equivalent. The wall stem is between 430mm and 485mm thick. The wall footing is of mass concrete, with an inside edge assumed by HPM to align with the retaining wall's inside face.

**Figure 6 Existing Retaining Wall Section © Hurst, Pierce & Malcolm**

The existing footing bears onto the made ground at a depth of 0.35-0.55 metres. Our assumption is that the retaining wall is positioned centrally to the footing width and this is less conservative than the HMP assumption shown in figure 6. This needs to be confirmed via probing or a trial hole.

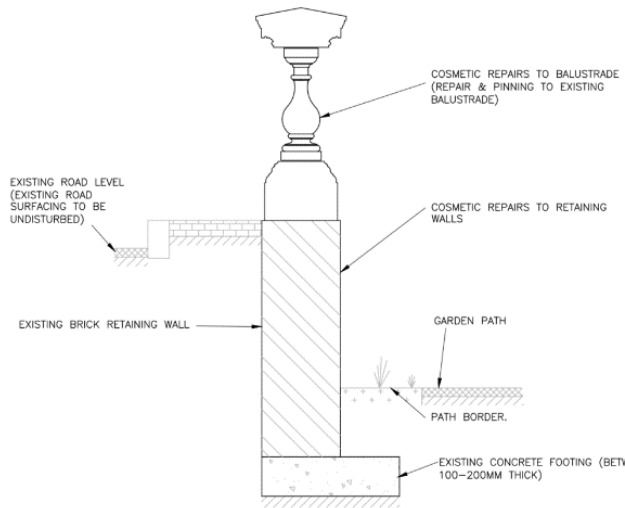
**Figure 15 Section 7 -Option 1: Only cosmetic repairs to the retaining wall. No in-situ strengthening or tying of retained elements.**

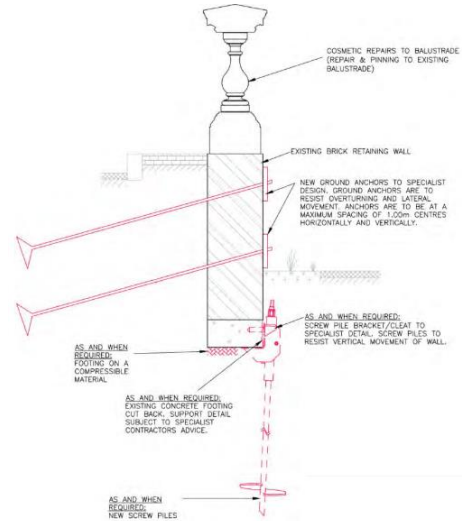
**Figure 16 Section 7 -Option 4: Introduction of lateral ground anchors in the short term and screw piles reactively to address vertical movement as and when. As per HPM Option 2A.**

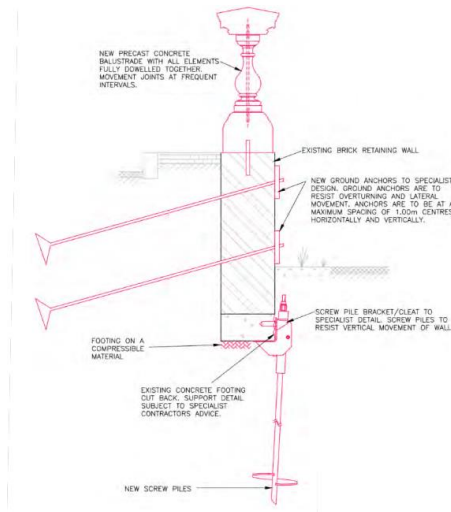
**Figure 17 Section 7 -Option 5: Introduction of ground anchors to the wall and screw piles to the base concurrently. As per HPM Option 3.**

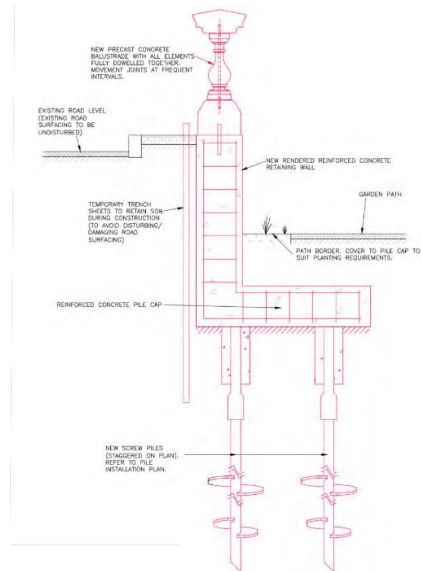
**Figure 18 Section 7 -Option 6: Demolition of the existing wall and replacement with an RC retaining wall with screw piles. As per HPM Option 4**

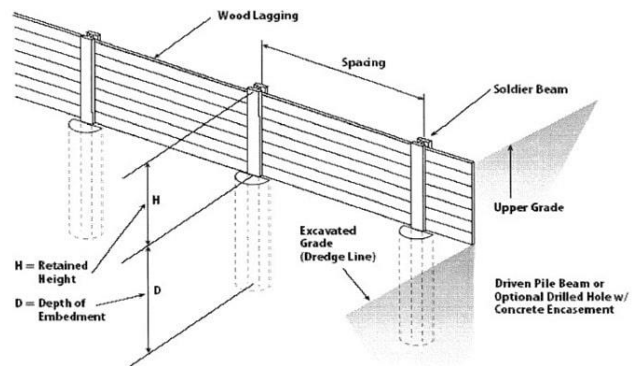
**Figure 20 Representative arrangement of king (soldier) posts**

This proposal entails the installation of new vertical- cantilevering retaining posts at regular centres in-front of the existing brickwork wall, off which it can be shored. By creating a borehole down into the clay strata, the king posts can be cast in position in good earth (not made ground) and are hence are able to provide lateral resistance. Furthermore, the king posts offer the option to re-support the balustrade on a new base plate, spanning between the posts clear of the existing wall – see Section 7.5. The newly seated bottles would remain in the same position, possibly circa 20mm higher, but not rely upon the (possibly) moving wall for support. The centres and aesthetic impact of the posts is to be confirmed with further design/analysis.

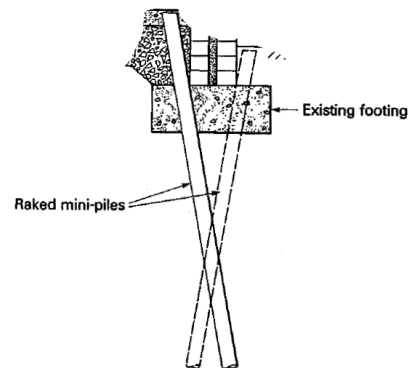
**Figure 21 Raked mini piles through footing. Note unlike this diagram, our raking piles would be installed from the garden side only, at a consistent angle.**

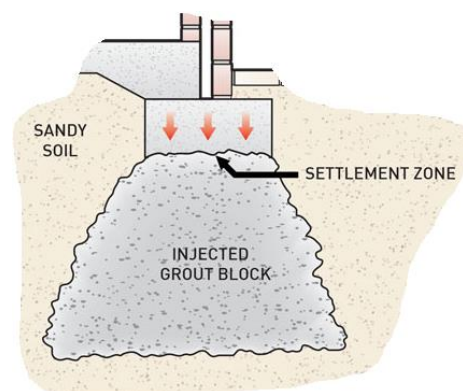
**Figure 22 Typical grout injection**
