## Report on Mayor's Parlour Balcony drainage

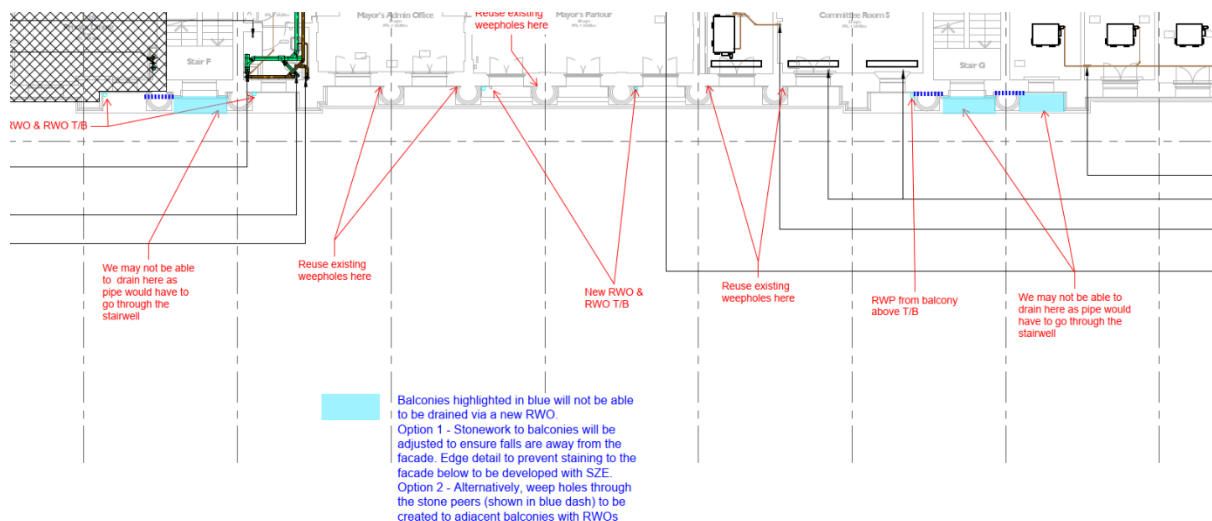
During the construction phase on site, we have experienced flooding to the mayor's parlour twice from the balcony apart from the one that took place on the 17th of August 2022. These all resulted from rainfall.

Regarding early warning 1292 (weep holes in balcony), I can confirm that due to the presence of stone clad piers either side of all the balconies, there is no other way we can provide an overflow/weep holes apart from what is currently proposed. As we continue to experience adverse weather conditions due to global warming, it is highly recommended to have this weep holes to avoid future flooding to the mayor's parlour.
