Geotechnical Survey Report

FSI Ref: [REDACTED]
Issue Date: January 2023
Risk Address: 14 Eton Avenue
London
NW3 3EH

Property Address: 14 Eton Avenue, London, NW3 3EH

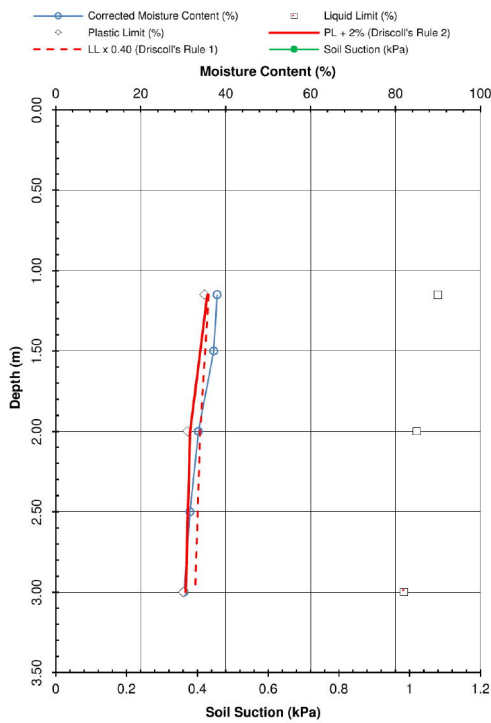
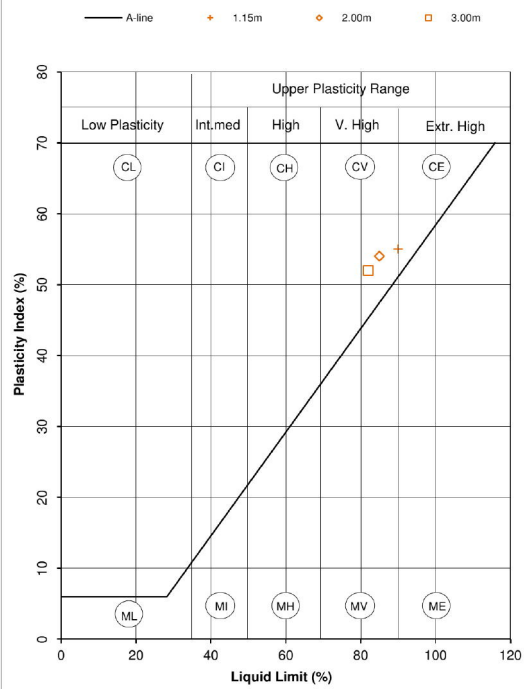
BOREHOLE 1

Depth (m)	MC (%)	Corr. MC (%)	LL (%)	PL (%)	PI (%)	Class	% Retained (425µm)	Soil Suction (kPa)	Condition of test	Soil Description
1.15	38	38	90	35	55	CV/E	0		Natural	Brown silty CLAY containing grey and orange mottle
1.50	37.2	37.2					0		Natural	Brown silty CLAY containing grey and orange mottle
2.00	33.6	33.6	85	31	54	CV	0		Natural	Brown silty CLAY containing grey and orange mottle
2.50	31.6	31.6					0		Natural	Brown silty CLAY containing grey and orange mottle
3.00	30.2	30.2	82	30	52	CV	0		Natural	Brown silty CLAY containing grey and orange mottle
