**ARBORICULTURAL IMPACT ASSESSMENT REPORT FOR:**

83 Belsize Park Gardens  
London  
NW3 4NJ

**Ref:** SMR/83BPG/AIA/01a

**Date:** 5<sup>th</sup> April 2023

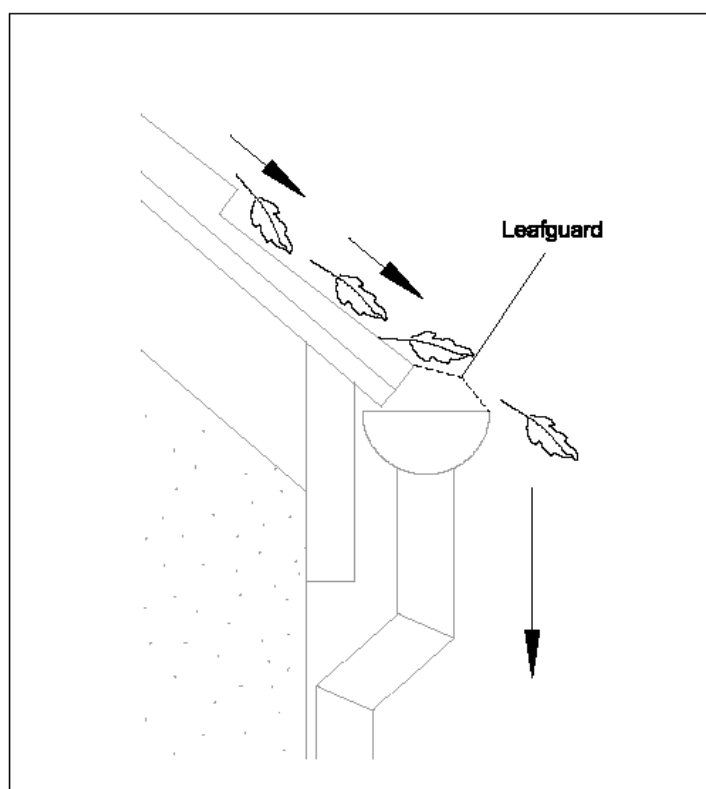
- 6.3.7 Nuisance deposition can be mitigated with routine maintenance, light pruning / deadwooding and the fitting of filtration traps on guttering (see Figure 7 below).

Figure 7: Filtration traps, as shown above, could be fitted on the gutters which can easily be maintained at 2-3m above ground.

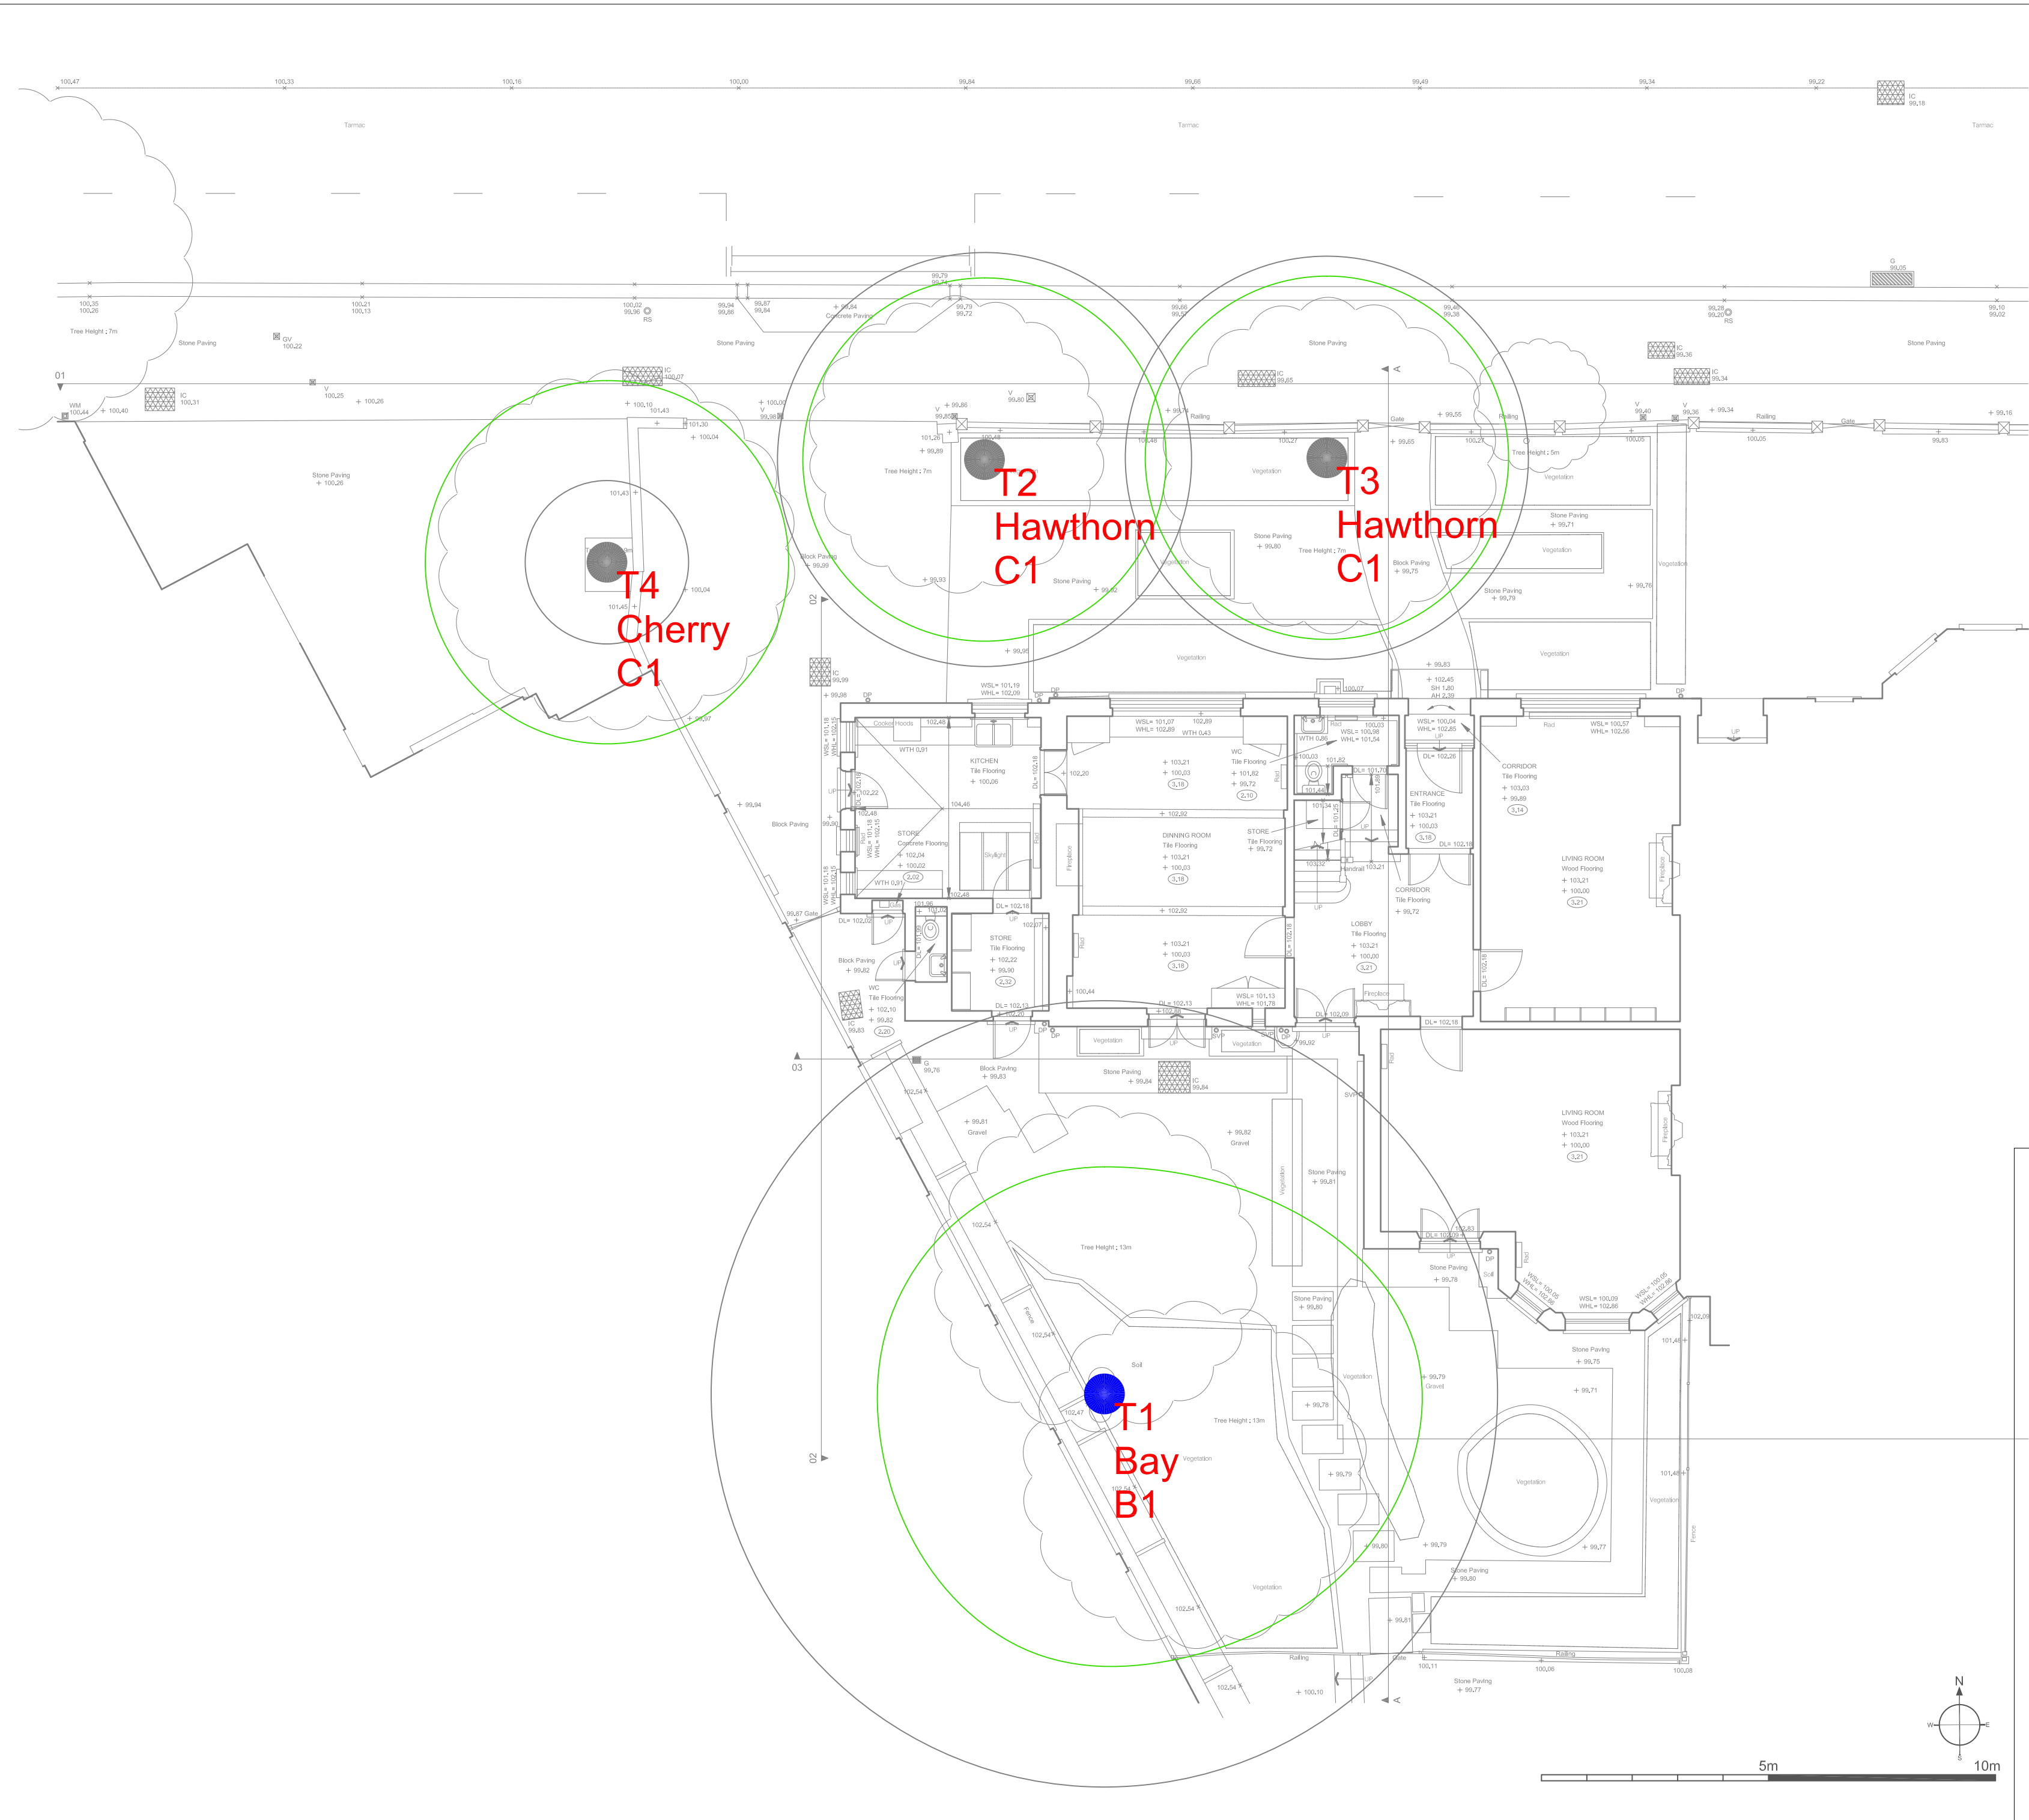
**PLAN 1****TREE CONSTRAINTS PLAN**

- 3.3.4 At the time of inspection, vertical cracks were evident on the stems of bay T1 and Ganoderma brackets were observed at its base. It is thus recommended that decay testing investigation be undertaken of this tree – the findings of which may affect the currently assessed B categorisation (moderate quality); i.e. it could conceivably be downgraded.

- 3.3.5 Full details of the surveyed trees can be found in Appendix 1 of this report.
- 3.3.6 In addition to the further investigation of the bay T1 referred to above, there are recommended general husbandry works for the two hawthorn trees (T2 & T3) on the site frontage. These are listed in Appendix 2.

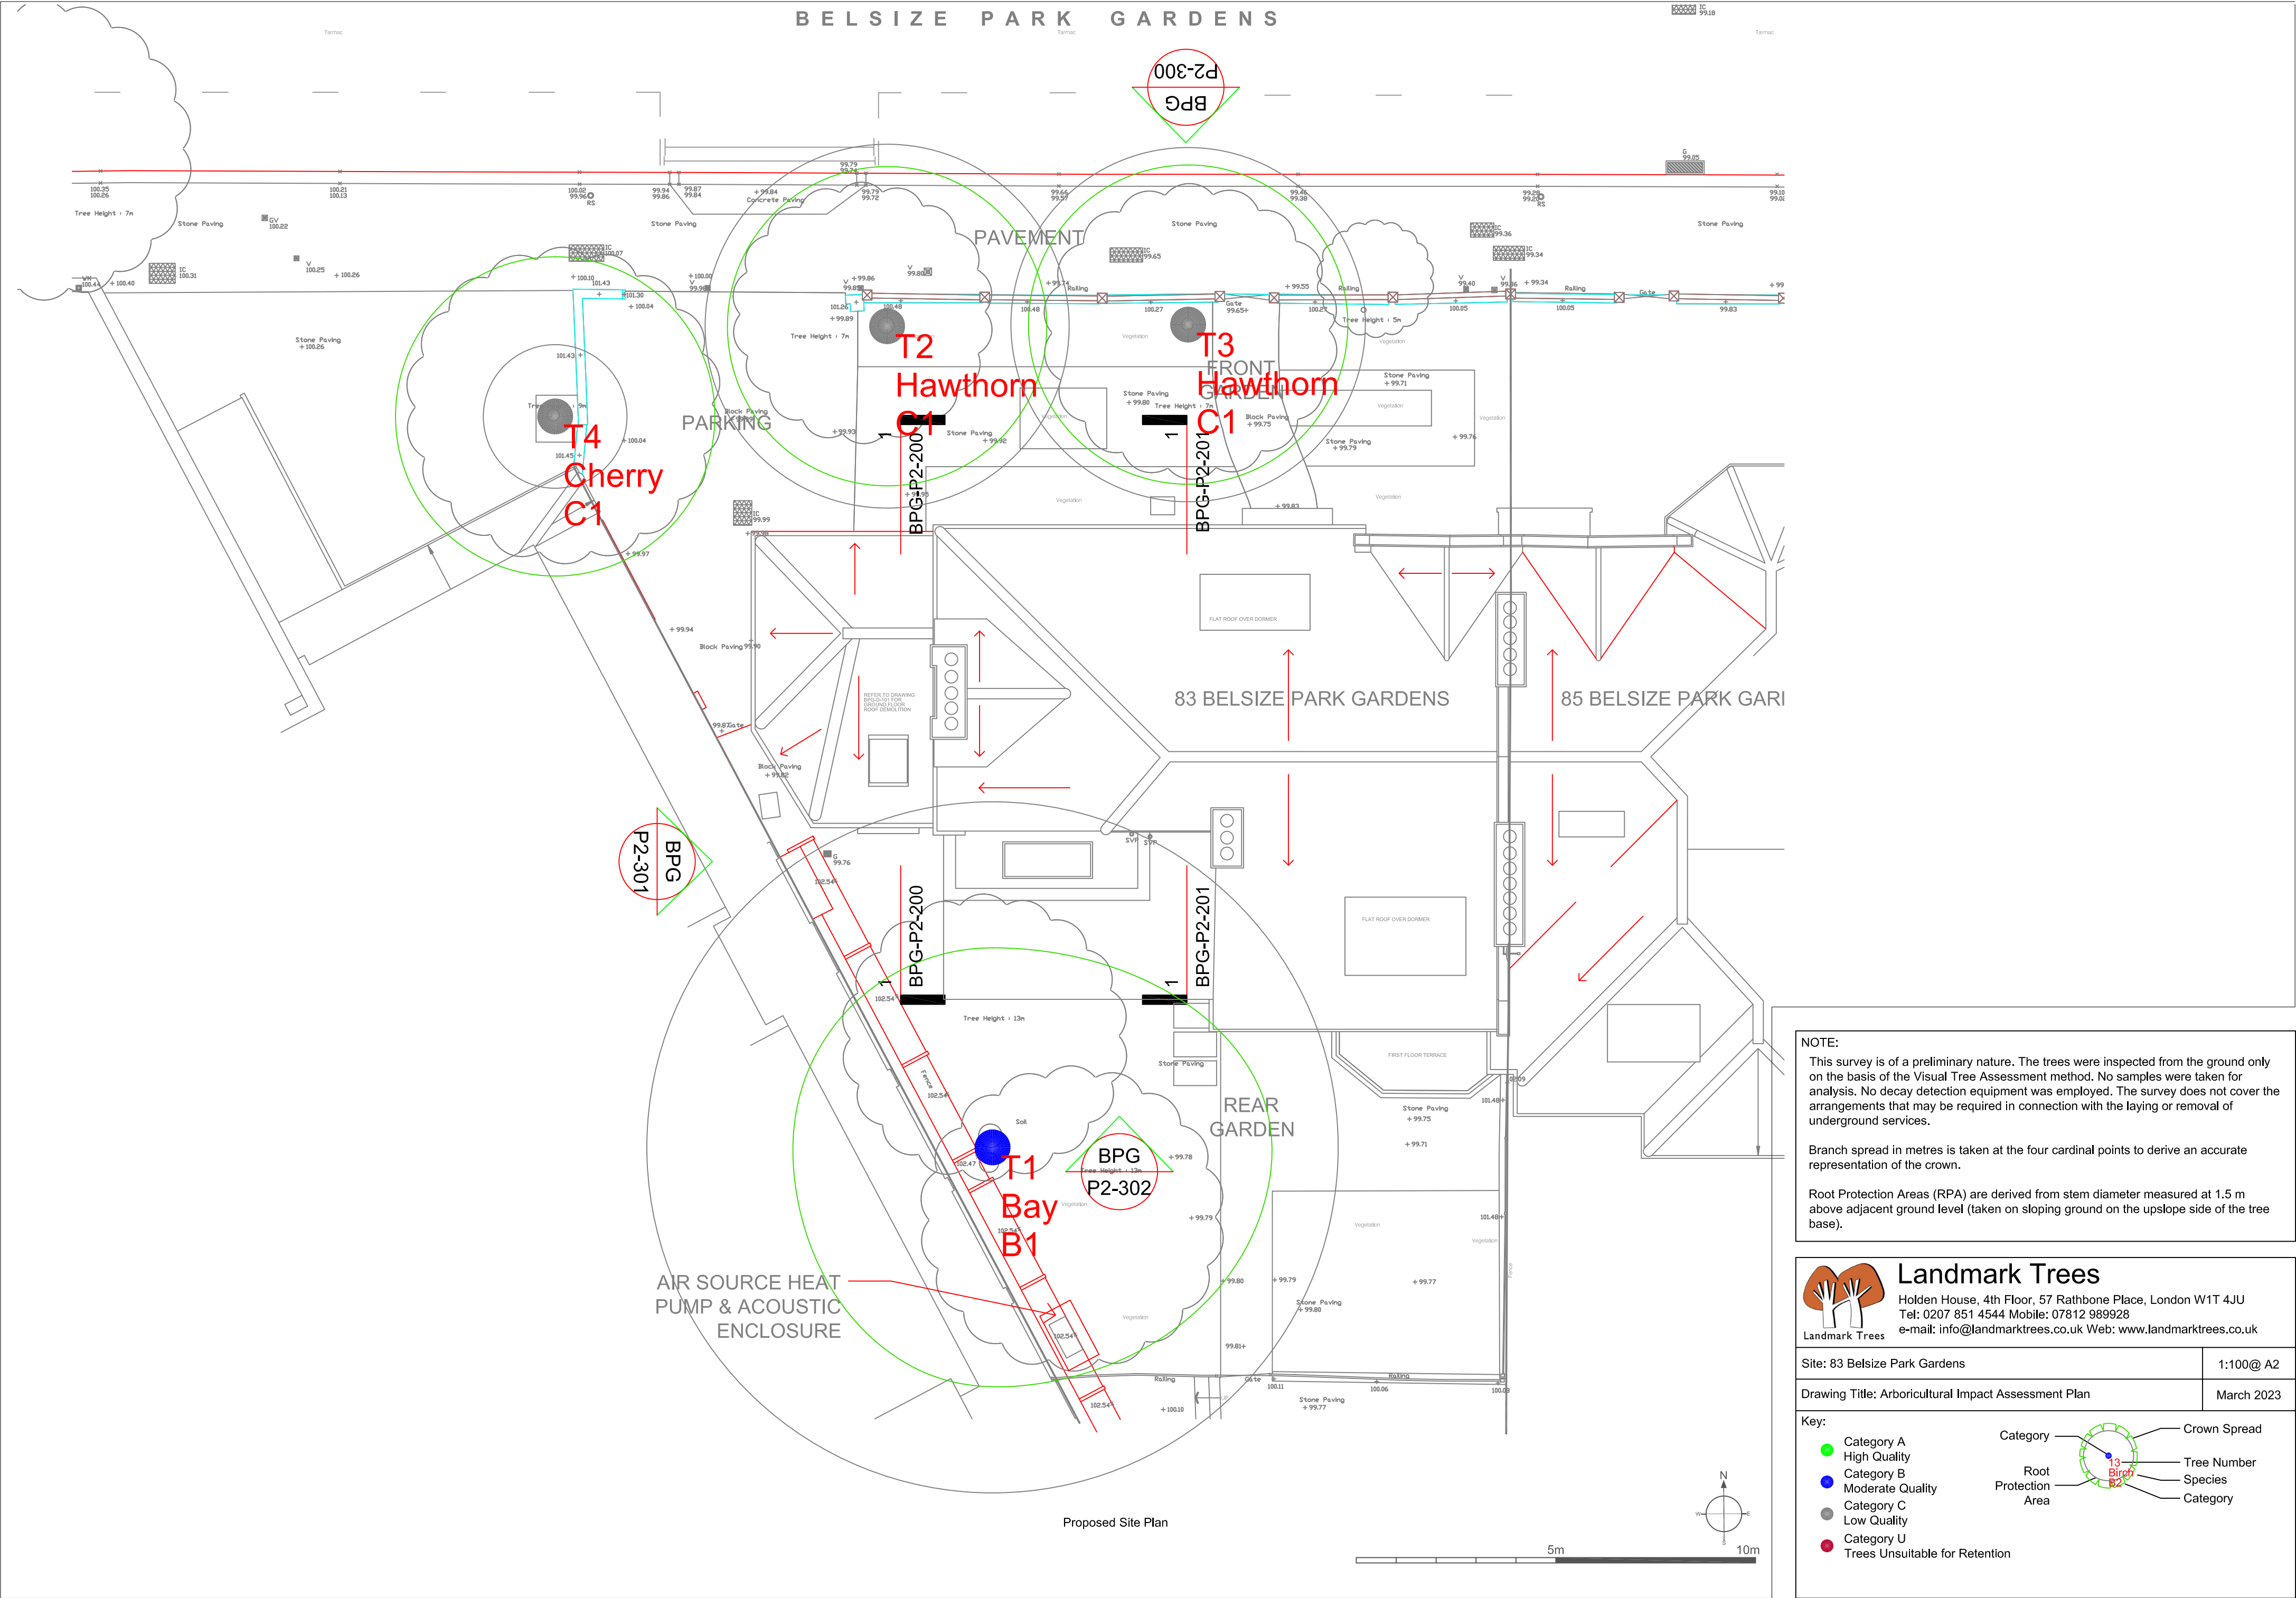
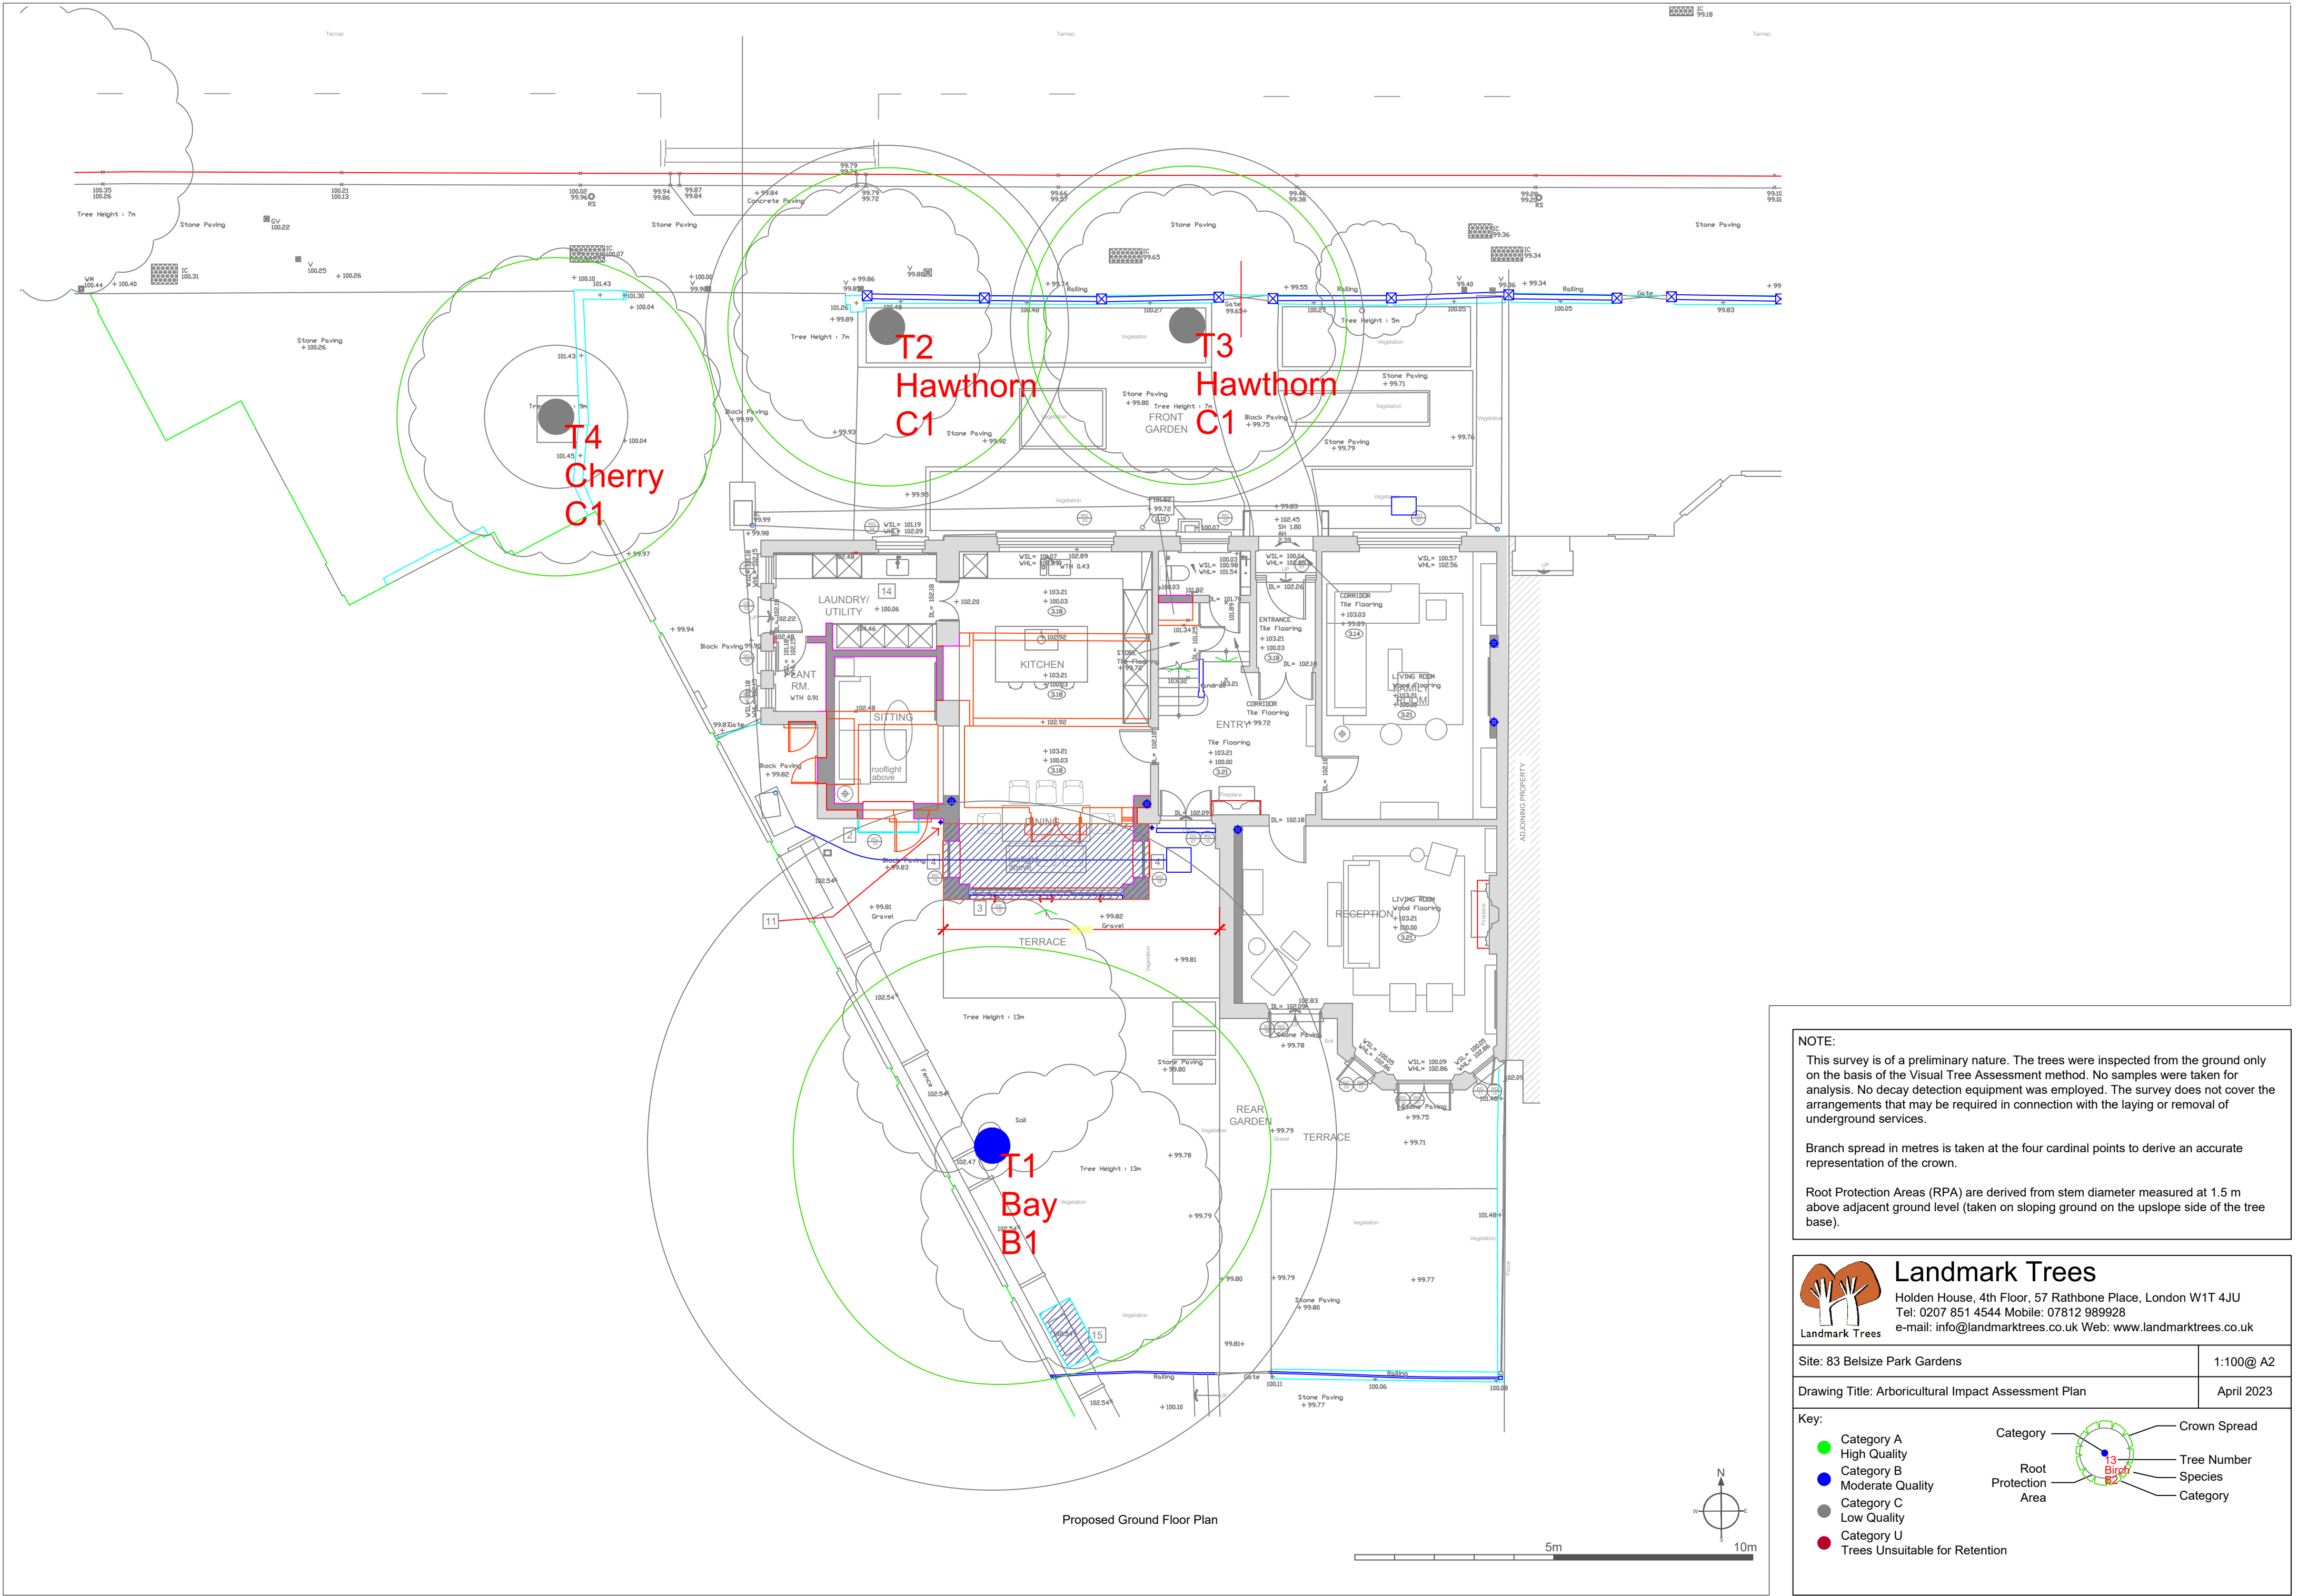
**PLAN 2****ARBORICULTURAL IMPACT ASSESSMENT PLAN (S)**

- 6.1.2 The principal impacts in the current proposals thus comprise the encroachments into the RPA of bay T1. It should be noted that the RPA has not been shown modified because, in the light of the proximity and age of surrounding built form, the whole of the rear garden in which redevelopment is proposed has been considered as an area where the protection of the roots and soil structure should be treated as a priority.

- 6.1.4 As the proposed redevelopment involves mostly internal demolition and rearrangement, the actual increase in external footprint for the ground floor extension is limited. The calculated encroachment into the 'nominal circle RPA' is 9.81 m<sup>2</sup> / 4.15%. It should, however, be noted that a trial pit 1m in depth was excavated at the west corner of the proposed extension (the closest position to bay T1) and no roots were apparent (photographs are provided at Appendix 4). The potential impact on the bay can be mitigated with the use of low-invasive foundation design.

- 6.3.4 The building encroachment will require the use of specialised foundation techniques, such as mini-piling or pad and raised beam. The foundation pits within the RPA should be trial-excavated by hand under arboricultural supervision using a double-headed spade (“shove-holer”) or similar to minimise breadth of hole required for inspection; any roots encountered will be cleanly pruned back to an appropriate junction with a sharp pruning saw or secateurs. Roots larger than 25mm diameter may only be cut in consultation with an arboriculturalist.

- 6.3.6 The replacement paving/hard landscaping, which will be set approx. 140mm above the existing ground level, will require a no-dig construction technique - either using a cellular confinement system with no fines aggregate for the sub-base or simply building upon the existing sub-base without disturbing the ground below. Choice of construction method will initially depend upon root penetration within the existing sub-grade. The key principle is not to excavate in the presence of roots and to provide a porous surface to promote healthy soil water relations for future root growth. A further consideration in the use of a more expensive cellular confinement system or similar, may be the claimed reduction in risk of possible future slab / surface displacement by roots of trees growing in paved areas. The degree of encroachment (>20% of RPA) means that a permeable paving surface (e.g. gravel or block paving) is required.
