10-11 Doughty Street, London WC1N 2PL

Structural engineer's report and feasibility

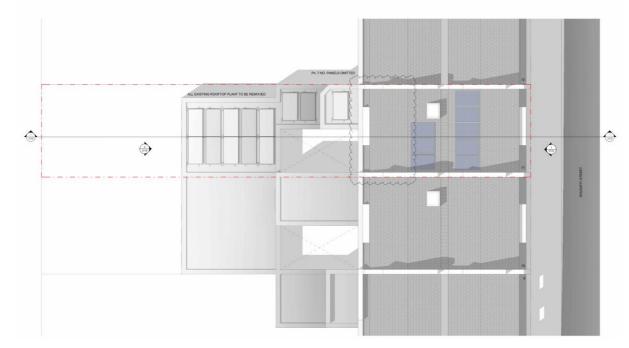
Figure 6: Proposed Roof Plan to no.11

Calculations carried out in the critical roof area (see Appendix II) confirm that the existing roof construction is capable of supporting the proposed panel layout without additional strengthening works.
