# ARBORICULTURAL ASSESSMENT REPORT

18 Bartholomew Villas, London, NW5 2LL

Survey Date: 27/02/2023

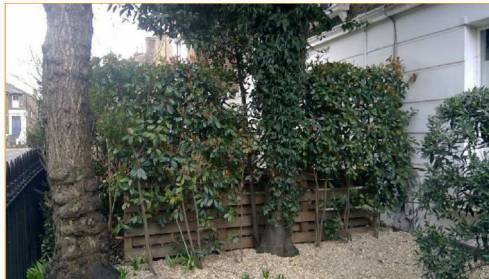
T3 - False Acacia

Tree No	Common Name	Age Class	Condition	Height (m)	Crown Spread (m)	Stem diam. (mm)	Dist to bldg. (m)	Roots implicated	Pruning history	Recommendation	Tree work constraints	Notes	Owner address	Owner
T3	False Acacia	Mature	Fair	9	6.6	365	3.90	N	Subject to past management-pollarded. No significant recent management.	Fell and treat stump with eco plugs (broadleaved).	Pre cone/signage/ barriers action required - footpaths/public access. Adjacent to highway - traffic management required. Parking restrictions.		18 Bartholomew Villas London NW5 2LL	PH
H2	Photinia	Early Mature	Fair	2.2	0.8	20	0.5	N	Managed as a hedge- looks newly planted.	No work required.			18 Bartholomew Villas London NW5 2LL	PH
H3	Cypress	Mature	Fair	2	0.4	40	2	N	Managed as a hedge.	No work required.			Boundary Vegetation	UKN
T4	Cabbage tree	Mature	Fair	8	3.6	140	0.4*	N	Subject to past management. No significant recent management.	No work required.			16 Bartholomew Villas London NW5 2LL	P3P
