Arboricultural Appraisal Report

Subsidence Damage Investigation at:

10 Park Village East
London
NW1 7PX

CLIENT:	Crawford & Company
CLIENT REF:	[REDACTED]
MWA REF:	[REDACTED]
MWA CONSULTANT:	Richard Percival (TechArborA)
REPORT DATE:	17/03/2023

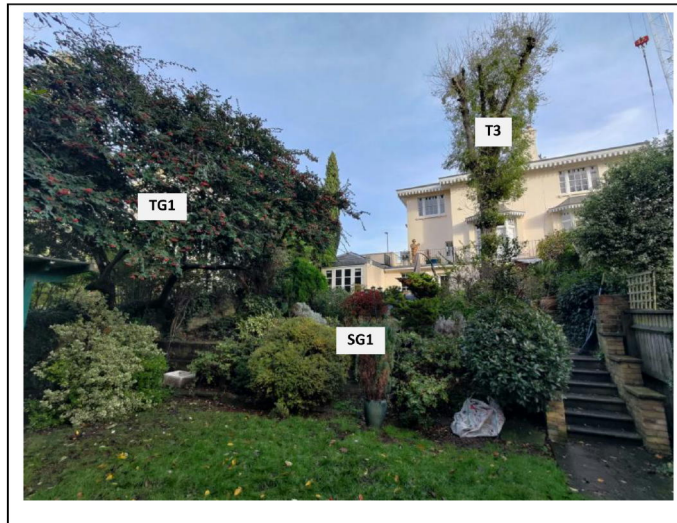
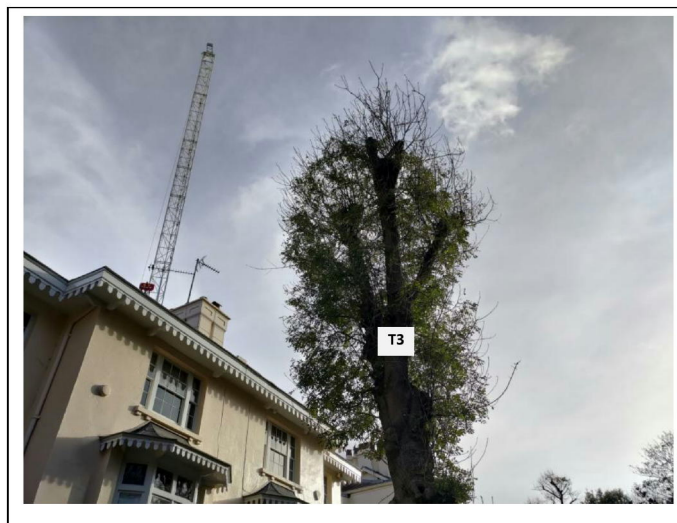
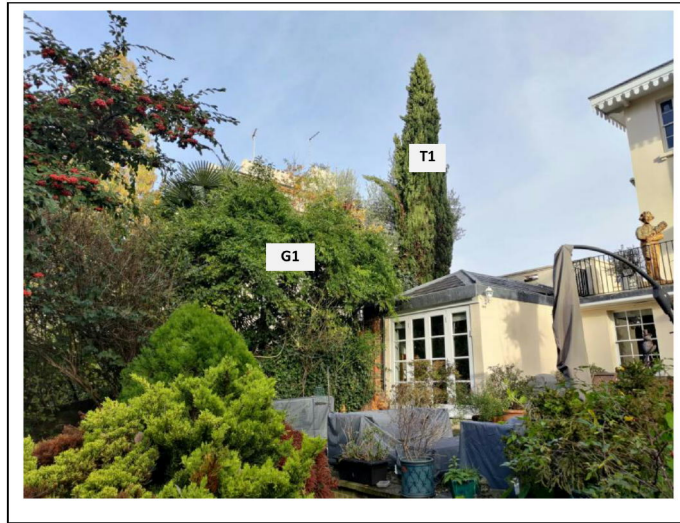
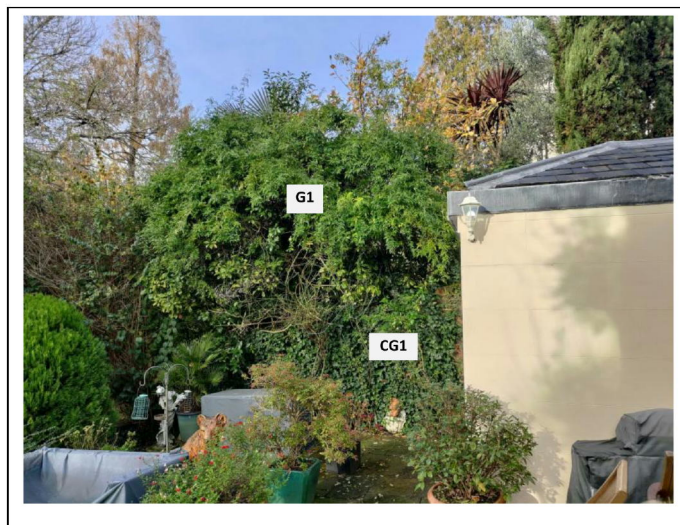
Images

Damage relates to the extension where internal and external cracking indicates downward movement.

Roots were observed to a depth of 0.5m bgl in TH2 and recovered samples have been positively identified (using anatomical analysis) as *Rosoideae*, the origin of which will be elements of CG1 confirming its influence on the soils below the foundations. A shrub root was also identified which is likely to be from a component of G1.

If an arboricultural solution is to be implemented to mitigate the influence of the implicated trees/vegetation we recommend that the works specified in Table 1 are carried out. Other vegetation recorded presents a potential future risk to building stability and management is therefore recommended.
