# ARBORICULTURAL IMPACT ASSESSMENT REPORT FOR:

20 Crediton Hill London NW6 1HP

Ref: SCA/20CDH/AIA/01a

Date: 19th May 2023

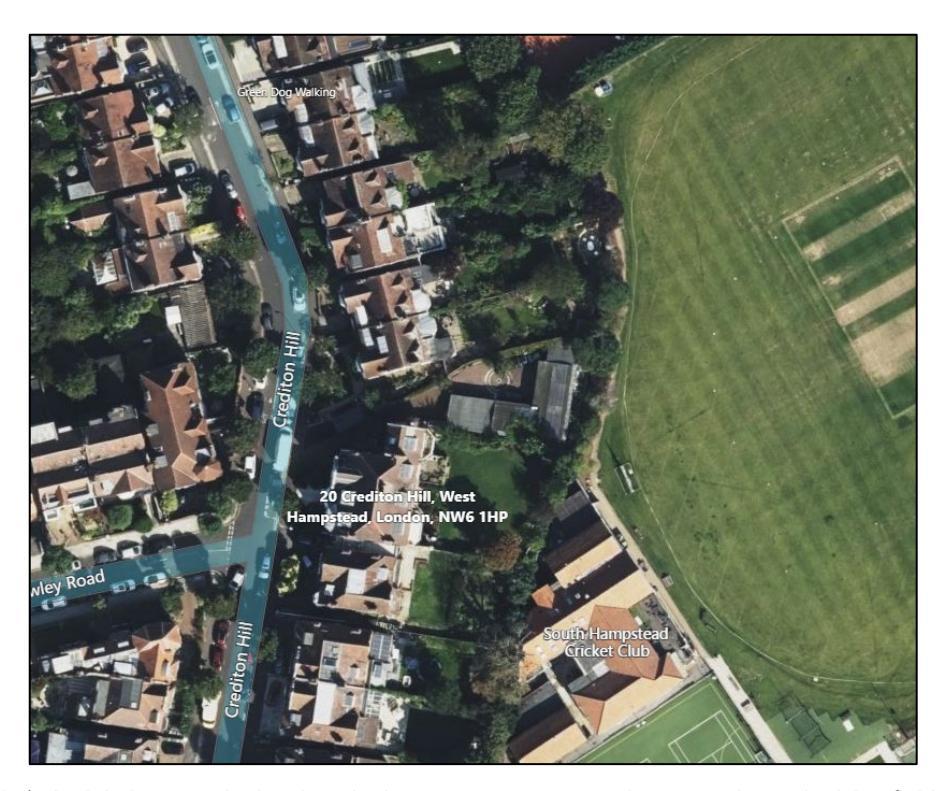
Photograph 1: Aerial photograph showing site in context – note trees between site and cricket field have been removed since image was captured (Source: Bing Maps)

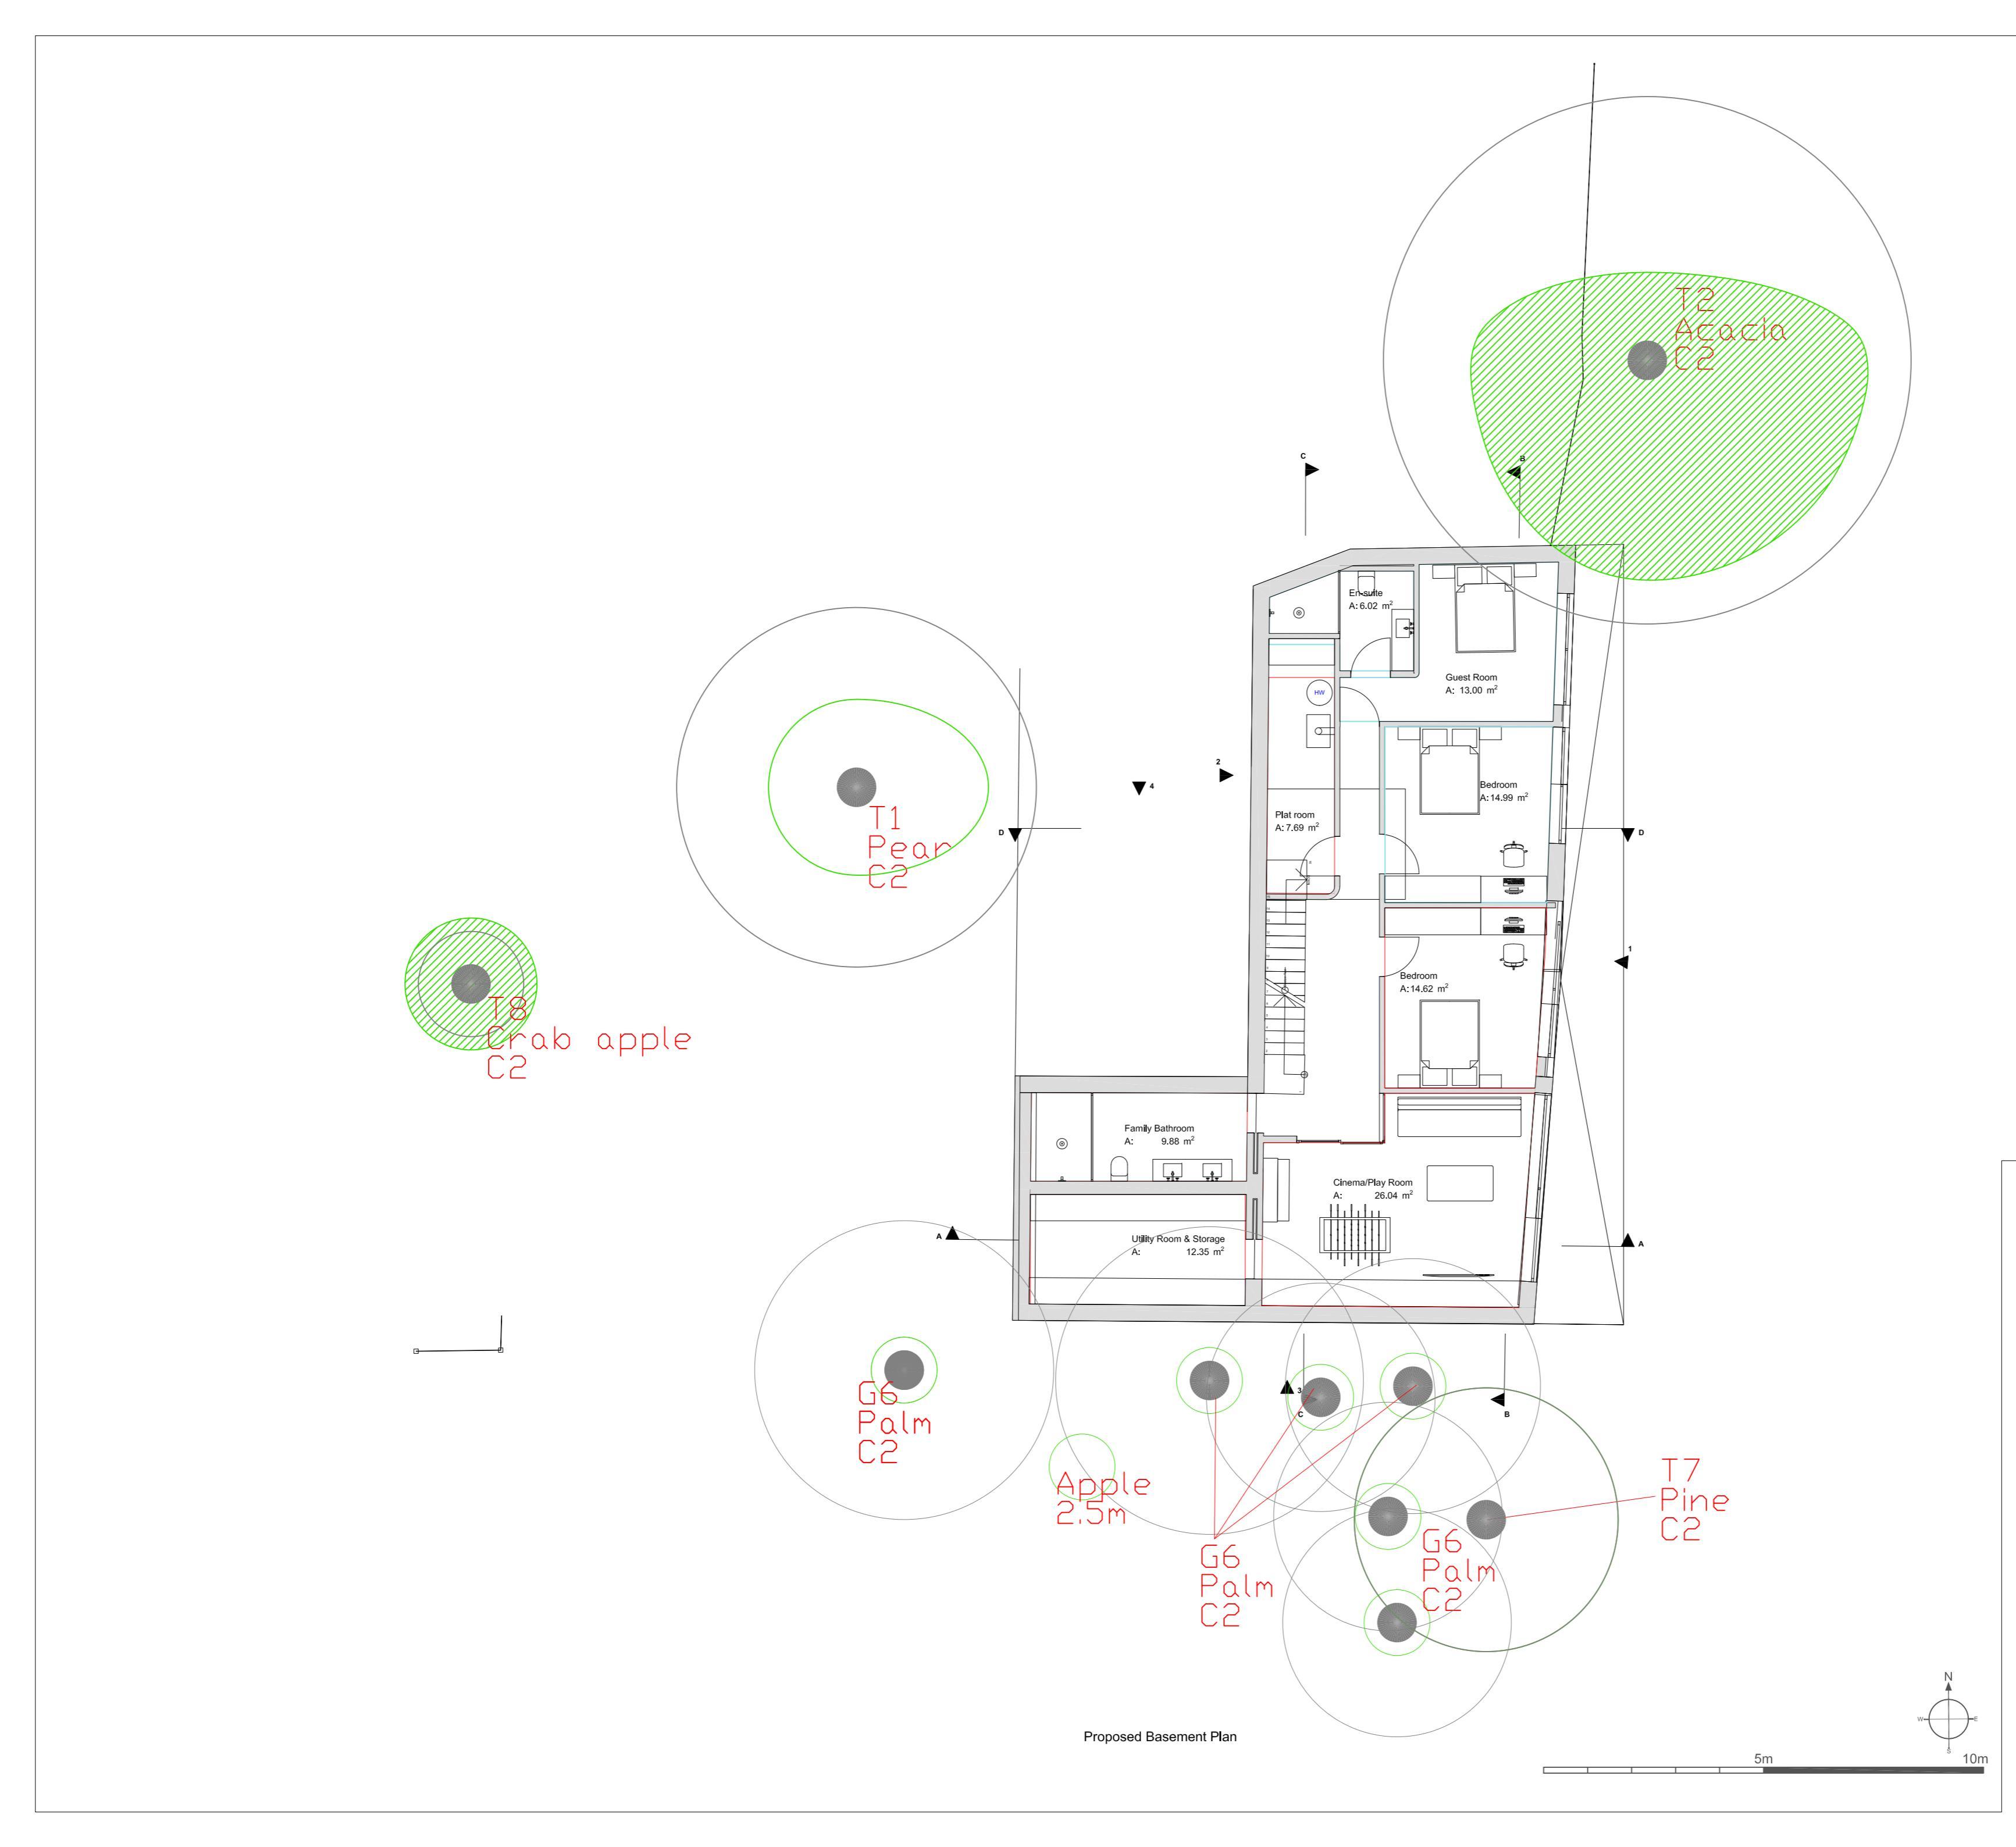
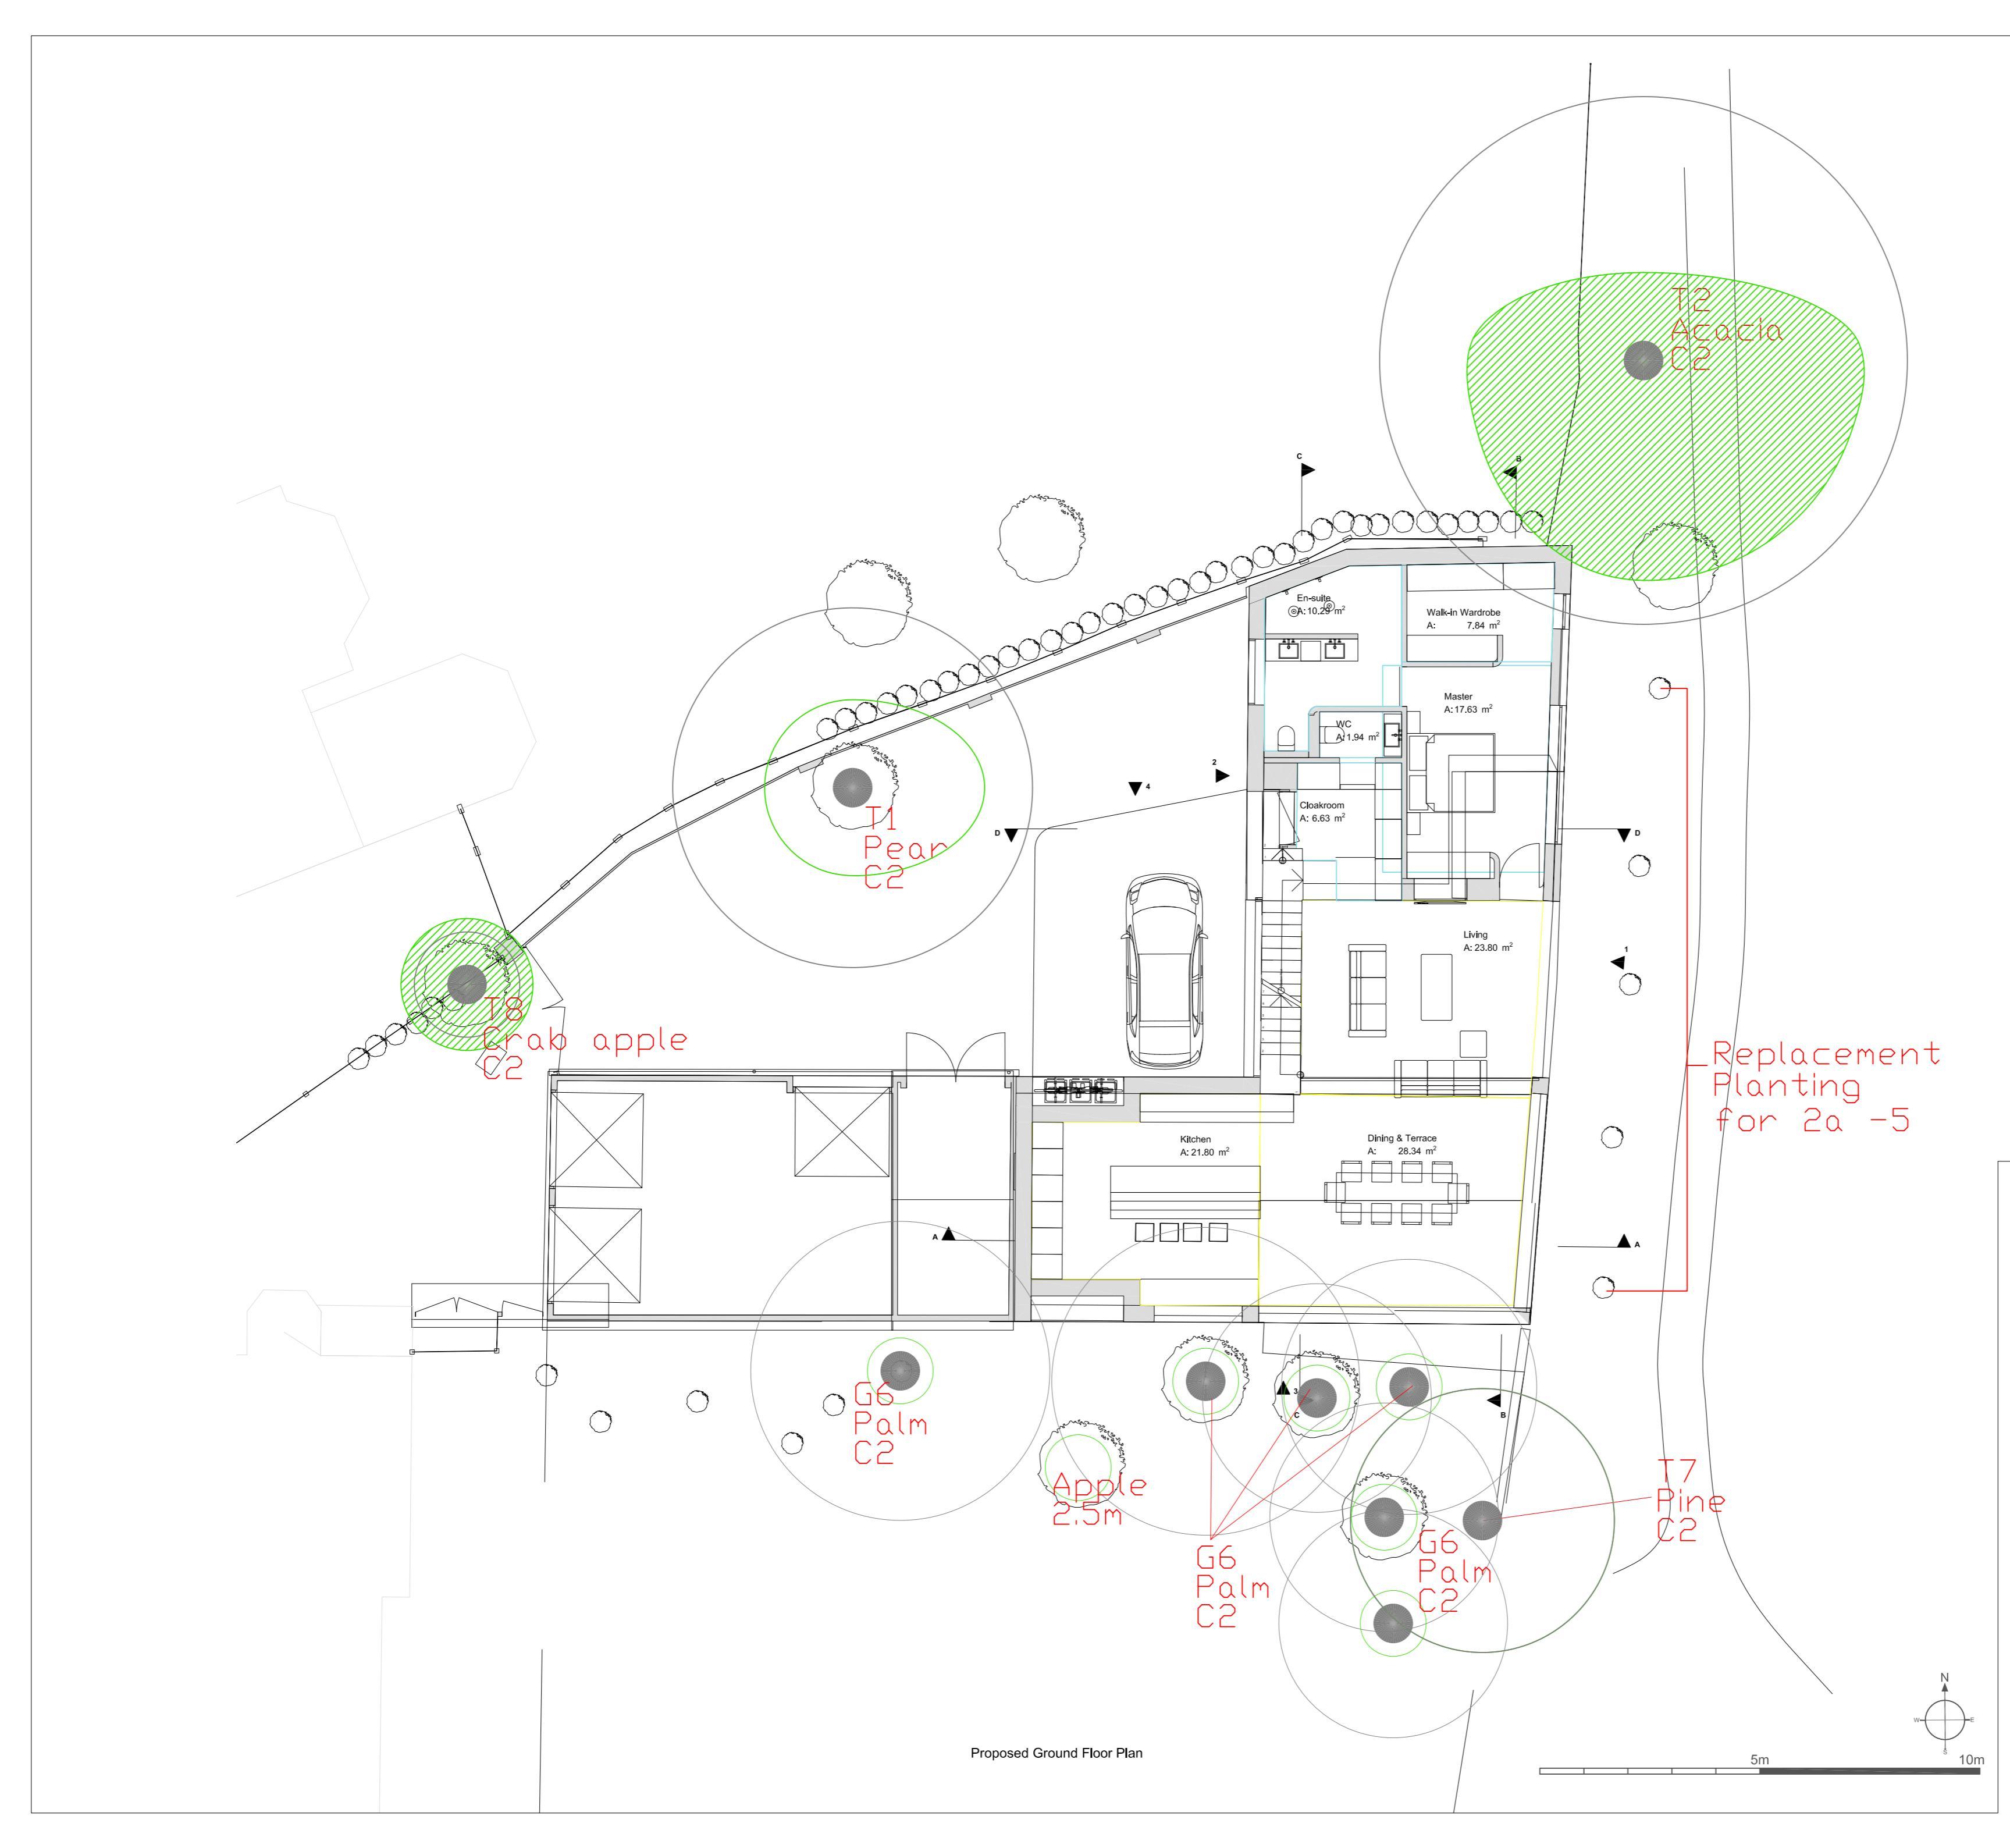
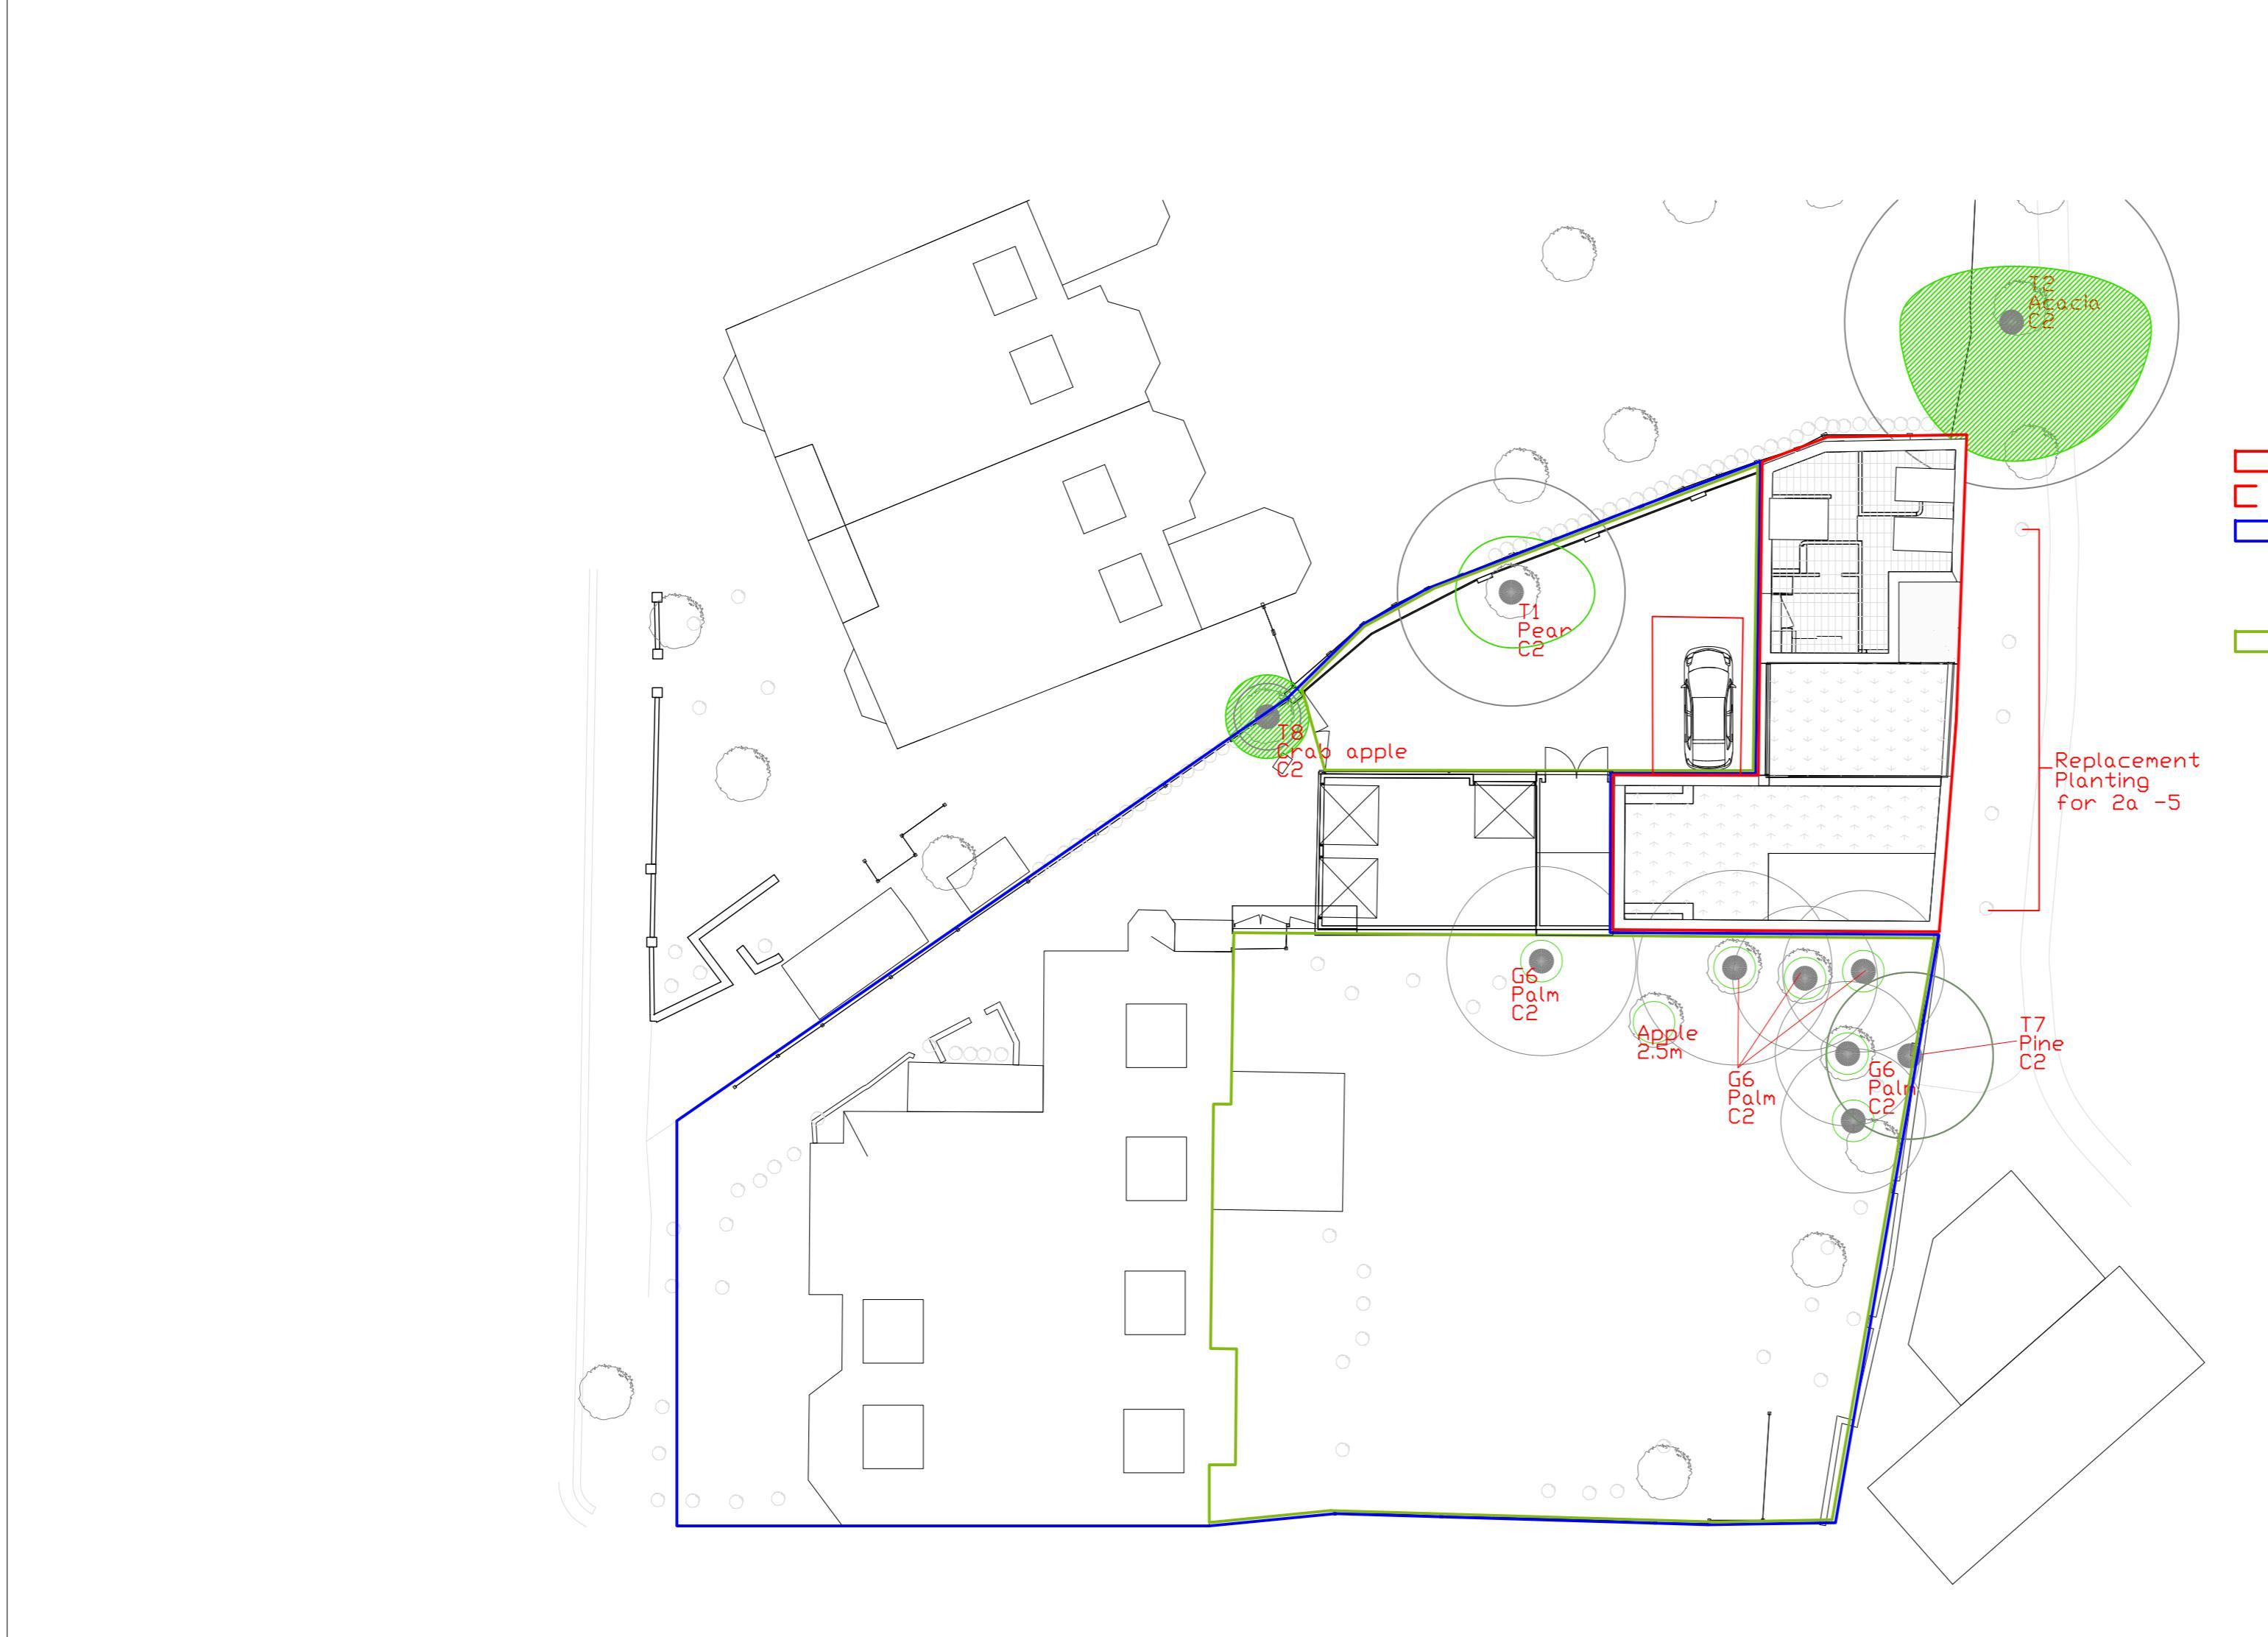
# ARBORICULTURAL IMPACT ASSESSMENT PLAN (S)

- 6.1.5 The principal impacts in the current proposals to the retained trees comprise the encroachments into the 'nominal circle RPA' of false acacia T2 and some of Chusan palm G6 by. However, these theoretical incursions would be beyond the 2.2m deep foundations of the existing buildings, so there is likely to be no impact in practice. It will also be noted that these impacts would be the same as for the partially implemented consented scheme.

- 6.3.1 All plant and vehicles engaged in excavation / construction works should either operate outside the RPA, or should run on a temporary surface designed to protect the underlying soil structure.
- 6.3.2 The existing hard surfacing to the front of the site, which will be the focus of construction access arrangements, will be retained in situ and appropriately supplemented to withstand anticipated loading until the main building construction works are completed. At the landscaping stage, the hard surfacing will be first broken up with manual power tools and then carefully lifted with caution by a skilled machine operator again working away from the tree(s).
- 6.3.3 Nuisance deposition can be further mitigated with routine maintenance, light pruning / deadwooding and the fitting of filtration traps on guttering (see Figure 7 overleaf).
