## Arboricultural Consultancy for LV=

Insured		Address	29 Edis Street, London, NW1 8LE		
Client	Subsidence Management Services	Contact	Robbie Taylor	Claim No.	
ES Ref		Consultant	Kirk Thompson	Contact No.	
Report Date	09/03/2023

# GEOTECHNICAL

**29 Edis Street, London, NW1 8LE**

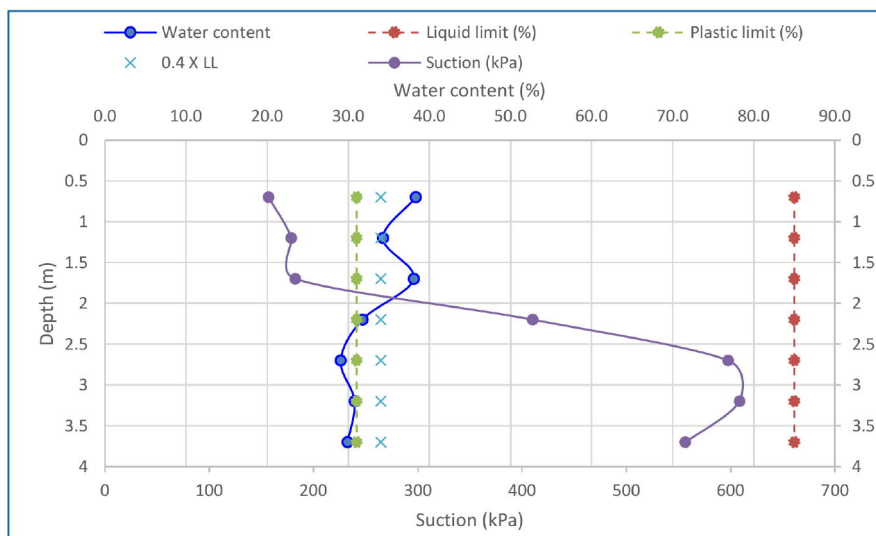
## Samples from BH1

Lab Ref	Depth (m)	WC (%)	LL (%)	PL (%)	PI (%)	.425 mm (%)	mod. PI (%)	Av. Suc. (kPa)	Description
1	0.7	38.3	85	31	54	94	51	157	Firm brown silty CLAY with rare gravel. Gravel is fine
2	1.2	34.3	85	31	54	94	51	179	Firm grey silty CLAY with rare gravel. Gravel is fine
3	1.7	38.1	85	31	54	94	51	182	Firm grey-brown/grey silty CLAY with rare gravel. Gravel is fine
4	2.2	31.7	85	31	54	94	51	410	Firm to stiff grey-brown silty CLAY with rare gravel. Gravel is fine
5	2.7	29.1	85	31	54	94	51	598	Stiff grey-brown silty CLAY with rare gravel. Gravel is fine
6	3.2	30.8	85	31	54	94	51	608	Stiff grey-brown silty CLAY with rare gravel. Gravel is fine
7	3.7	29.9	85	31	54	94	51	557	Stiff grey-brown silty CLAY with rare gravel. Gravel is fine
