University of London
Senate House
Malet Street
London
WC1E 7HU

The University of London submit this Request for listed building consent to carry out maintenance, repair and performance enhancement works to fire doors in Senate House located on Fire Escape Route Staircases within the University of London's demise.

PROPOSED ADDITIONAL FIRE RATED GLAZING TO ORIGINAL 1930S STAIRCASE DOORS TO IMPROVE FIRE PROTECTION TO PROTECTED ESCAPE STAIRCASE.

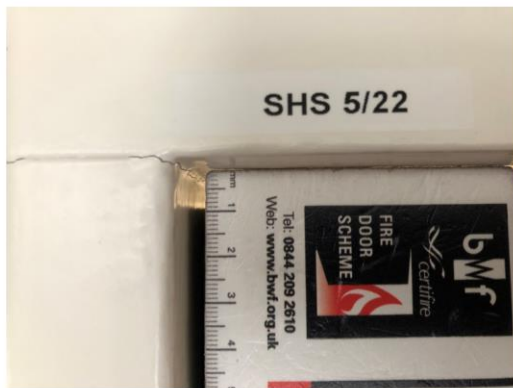
TITLE:
 SENATE HOUSE

REVISIONS:
 The drawing has been updated to include proposed additional fire rated glazing to improve fire protection to protected escape staircase.
 The drawing has been updated to include proposed additional fire rated glazing to improve fire protection to protected escape staircase.
 The drawing has been updated to include proposed additional fire rated glazing to improve fire protection to protected escape staircase.

Note the left hand leaf of this set of double doors leading to the Court, Jessel & Senate Rooms already has a small slotted bead applied (for signage) on top of the original glazing beading. The proposal is to fit additional solid beading to secure the new fire rated glass of the same thickness 12mm and stained, finished to match door. See drawing SENATE FRAW 0001 below.
